SERVICE INFORMATION BULLETIN

APPLICABILITY: 2020-21MY Legacy/Outback 2.4 DIT (Turbo)
2019-21MY Ascent

NUMBER: 02-186-21

SUBJECT: Scavenge Pump Installation- Service Procedure Change

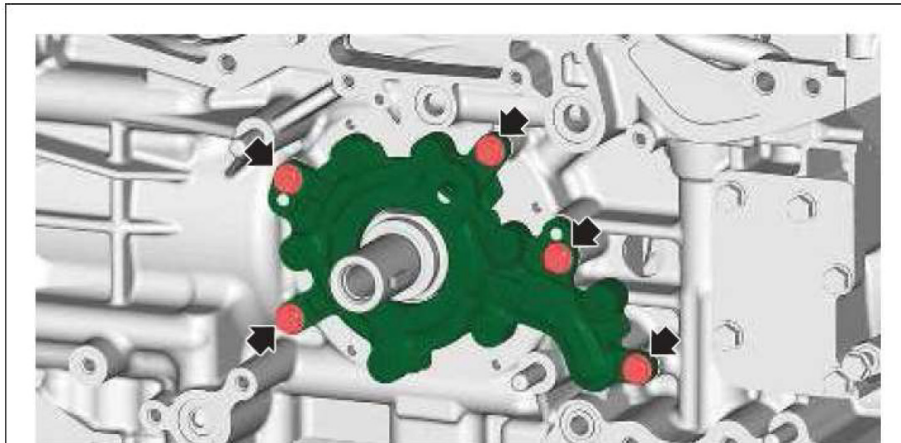
This Service Information Bulletin outlines changes in the service procedure for scavenge pump assembly installation. A two-step torque procedure has been developed to ensure proper pump to cylinder block contact and optimize sealing.

The five (5) bolts shown in the illustration above are affected.

STEP 2) Install the scavenge pump and temporarily tighten the bolts in a star pattern.

Initial tightening torque:

5.9 Nm (4.4 ft.-lbs. or 53 inch-lbs.)

Confirm the scavenge pump is properly seated to the cylinder block and final torque the bolts in a star pattern.

Final tightening torque:

6.4 Nm (4.7 ft.-lbs. or 56 inch-lbs.)
