Technical product information

Topic	Creaking noise from the rear seats (5 and 7 seat variants only)
Market area	Bentley: worldwide (2WBE)
Brand	Bentley
Transaction No.	2063240/1
Level	EH
Status	Approval
Release date

Creaking noise from the rear seats (5 and 7 seat variants only)

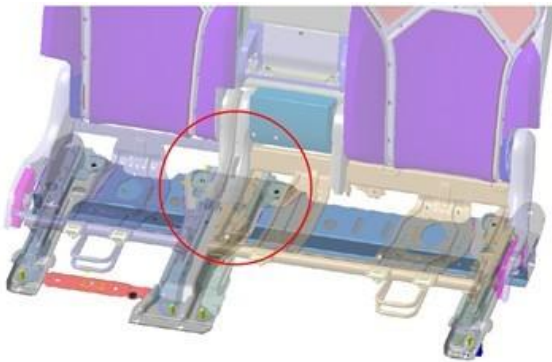
1) Refer to Figure 1 - The area shown should be considered after removing the applicable trim from the seat frame as per applicable Repair manual-Rep.Gr

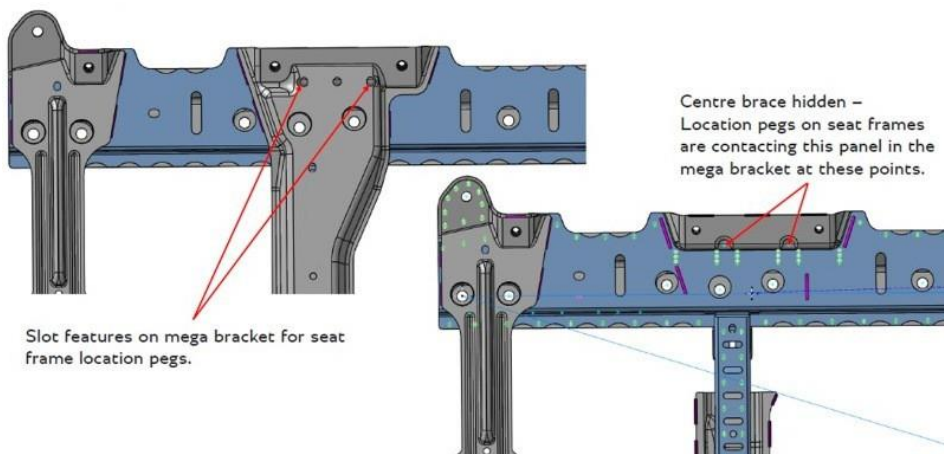
Figure 2

- Refer to Figures 2 and 3 to check for any signs of contact between the Mega bracket and the seat location pegs

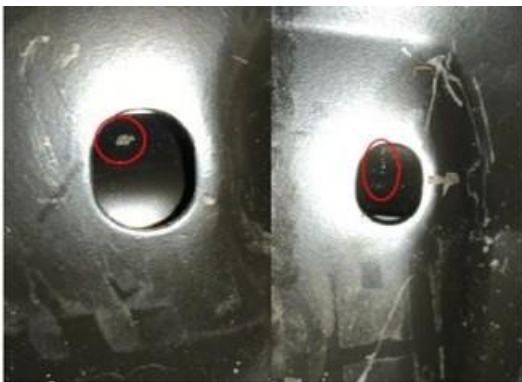
Figure 4

- Inspect both the Mega bracket (Figure 4) and the Seat frame location pegs (Figure 5) to confirm if there is evidence of contact

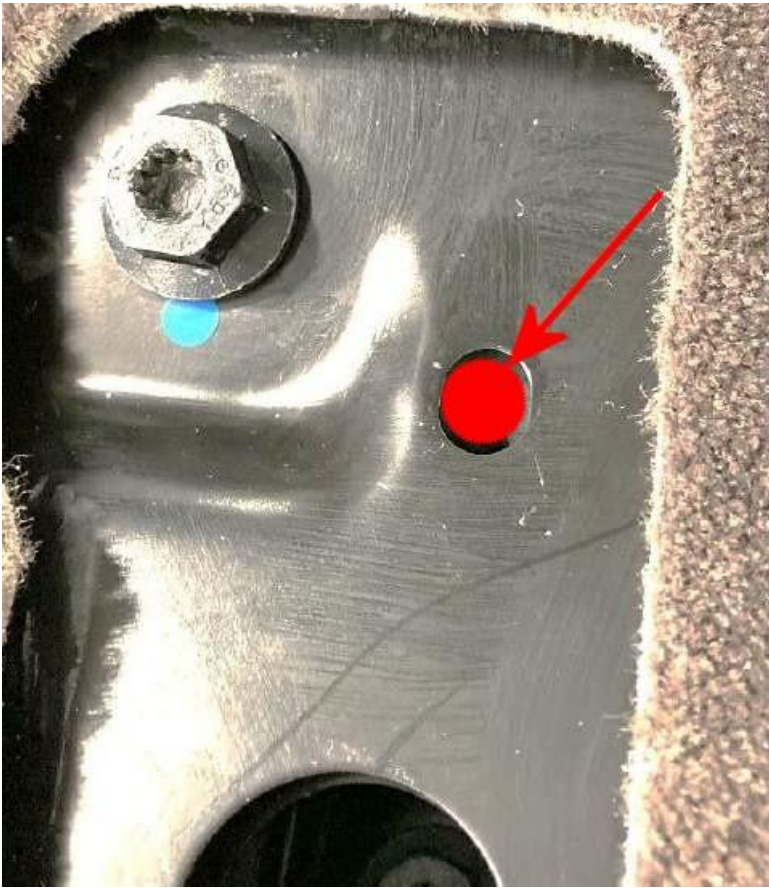
In the holes of the Mega bracket (Where the seat location pegs are chaffing - witness marks are evident) against the mega bracket

- Referring to Figure 6 - Apply/stick Paraskin tape

Apply/stick a Velcro patch/pad

TIP: Do not use Anti creak tape as this is too thin

NOTE: The loop side not the hook side should be used and MUST be facing upwards
