## Technical product information

<b>Topic</b>	Vehicle vibration / humming at idle - Active engine mount leak - Active engine mount replacement
<b>Market area</b>	Russische Föderation (5RU),Australia E04 Bentley rest Asia and Australia (6E04),China 796 VW Import Comp. Ltd (Vico), Beijing (6796),Germany E02 Bentley rest Europe (6E02),Japan E03 Bentley Japan (6E03),Korea, (South) E08 Bentley South Korea (6E08),United Arab Emirates E06 Bentley Middle East and Africa (6E06),United Kingdom E01 Bentley UK (6E01),United States E05 Bentley USA and rest America (6E05)
<b>Brand</b>	Bentley
<b>Transaction No.</b>	2060418/2
<b>Level</b>	EH
<b>Status</b>	Approval
<b>Release date</b>

Vehicle vibration / humming noise at idle

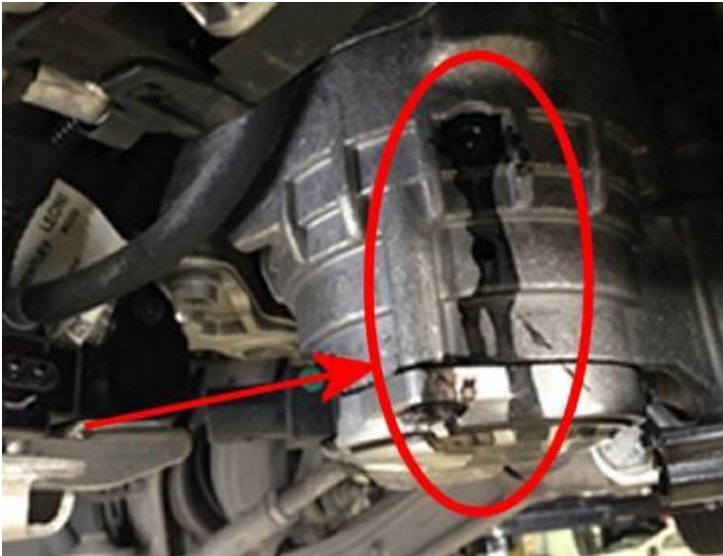
Figure 1

Right hand Active Engine Mount (AEM) failed, oil may also be leaking from the AEM (Figure 1). This failure mode is only seen on W12 engine installations and is only apparent at idle

Current software is incompatible with AEM part numbers 4M0 199 255/6 BH.

When the AEM's are replaced with the above part numbers, the AEM control module must be reprogrammed or replaced as detailed within the onward instructions

In the event of a failure / complaint as detailed, then replace the right and left hand AEM with 4M0 199 255 BH and 4M0 199 256 BH

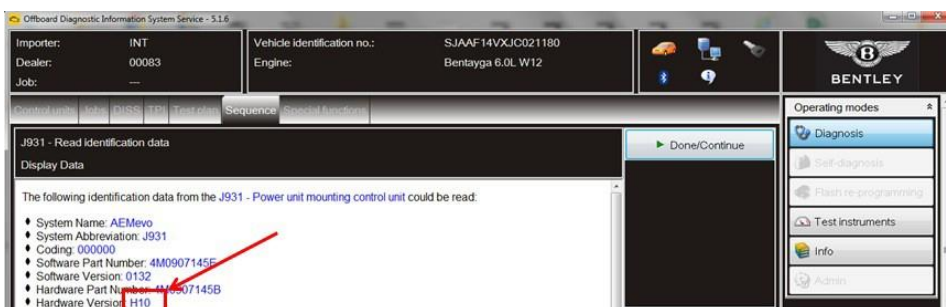
Figure 2 shows the Hardware version number at H10

- Should the Hardware version number not be H10, you must replace the AEM control module with part number 4M0 907 145 E.
