Polaris Industries Inc.
Product Development Center
 7290 Viking Blvd E
 Wyoming, MN 55092
 T: 651-408-7579
 F: 651-408-7605
 December 3, 2015

RE: 579.5 Notices, bulletins, customer satisfaction campaigns, consumer advisories, and other communications for the month of November, 2015.

Bulletin Number: I-15-04
Model Year(s): 2015-2016

SUBJECT: 2015-2016 Indian Full Size Motorcycles – Rear Master Cylinder Repair

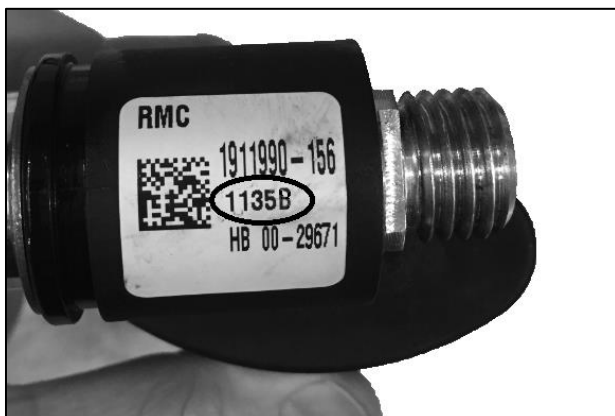
Include the Vehicle Identification Number (VIN) and the date code located on bottom of the master cylinder housing (refer to image below). **NOTE:** Date code is also pin stamped on the master cylinder housing under the label.

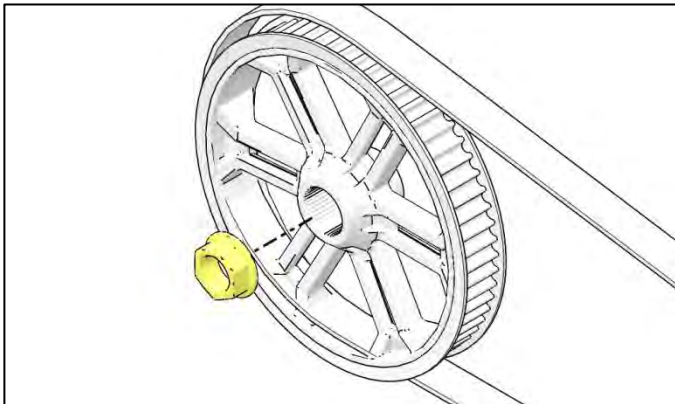
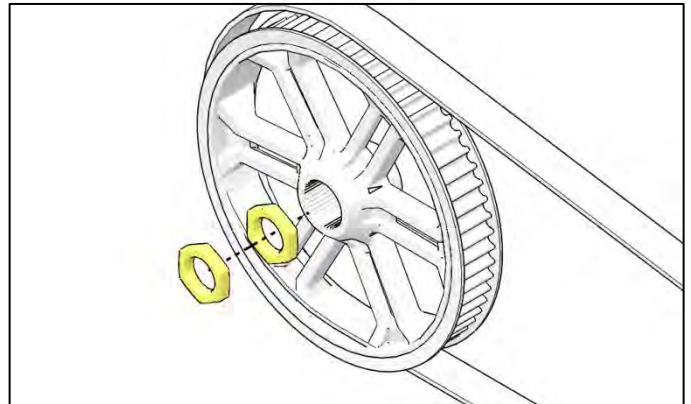
The Slingshot Division of Polaris Industries has developed updated rear sprocket retaining nuts and Loctite® on 2016 Slingshot models manufactured after 11/02/2015. The single hex flanged-style nut has been replaced with two hex head nuts. Loctite® 641 (Yellow) applied to the rear axle splines and threads has been replaced by Loctite® 680 (Green).

1. A clicking or popping noise from the rear axle area during low speed operation
NOTE: This noise is similar to and may be mistaken for a damaged rear wheel bearing
2. Reduced clamp force on the rear sprocket nut
3. A service procedure requiring removal of the rear sprocket is performed

Updated rear sprocket retaining nuts and Loctite® should be installed on any vehicles built prior to 11/2/2015 if any of the following conditions are encountered:

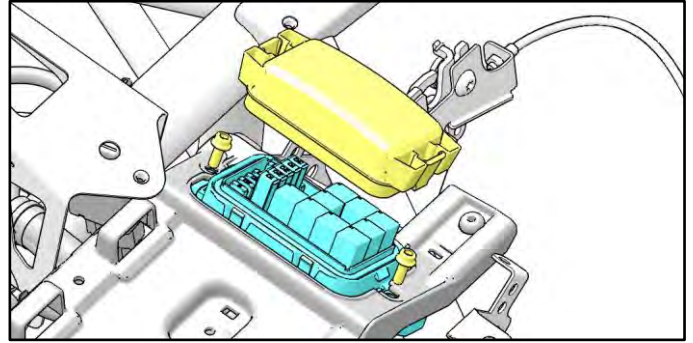
1. Park the vehicle on a level surface and apply the parking brake. Raise the hood.
2. Remove the fuse box cover.
3. Remove the Primary Light Relay. Inspect the fuse box pins for damage.
4. If no damage is observed, proceed to HEADLIGHT JUMPER HARNESS INSTALLATION procedure.
5. If damage is observed, photograph the damaged pins and submit an Ask Polaris case for further guidance before beginning installation procedure.
