SS 1032728 Bulkhead Module Fault Codes 524280 thru 524286 with FMI 7 Clarification

This solution only applies to vehicles that were built with a Bulkhead Module (BHM).

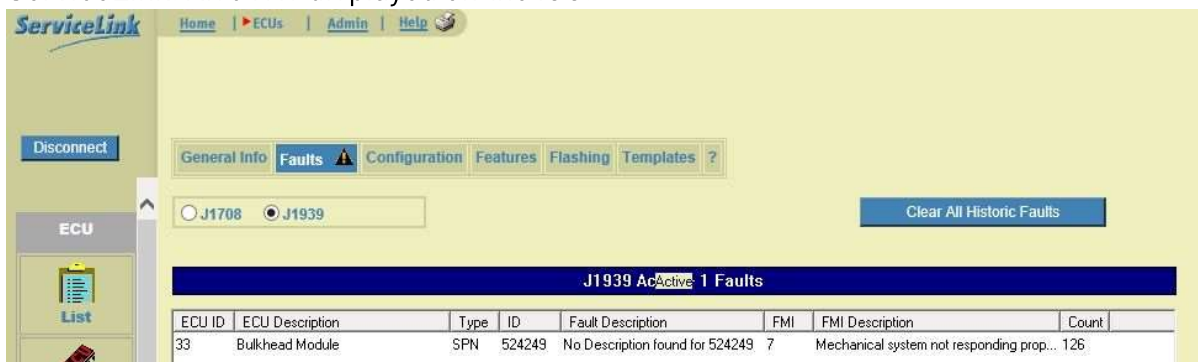
Kyle, we have another truck from same customer. JE5179. Here is screen shot from ServiceLink. Also it is displayed on the ICU.

524249/7 = Missing Smart Switch
