SERVICE BULLETIN

Classification: DA21-003	Reference: NTB21-040	Date: May 20, 2021
-----------------------------	-------------------------	-----------------------

2021 ROGUE; DTCS B2740-87, B2744-87, AND/OR B274D-87 STORED

APPLIED VEHICLE: 2021 Rogue (T33)

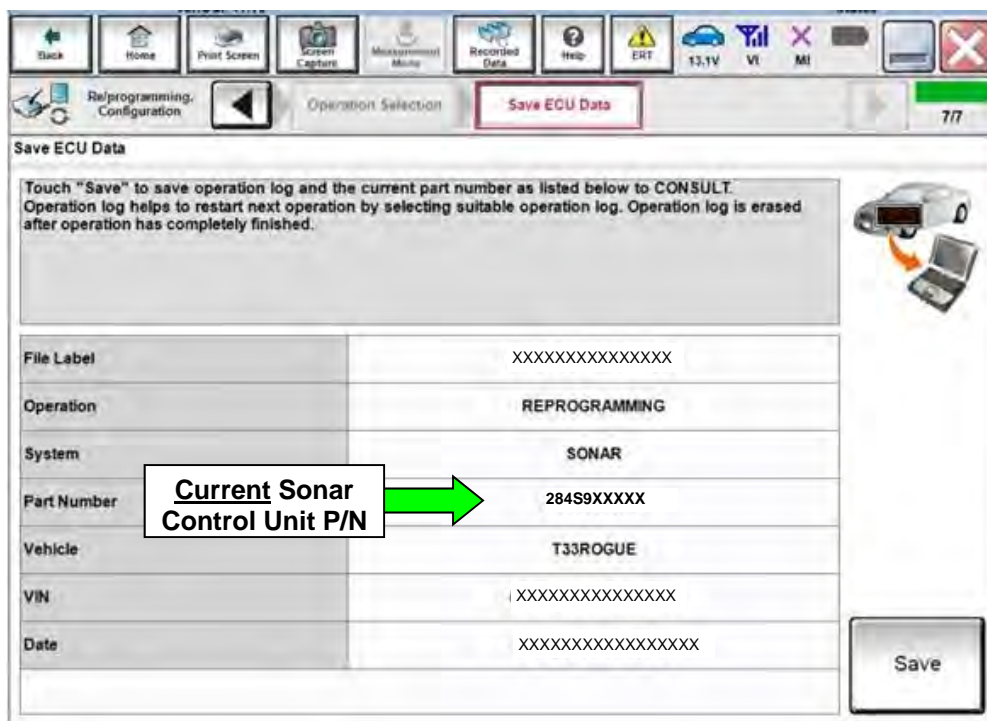
Figure 15

23. When you get to the screen shown in Figure 15, confirm that a reprogram is available as follows:

a. Find the Sonar Control Unit **Part Number** and write it on the repair order.

b. Compare the part number you wrote down to the part numbers in **Table A**.

- If there is a match in **Table A**, continue with the reprogramming procedure.
- If there is not a match in **Table A**, this bulletin does not apply. See the ESM for further diagnostic information.

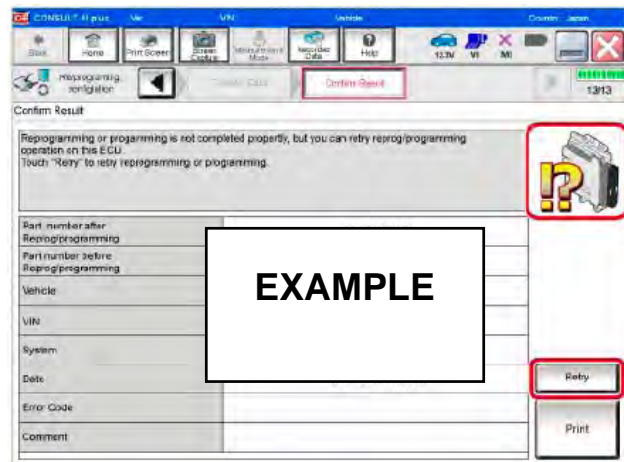
Figure 27

If reprogramming does not complete and the “!?” icon displays as shown in Figure 27:

- Check battery voltage (12.0 - 15.5 V).
- Ignition is ON, engine OFF.
- External Bluetooth® devices are OFF.
- **All electrical loads are OFF.**
- **Select retry and follow the on screen instructions.**
- “Retry” may not go through on first attempt and can be selected more than once.

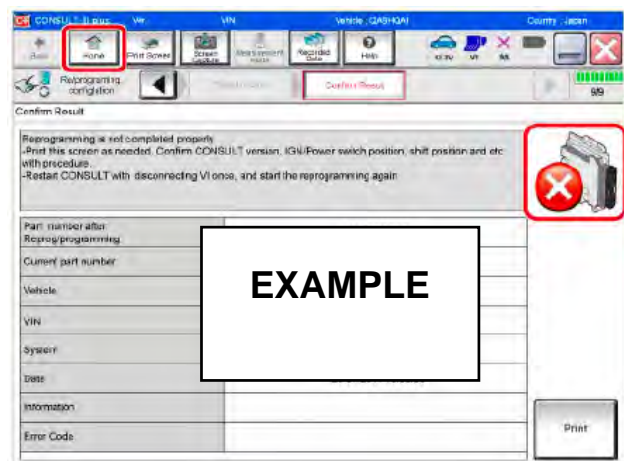
Figure 28

If reprogramming does not complete and the “X” icon displays as shown in Figure 28:

- Check battery voltage (12.0 - 15.5 V).
- CONSULT A/C adapter is plugged in.
- Ignition is ON, engine OFF.
- Transmission is in Park.
- All C-III plus / VI cables are securely connected.
- All C-III plus updates are installed.
- **Select Home, and restart the reprogram procedure from the beginning.**

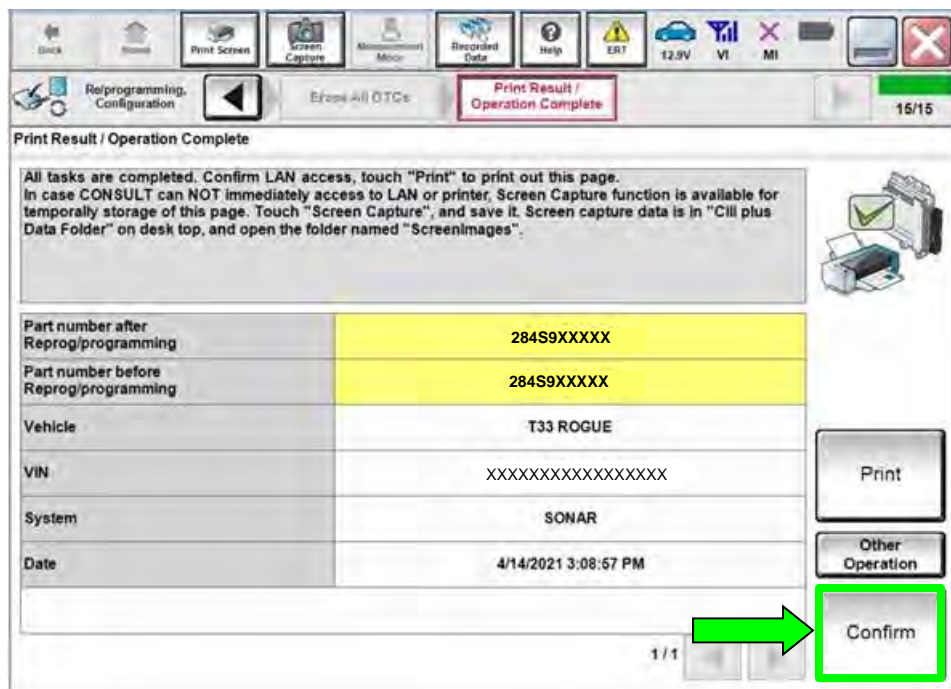
HINT: When the entire reprogramming process is complete, the screen in Figure 30 will display.

41. Verify the before and after part numbers are different.
42. Print a copy of the screen below (Figure 30) and attach it to the repair order for warranty documentation.
