PIT5840 Wind Noise From Either Front door(s) While Driving

Brand:	Model:	Model Years:	VIN:		Engine:	Transmissions:
			from	to		
Buick	Envision	2021	All	All	All	All
Involved Region or Country	North America					
Condition	Wind Noise From Front Door(s) While Driving					
Cause	Improper installation or missing foam seal in either front door.

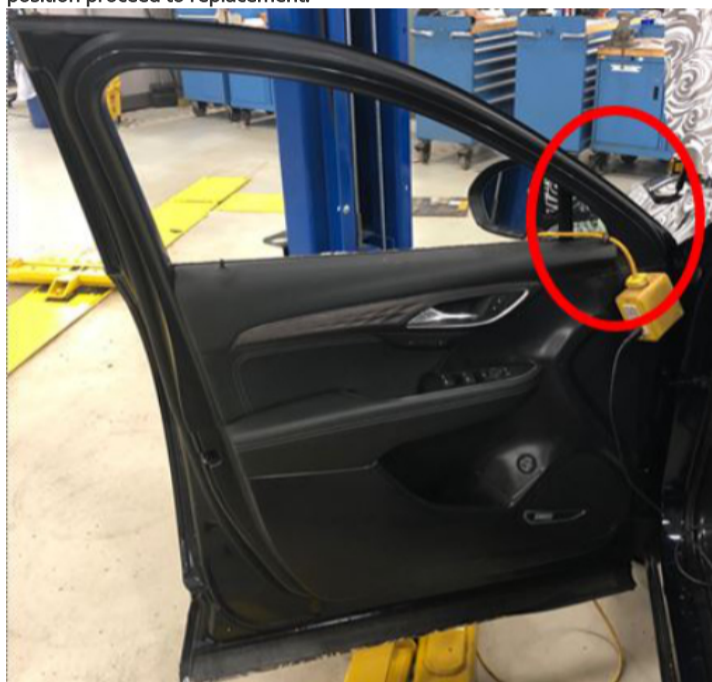
Open affected front door and pull back the seal on the window run channel (see highlight). Inspect the Window Stuffer If out of position proceed to repair. If out of position proceed to replacement.

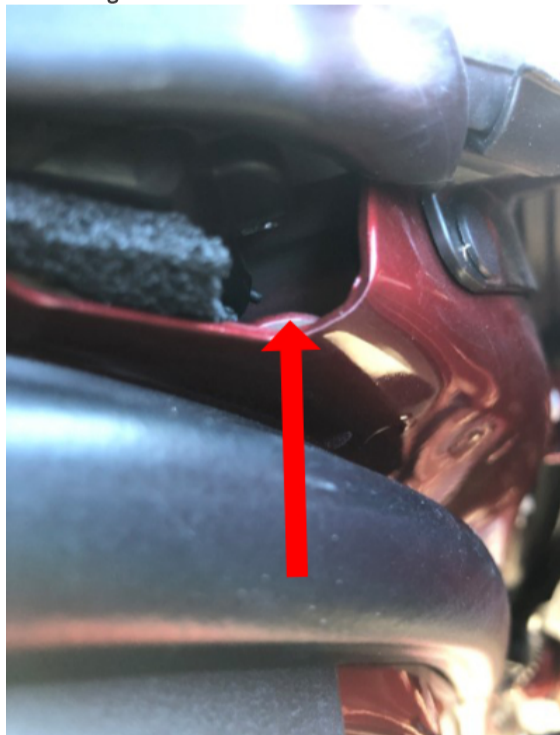
Seal Missing

If the seal is missing the Front Side Door Window Weather strip will need to be removed to add the Window Stuffer.

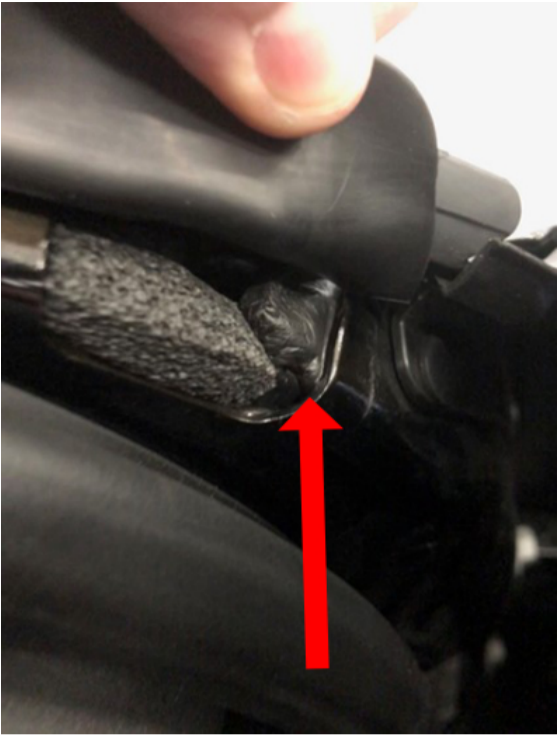
Seal Properly Installed

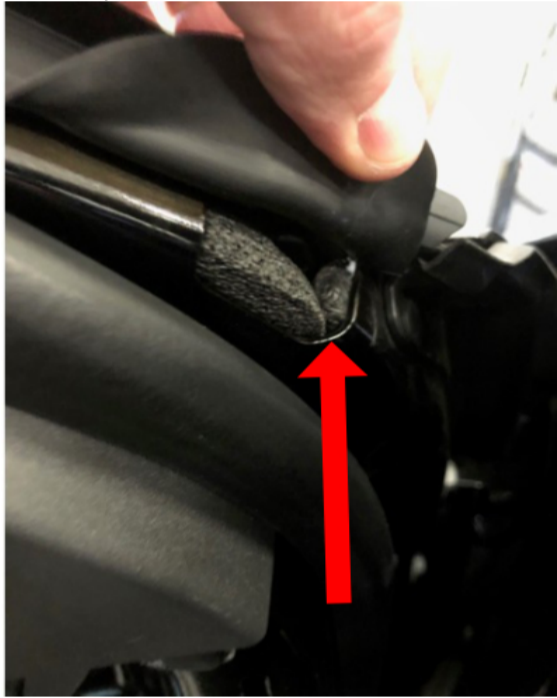
Seal out of position (Note how it sits lower)

If the seal is mispositioned the Window Upper Reveal Molding (1) and Belt Molding (2) need to be removed to access the area to add the 3M Strip Caulk.

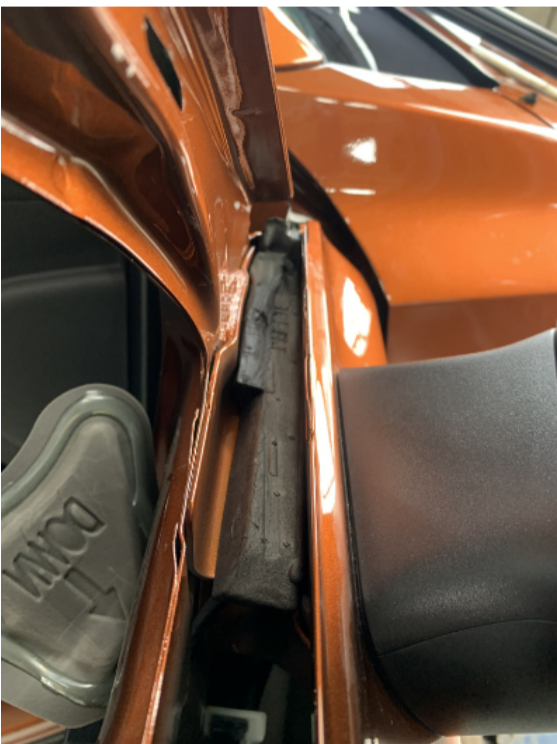
Void where Stuffer will go with Front Side Door Window Weather strip removed

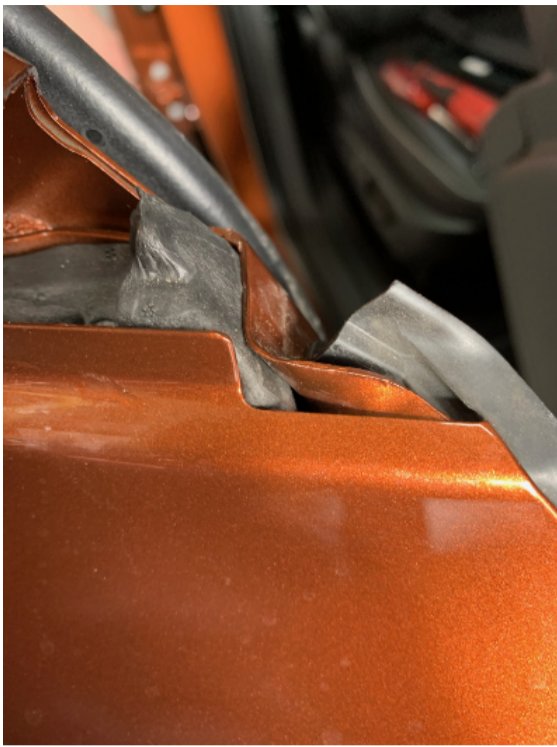
Proper Stuffer orientation in the channel

Please Make sure before installing Window Run Channel that the Stuffer is properly oriented.
