GLOBAL SAFETY FIELD INVESTIGATIONS
DCS5785
URGENT - DISTRIBUTE IMMEDIATELY

Subject: REVISION: N202307080-01 - Service Update
Auto Stop with Low Battery State of Charge
Labor Codes Added for T1 SUV Vehicles

N202307080 Auto Stop with Low Battery State of Charge

Revision: 01

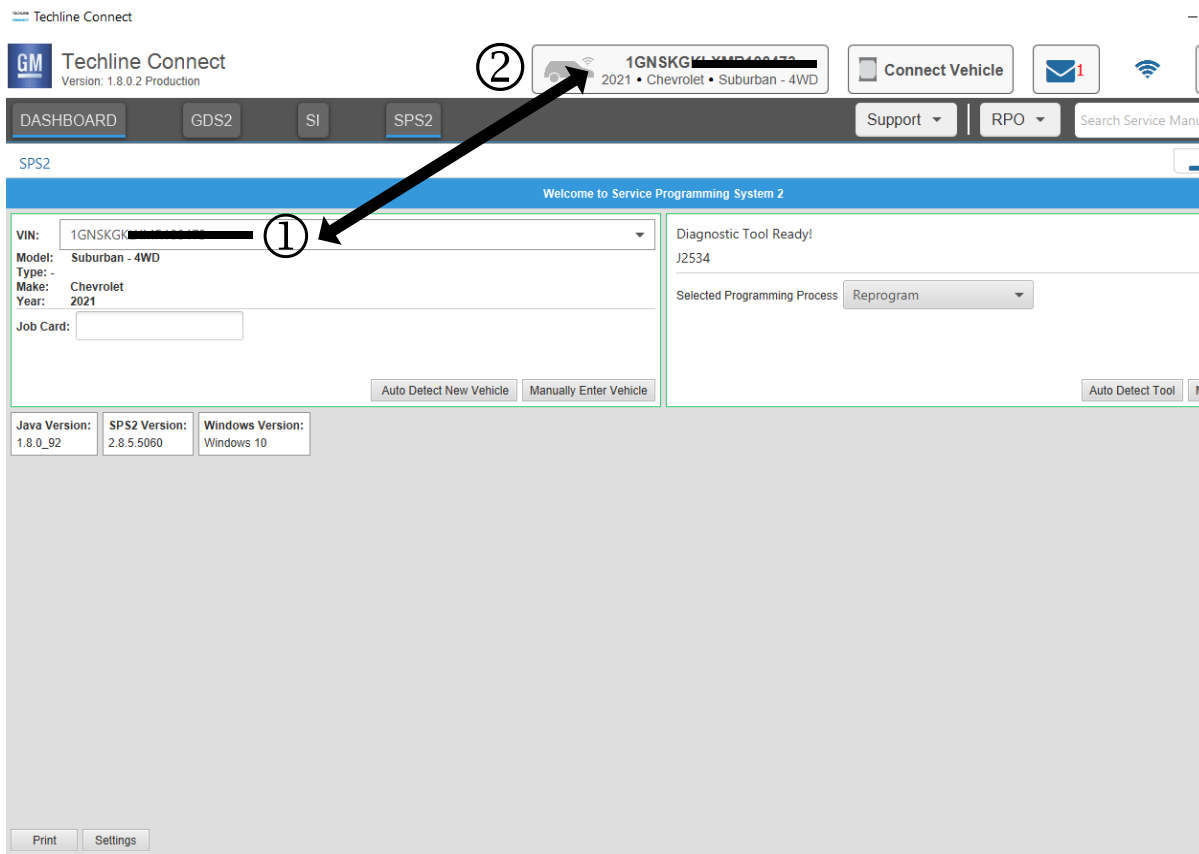
5743643

Caution: Be sure the VIN selected in the drop-down menu (1) is the same as the vehicle connected (2) before beginning programming.

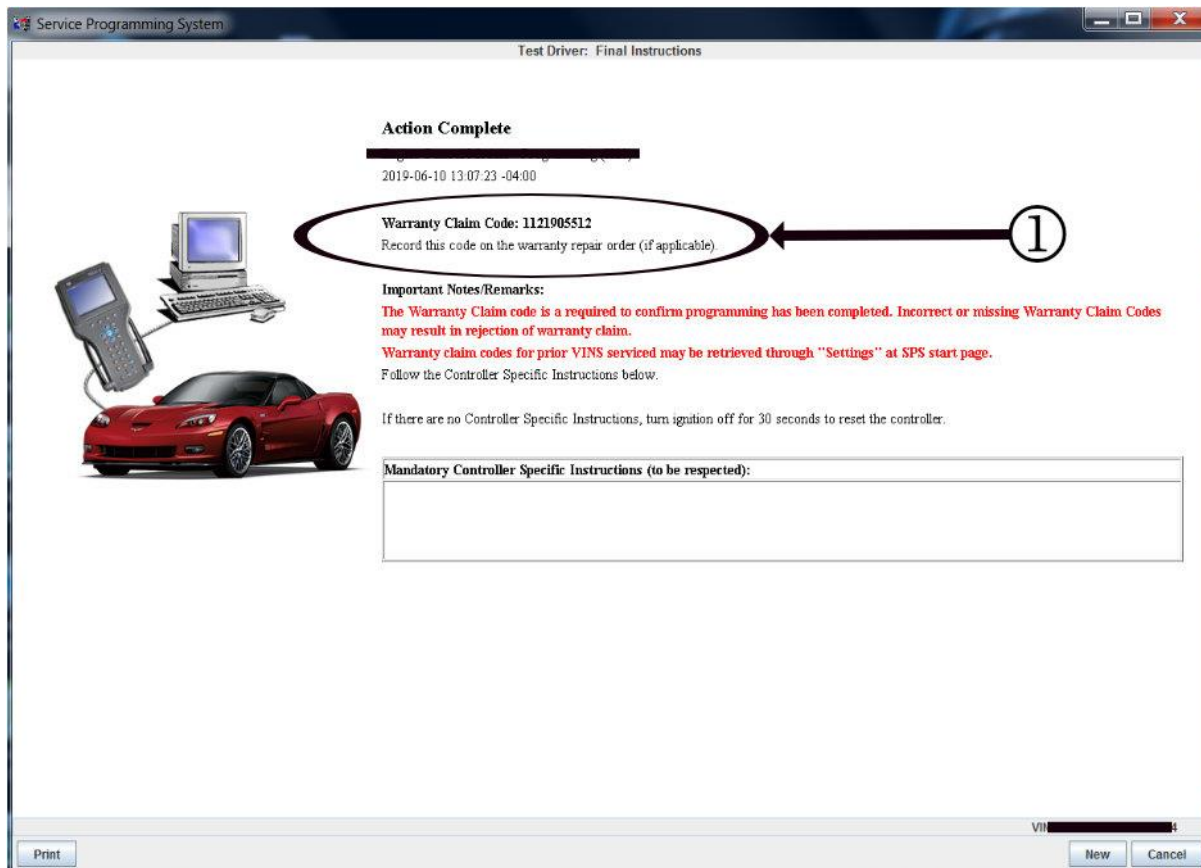
5431209

Important: To avoid warranty transaction rejections, you **MUST** record the warranty claim code provided on the Warranty Claim Code (WCC) screen shown above on the job card. Refer to callout 1 above for the location of the WCC on the screen.

- Record SPS Warranty Claim Code on job card for warranty transaction submission.
