Service Journal

Head Lamp Washer pump not available

REF NO: 1000772	ISSUING DEPARTMENT: Customer Service	REVISIONS:
CATEGORY: Parts & Logistics	SUBCATEGORY: General	CAR MARKET: United States and Canada
ISSUE DATE: 2021-05-19	STATUS DATE: 2021-05-19	Page 1 of 17

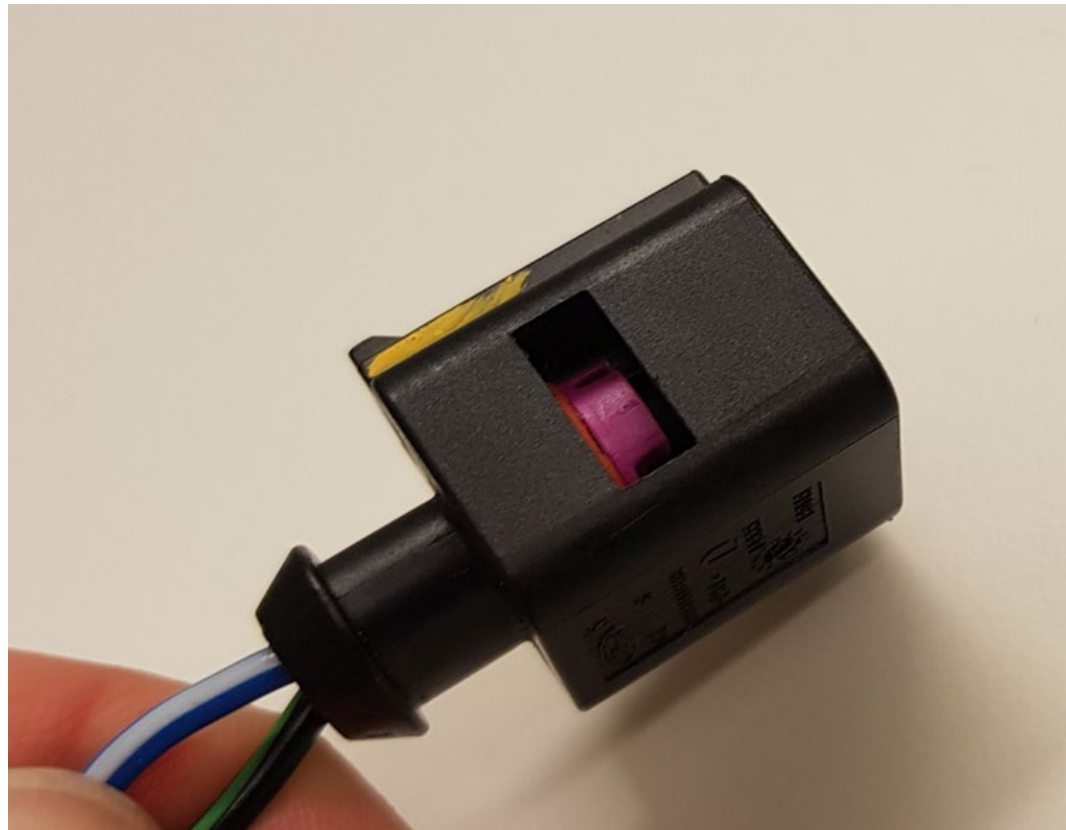
Repining of connector PN 9187020

Identify the connector with PN 9187020. se next slide

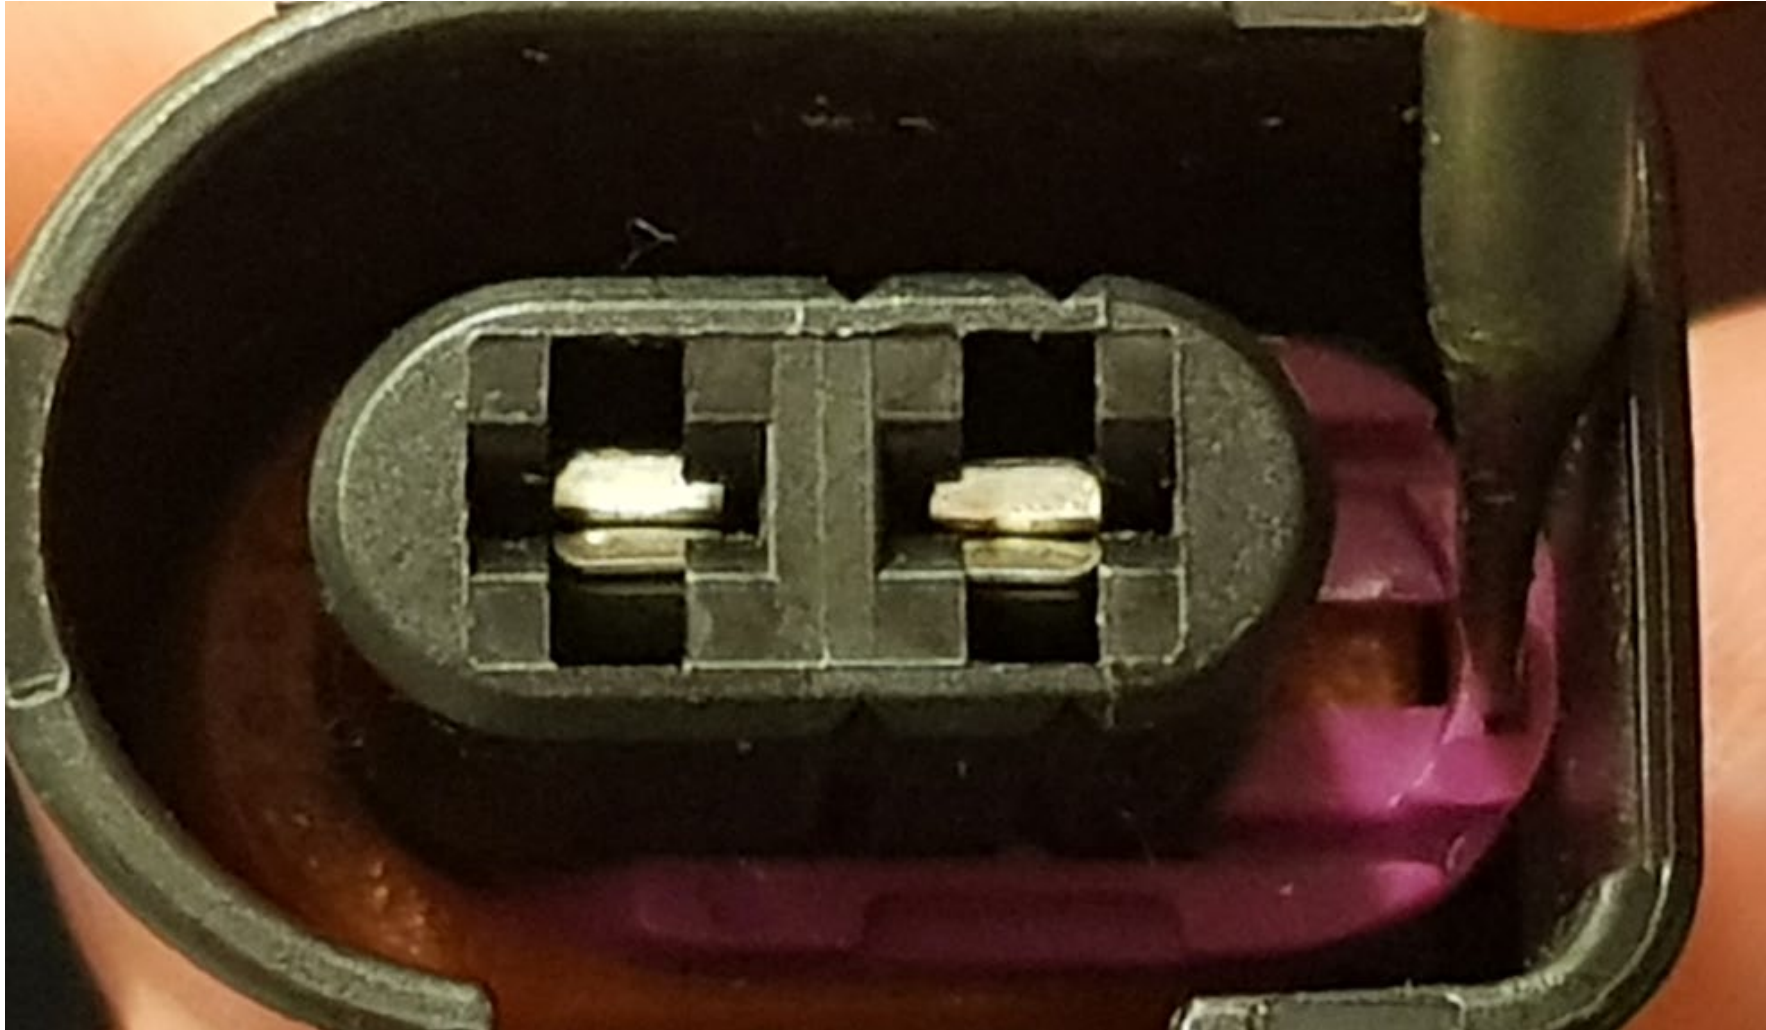
In open position

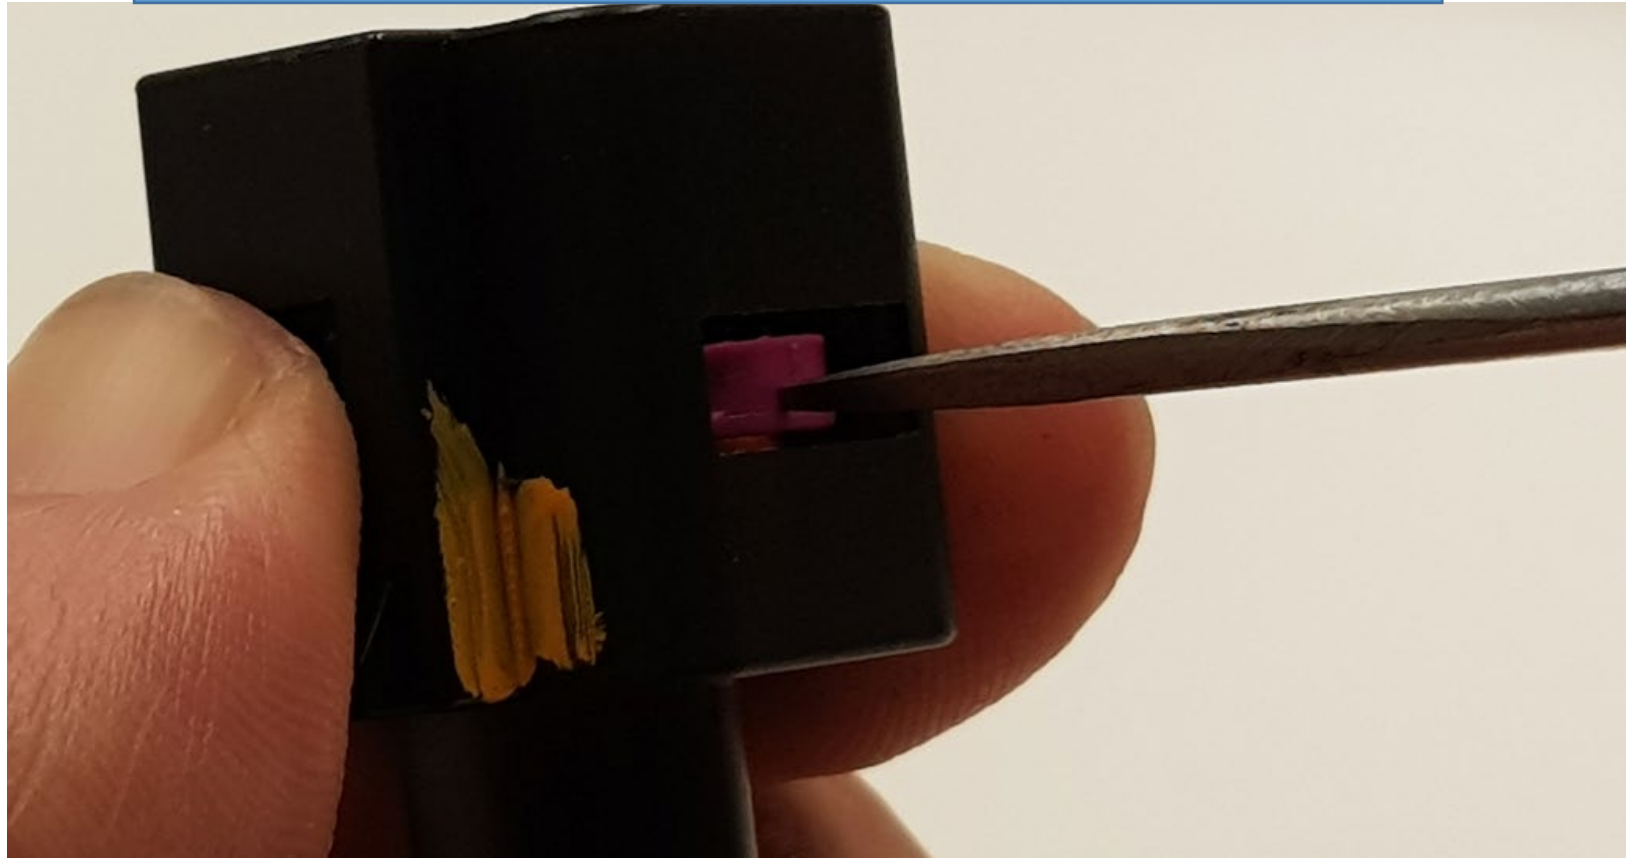
Currently cavity 1 is having BU/WH cable. This one shall be pushed in to cavity 2.
BK/GN which is in cavity 2 shall be added in to cavity 1

When terminal are in position make push pull. Than insert the TPA and again make push pull on the wire. This to assure that there is no unseated terminals. See next slide

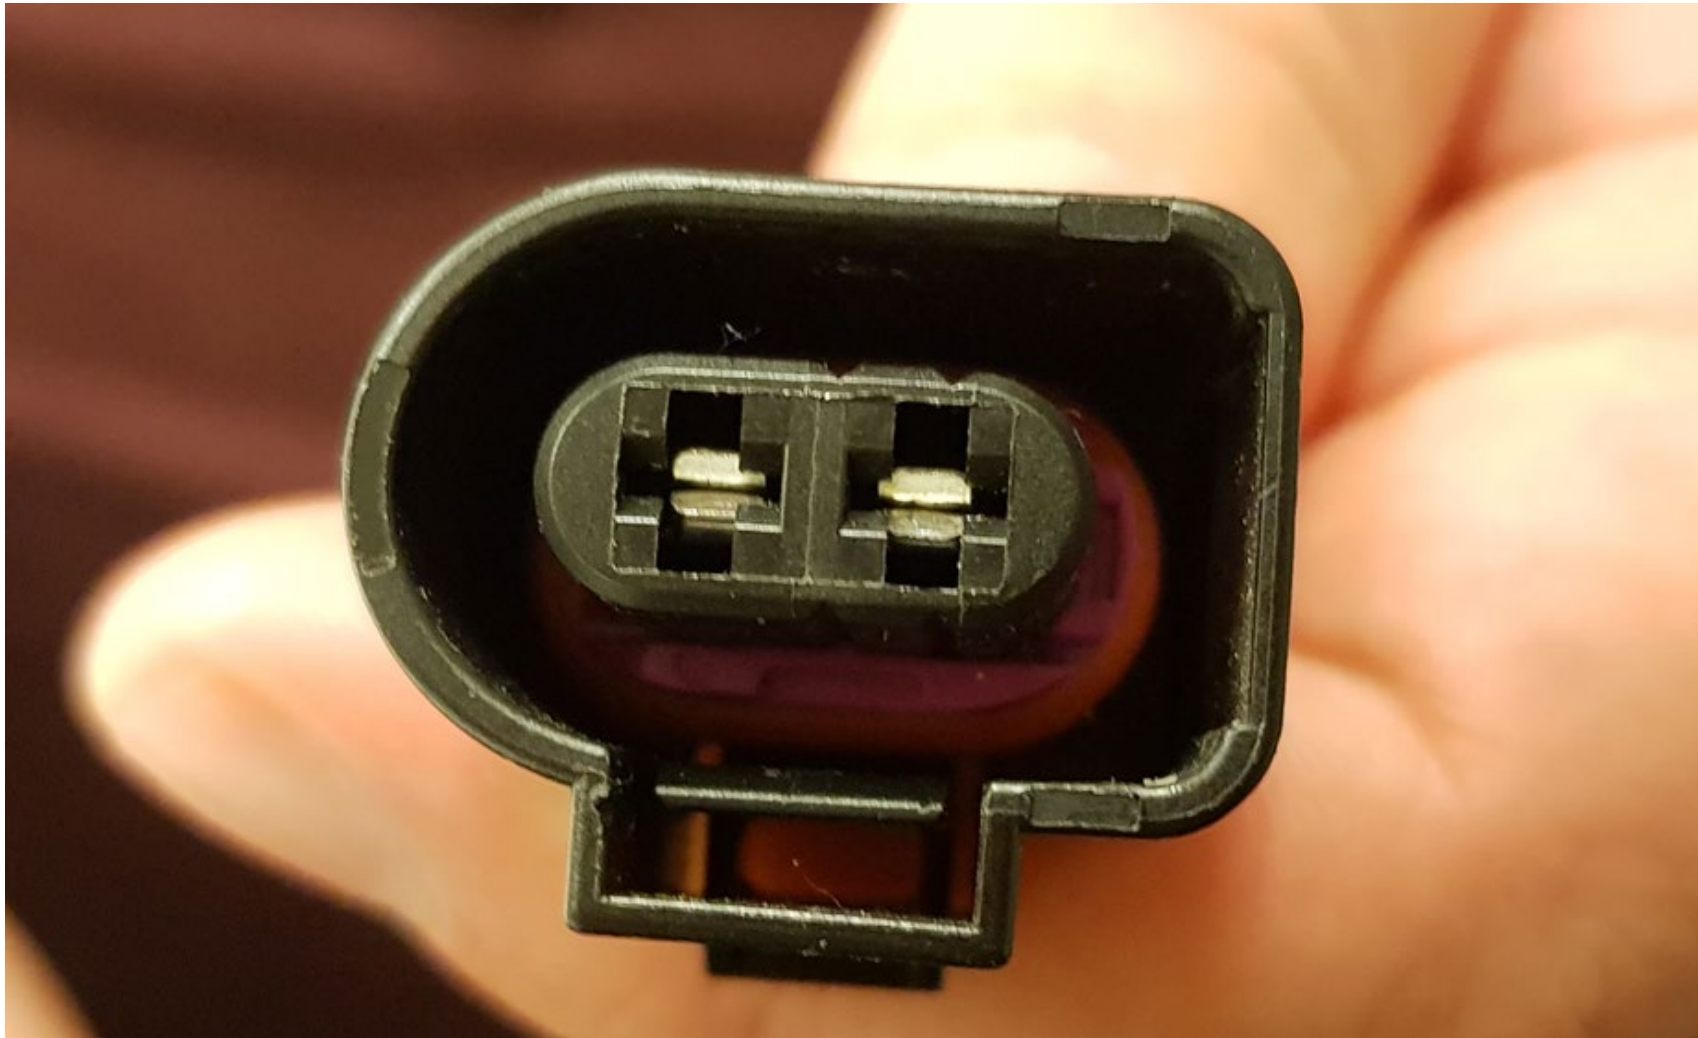
Terminal in correct position
