**Polestar 2: Charging Issues at Signet Charging Stations (Information Only)**

<b>REF NO:</b> TJ 35800.1.2	<b>ISSUING DEPARTMENT:</b> Technical Service	<b>CAR MARKET:</b> United States and Canada	
<b>PARTNER:</b> 3 US 7515		<b>ISSUE DATE:</b> 2020-12-02	<b>STATUS DATE:</b> 2021-05-17
<b>FUNC GROUP:</b> 3234	<b>FUNC DESC:</b> Onboard charger, high voltage	Page 1 of 3

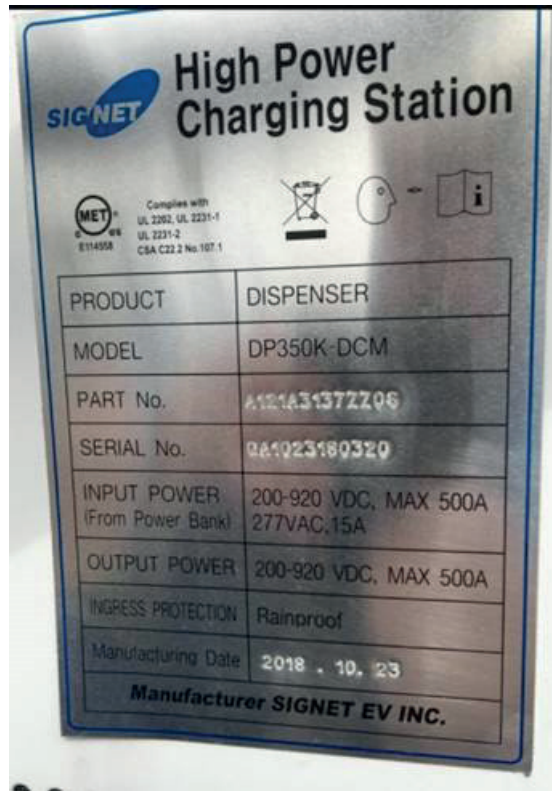
File Name	File Size
Example_Signet_Metal_Sign.jpg	0.0392 MB

Please submit a Vehicle report if this issue is encountered and include a picture of the metal sign (see Example\_Signet\_Metal\_Sign.jpg) on the side of the HV charging station whenever possible.
