# Technical Service Bulletin

**8 Noises from the engine compartment are heard inside the vehicle (via the intermediate steering shaft)**

48 21 04 2063528/1 June 9, 2021.

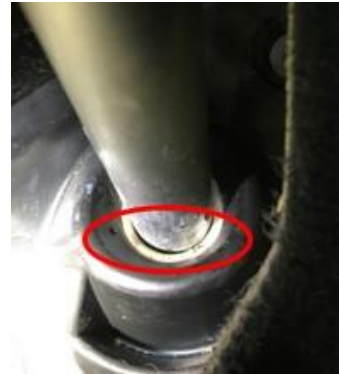
There are multiple causes of noise being transmitted from the engine compartment to the interior of the vehicle. A possible cause of noise being transmitted from the engine compartment is insufficient noise insulation at the opening for the intermediate steering shaft in the bulkhead.

1. Therefore, check whether the sealing boot is seated correctly on the intermediate steering shaft and on the bulkhead without any visible gaps (Figure 1).

**Figure 1.** Poor sealing on the intermediate shaft.

2. The noise may also be influenced by the height adjustment of the steering wheel.
3. If a similar condition is found in the vehicle, then proceed with intermediate steering shaft replacement following instructions according to the Elsa repair manual, *Chassis >> Suspension, Wheels, Steering >> 48 Steering >> Steering Column >> Steering Intermediate Steering Shaft, Removing and Installing.*
