Technical Service Bulletin

90 Audi virtual cockpit's display is blank, DTC U10C000 is stored in the information electronics control module

90 21 05 2063106/1 June 10, 2021.

Model(s)	Year	VIN Range	Vehicle-Specific Equipment
A4, A5	2020	All	Audi virtual cockpit

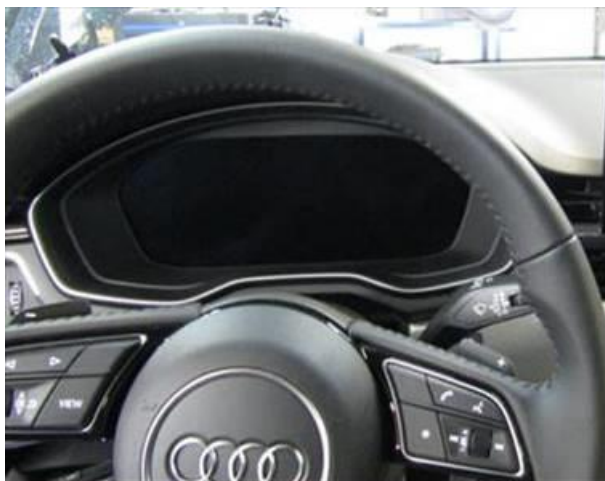
- After opening the driver's door, the Audi virtual cockpit doesn't start up and remains blank (Figure 1).

Figure 1. Audi virtual cockpit is blank.

- **DTC U10C000** (Control module for instrument panel insert on optical data bus no communication) with symptom code 6696.

A software malfunction in the instrument cluster can cause it to fail to start up.

- Update the MIB3 infotainment system using either Method 1 or Method 2 according to TSB 2060523: *91 MIB3 Software Update Instructions* and use SVM code FPK2US0067.

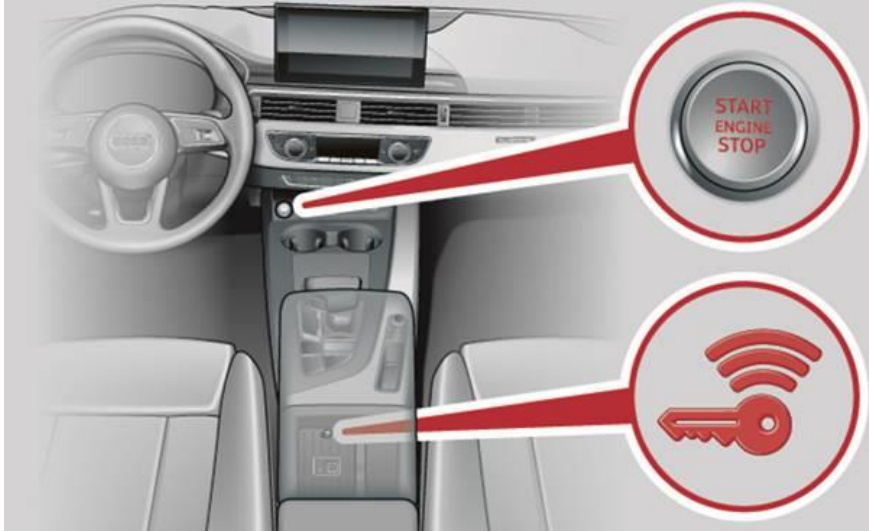
Figure 2. Location of the key reader coil.

- Place the vehicle key over the key reader coil and leave it there until the update is completed (Figure 2).
