91 Function on Demand (FoD): purchased functions are not available in the vehicle

91 21 08 2063290/1 June 16, 2021.

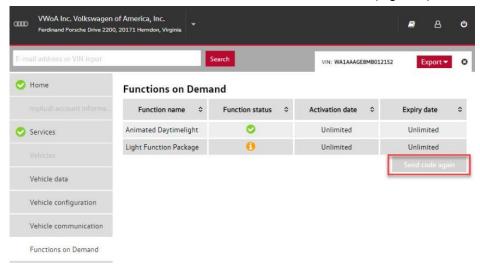
Figure 1. Resending activation to the vehicle using Service Portlet.

- 1. To do this, the vehicle needs to be at a location with good GPS and LTE network signal.
- Use the Service Portlet to resend the activation to the vehicle (Figure 1).

3. Perform an MMI reset (press and hold volume control >10 sec.)
