### **Low Pressure – Fuel Leak From Clamps**

Updated: 05/21/2021

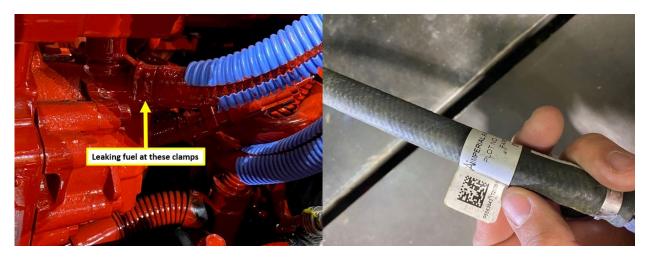
lam part of Gillig quality team, I got your contact info from . We are currently having issues with fuel lines leaking fuel at the clamps, is replacing another 2 hoses today. Have you started a failure analysis or found a root cause of this issue yet? Please let me know what has been found.
