Campaign No. 2021050003, May, 2021

SUBJECT: **Model 907 Sprinter, Model Year 2019-2020**
Inspect Power Steering Hose Clamps

Mercedes-Benz AG (“MBAG”), the manufacturer of Mercedes-Benz and Freightliner vans, has determined that on certain Mercedes-Benz and Freightliner Sprinter vehicles from platform 907 (VS30), the hydraulic power steering return line hoses may detach at their connection points under certain operating conditions and may cause hydraulic fluid to leak resulting in the loss of power steering. If the hydraulic power steering hose detaches, the driver will still have manual steering functionality, but increased steering effort is needed, particularly at low speeds. Sudden loss of power steering as well as the loss of hydraulic steering liquid to the road surface may increase the risk of a crash. An authorized Mercedes-Benz or Freightliner Sprinter dealer will check the return line connections of the power steering system and if needed, install the respective replacement clamp.

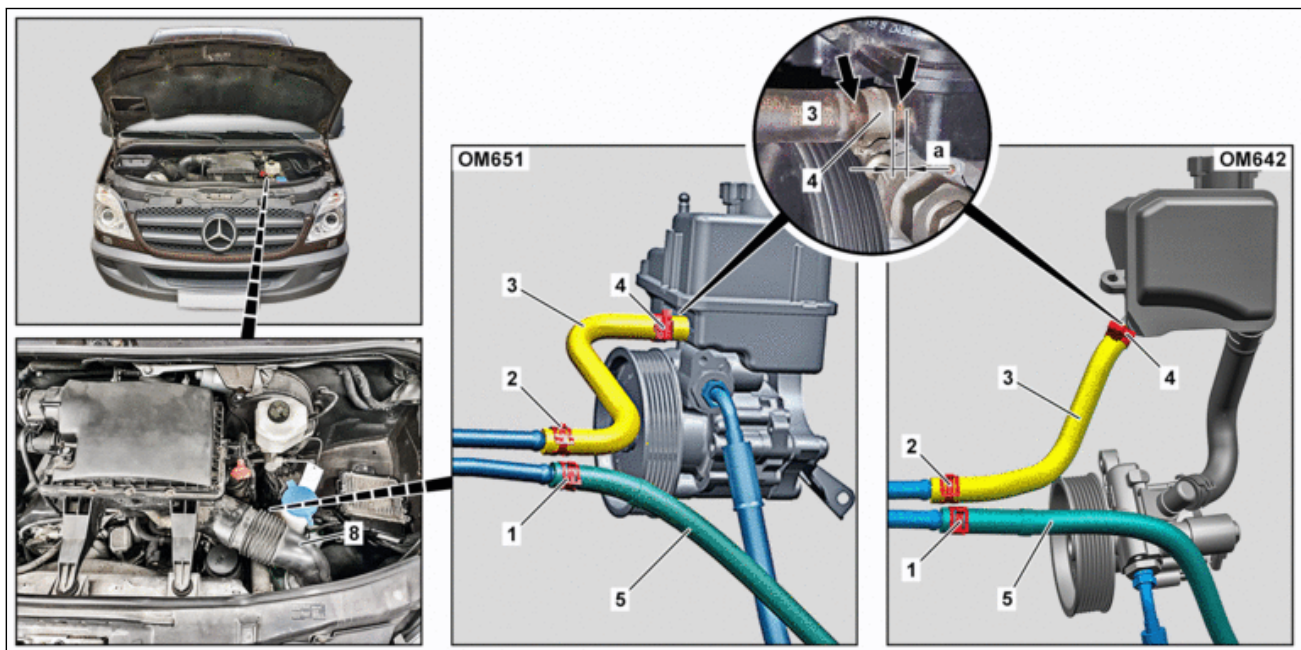
D46.25-A008-79

All 3 clamps (1, 2, 4) together with the listed connections must always be checked.

On vehicles with engine 642, the as-built configuration may deviate slightly (see first picture), which does not impair the procedure shown here.

- 1 Clip
- 2 Clip
- 3 Return hose
- 4 Clip
- 5 Low-pressure hose
- 8 Air ducting
- a Dimension (2 to 4 mm)

2	Remove air ducting (8).		
3	Check hydraulic hoses and clamps (1, 2) of power steering.	<p>i</p> <p>Check the following points:</p> <ul style="list-style-type: none"> → Check both connections of hydraulic lines for leak tightness. → Check installation position of clamps (1, 2) on respective hydraulic hose. The clamps must be seated centrally between the markings (arrows) on the hoses. <p>Also check whether the distance indicated by dimension (b) is maintained. See specification in picture.</p> <p>If clamps (1, 2) are not correctly positioned or if there is a leakage (see fail image above),</p> <p style="text-align: center;">↓</p> <p>replace affected clamp (1, 2). To do so, see operation step 5 onward in reference document.</p> <p>Replace clamps on hydraulic hoses of power steering (code: NV3LETULPX, acc. no.: 46 950 80)</p>	<p>SM46.25-D-0032-02SG</p>

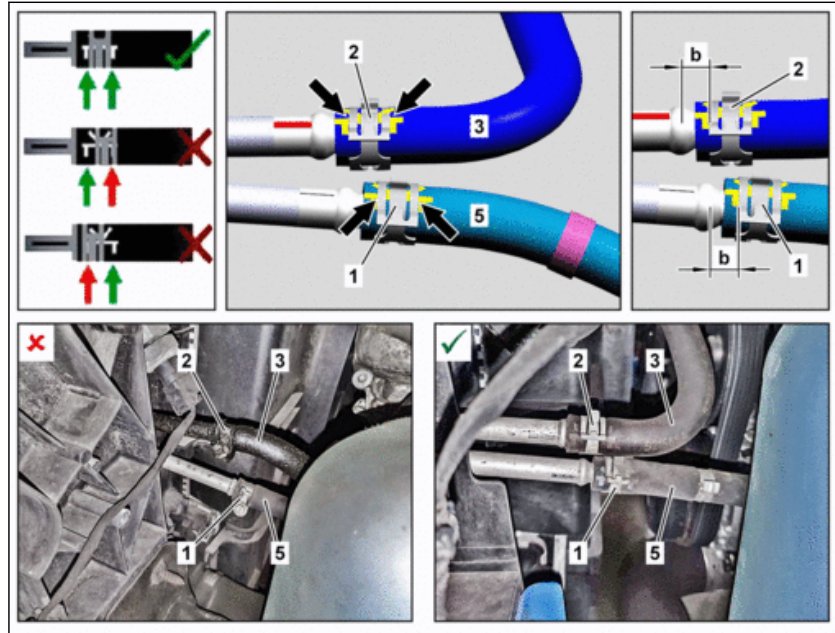
D46.25-A009-76

- 1 Clip
- 2 Clip
- 3 Return hose
- 5 Low-pressure hose
- b Dimension (2 to 7 mm)

4	Check return hose (3) and clamp (4) at power steering expansion reservoir.	<p>i</p> <p>Check the following points:</p> <ul style="list-style-type: none"> → Check connection of return hose (3) at power steering expansion reservoir for leak tightness. → Check whether return hose (3) is pushed on power steering expansion reservoir up to end stop. → Check installation position of clamp (4) on power steering expansion reservoir. The clamp (4) must be seated centrally between the markings (arrows) on the return hose (3). See specification in picture. If markings (arrows) are no longer visible, then check distance against dimension (a). <p>If clamp (4) is not positioned correctly or if a leakage is present,</p> <p style="text-align: center;">↓</p> <p>reposition affected clamp (4). To do so, see operation steps 1 to 4 in reference document.</p> <p>Replace clamps on hydraulic hoses of power steering (code: NV3LETULPX, acc. no.: 46 950 80)</p> <p>If all specifications and test criteria of operation steps 3 and 4 are fulfilled,</p> <p style="text-align: center;">↓</p> <p>install air ducting (8) and end measure.</p>	SM46.25-D-0032-02SG
