Clicking Noise From Front PCCB Rotors

This bulletin replaces bulletin Group 4,
#1503, dated 8-25-15

Vehicle Type: **911 Turbo S (991)**

Model Year: **2014 to Present**

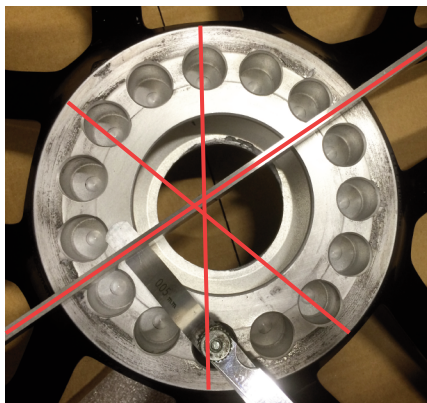
Wheels - Before rotors are replaced, it is necessary to check the mating surface of the wheels with a straight edge (12" Starrett 380) to insure flatness of the surface. Imperfections in the surface may have an influence on the rotor and cause noise.

It is necessary to check for flatness in about 6 different positions around the mating surface (roughly every 60°), it is ok to do more than that, but not less.

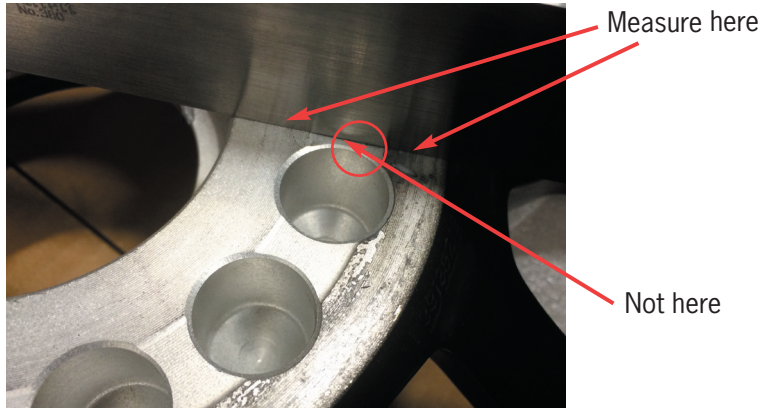
The mating surfaces at the outer and inner areas of the mounting circle need to be checked for flatness. The recessed area in between (photo below) is not a part of the measurement.

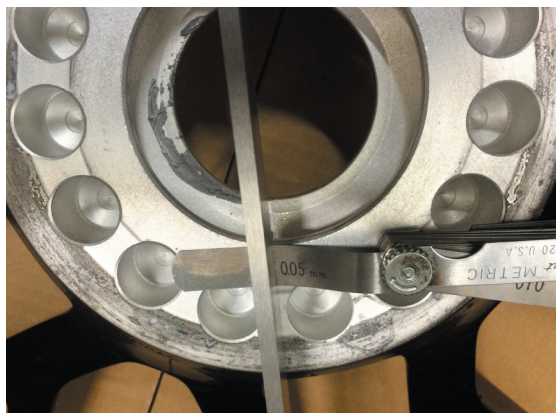
Use a feeler gauge that is very thin. The .05mm thickness is probably going to be necessary to find the uneven areas.

Record all measurements; make sure to include photos in PQIS.
