**THIS IS A TECH TIP, NOT A TECHNICAL BULLETIN.
TECH TIPS ARE NOT ASSOCIATED WITH WARRANTY CLAIMING.**

Model(s)	Year	Eng. Code	Trans. Code	VIN Range From	VIN Range To
Passat, Golf, Golf Sportwagen Jetta, Beetle	2015	2.0L TDI (CVCA, CRUA)	All	All	All

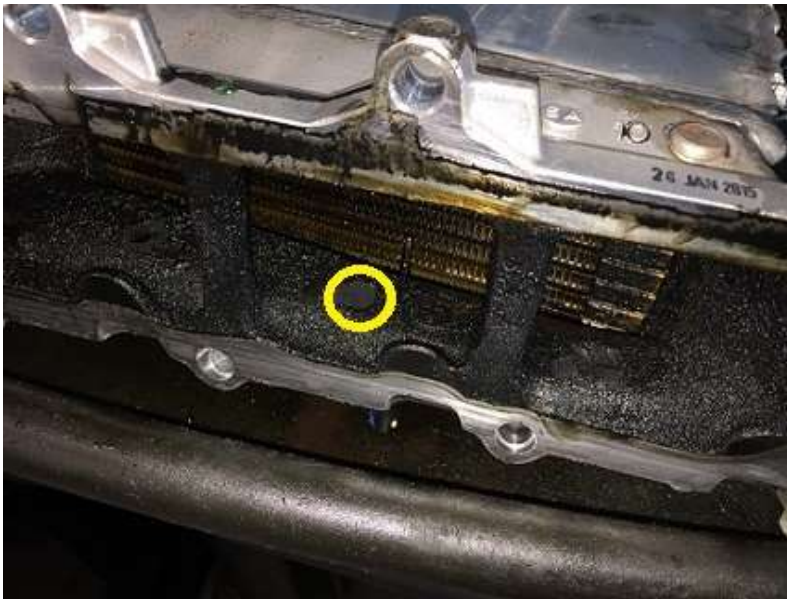
Figure 1

For customer concerns of MIL ON with fault P0401/P2002. Inspect the EGR passage in cylinder head for casting irregularities or carbon build up (figure 1). Also inspect the EGR ports on the intake valve side of the intake manifold/intercooler (figure 2).

If the ports internal to the intake manifold are found restricted and faults P2002 and/or P0401 are set, replace the intake manifold. For the cylinder head ports, clean with an appropriate diameter pick and/or brush.
