TECHNICAL SERVICE BULLETIN

Lack Of Heat Or Cooling From The Cabin Vents - Temperature Door Or Door Actuator Binding/Inoperative - DTC B1081:07

21-2199
28 June 2021

Ford 2017-2021 F-Super Duty
2015-2020 F-150

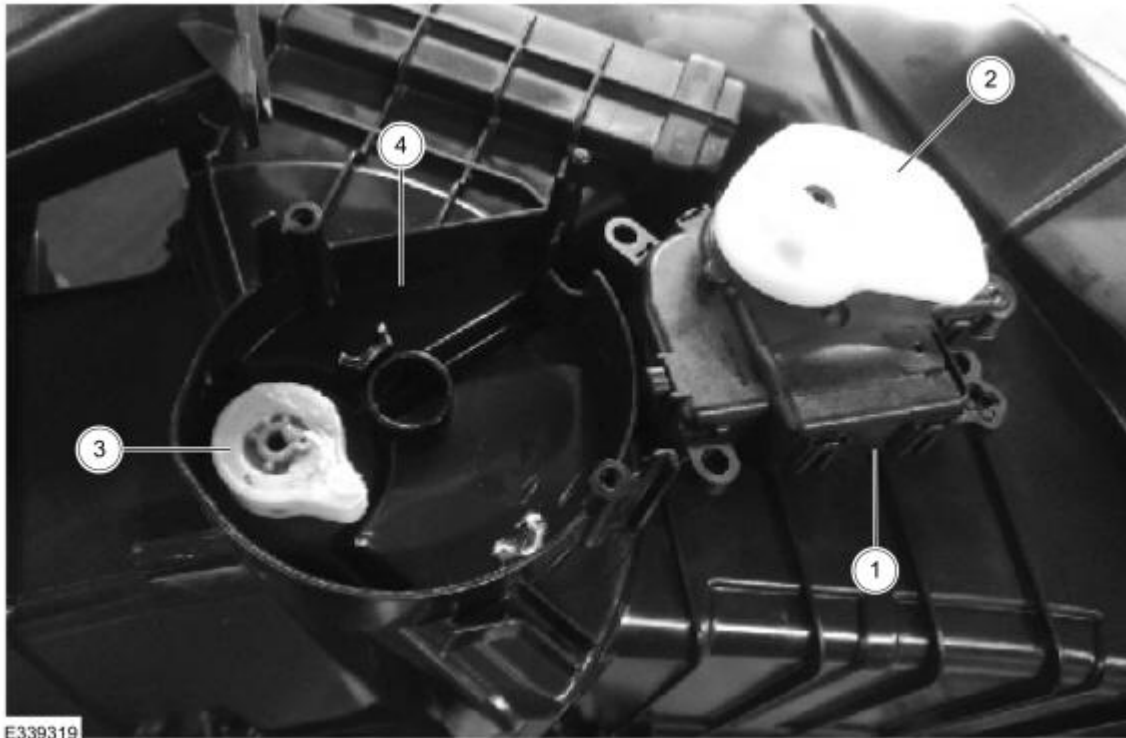
E339319

NOTE: Do not remove the cam follower from the climate control housing blend door. It is critical to be gentle when cleaning the cam follower as damaging the temperature blend door shaft will require replacement of the climate control housing. (Figure 1)

1. Gently wipe the driver side temperature blend door actuator, cam, and cam follower attached to the climate control housing blend door to remove any debris and existing lubricant.

2. Replace the driver side temperature door actuator and cam. Refer to WSM, Section 412-00. Lubricate the new cam and cam follower pin using Motorcraft® HVAC Duct Component Grease.
3. Reassemble per WSM. Test the temperature blend door operation. Does the system operate properly?
 - (1). Yes - repair is complete.
 - (2). No - proceed to Procedure B.
