Technical product information

Topic	Discolouration around the sunroof aperture
Market area	Russische Föderation (5RU),Australia E04 Bentley rest Asia and Australia (6E04),China 796 VW Import Comp. Ltd (Vico), Beijing (6796),Germany E02 Bentley rest Europe (6E02),Japan E03 Bentley Japan (6E03),Korea, (South) E08 Bentley South Korea (6E08),United Arab Emirates E06 Bentley Middle East and Africa (6E06),United Kingdom E01 Bentley UK (6E01),United States E05 Bentley USA and rest America (6E05)
Brand	Bentley
Transaction No.	2063726/1
Level	EH
Status	Approval
Release date

Bentayga

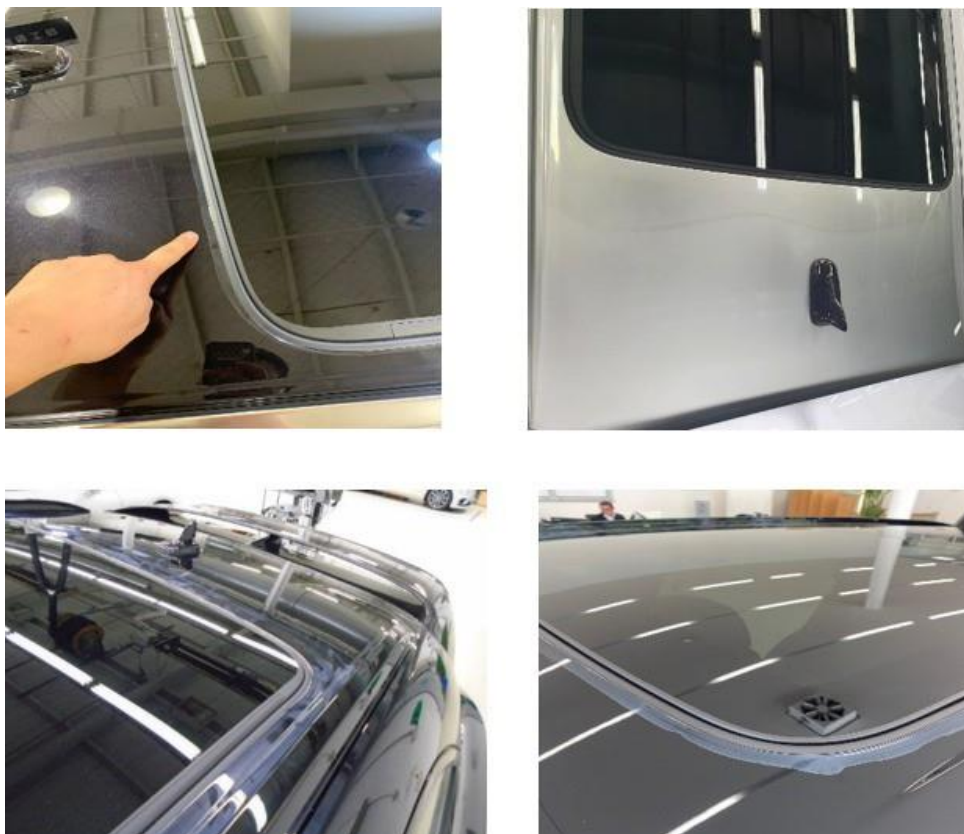
Discolouration around the sunroof aperture, Refer to the examples shown in Figure 1

Discolouration may become visible around the sunroof aperture, this is mainly evident if vehicles are left for a reasonable period prior to the PDI being conducted.

This is a known condition that was traced to the overspray of sunroof sealant primer during sunroof installation.

The discolouration can be removed by polishing the area affected in line with Bentley recommended preparation and care products.
