SERVICE INFORMATION BULLETIN

APPLICABILITY: 2018MY Legacy and Outback w/8-inch Navi System
 2017-18MY Impreza with 8-inch Navi System
 2018MY Crosstrek with 8-inch Navi System
 2018MY BRZ with 7-inch Navi System

NUMBER: 15-254-19R

SUBJECT: Map Data Update Procedure for Harman Gen 3.0 Navigation Equipped Head Units (H/U)

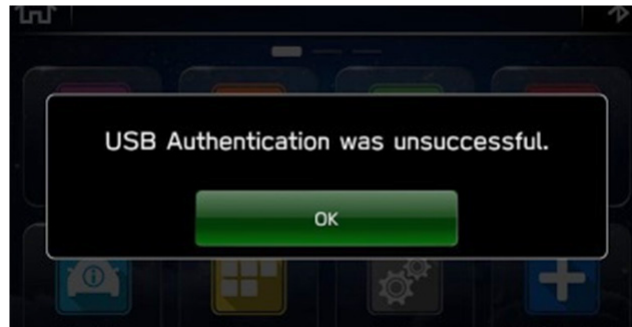
CAUTION: NEVER attempt to install this software update on any 2019 or 2020 MY vehicles as they are equipped with Gen 3.1 Navigation systems. This update is ONLY for models equipped with Gen 3.0 Navigation systems. Should an attempt be made to install any of these files into a Gen 3.1 H/U, the USB Authentication error screen below will be displayed.

- The USB Authentication error screen will also be displayed when attempting to install the map data bundled with a software version older than the version already installed in the H/U.
- Move the vehicle to an outside location where the engine can be safely started and kept idling during the update process.
- Never idle the vehicle in a closed space such as a garage, even if the garage door is open.
- Once the vehicle is in a safe location, be sure the vehicle is in Park if CVT or Neutral if MT and the parking brake is fully engaged.
- Unplug any cables or devices from the USB ports.
