ID # CBR-15-9

Diagnostic Trouble Codes (DTC) For The Engine Pre-Heat Relay: Supplementary Instructions

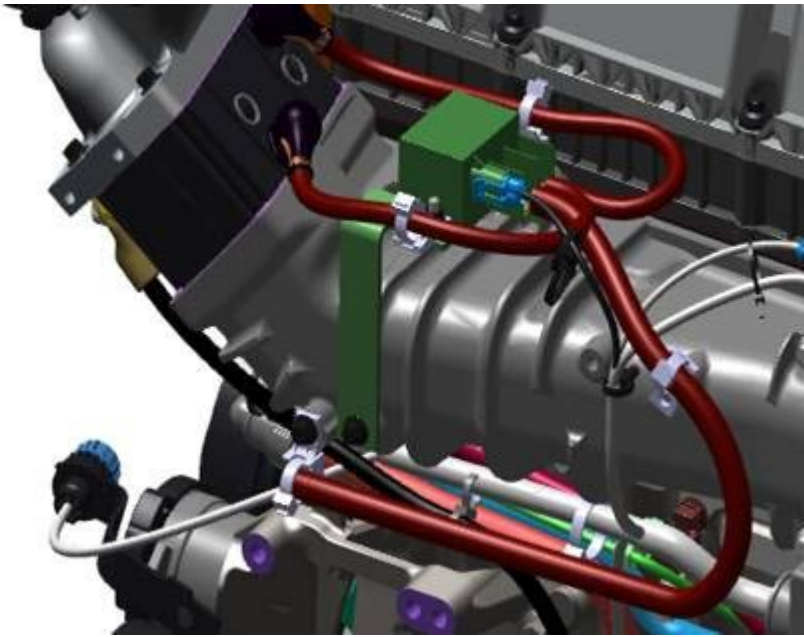
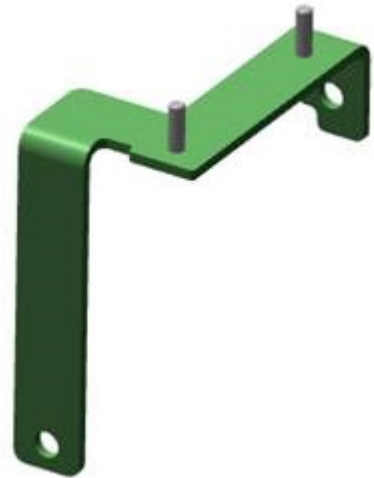
For vehicles with US10+OBD13 and newer emissions (model year 2014 and newer), it is possible that when diagnosing an issue involving the engine pre-heat relay, performing a standard resistance check on certain versions of the power cable with an ohm meter will not identify a cable that requires replacement, potentially leading to repeated issues.

- Replace **both** the Pre-heat relay ([P/N 23692384](#)) and the Supply Power Cable.
- For 13L models install the newly updated bracket design with 2 mounting locations ([P/N 23803412](#)). See illustration below.
