Service Bulletin

Bulletin No.: 21-NA-128

Subject: MIL Illuminated- ECM Update for P026C, P20EE, or P11D5

Brand:	Model:	Model Year:		VIN:		Engine:
from	to			Transmission:		from
						to
Chevrolet	Silverado 2500HD/ 3500HD	2021	2021	Before 1GC4YTEY5MF261413		Equipped with 6.6L Engine (RPO L5P)
GMC	Sierra 2500HD/ 3500HD	2021	2021			Equipped with 6.6L Engine (RPO L5P)

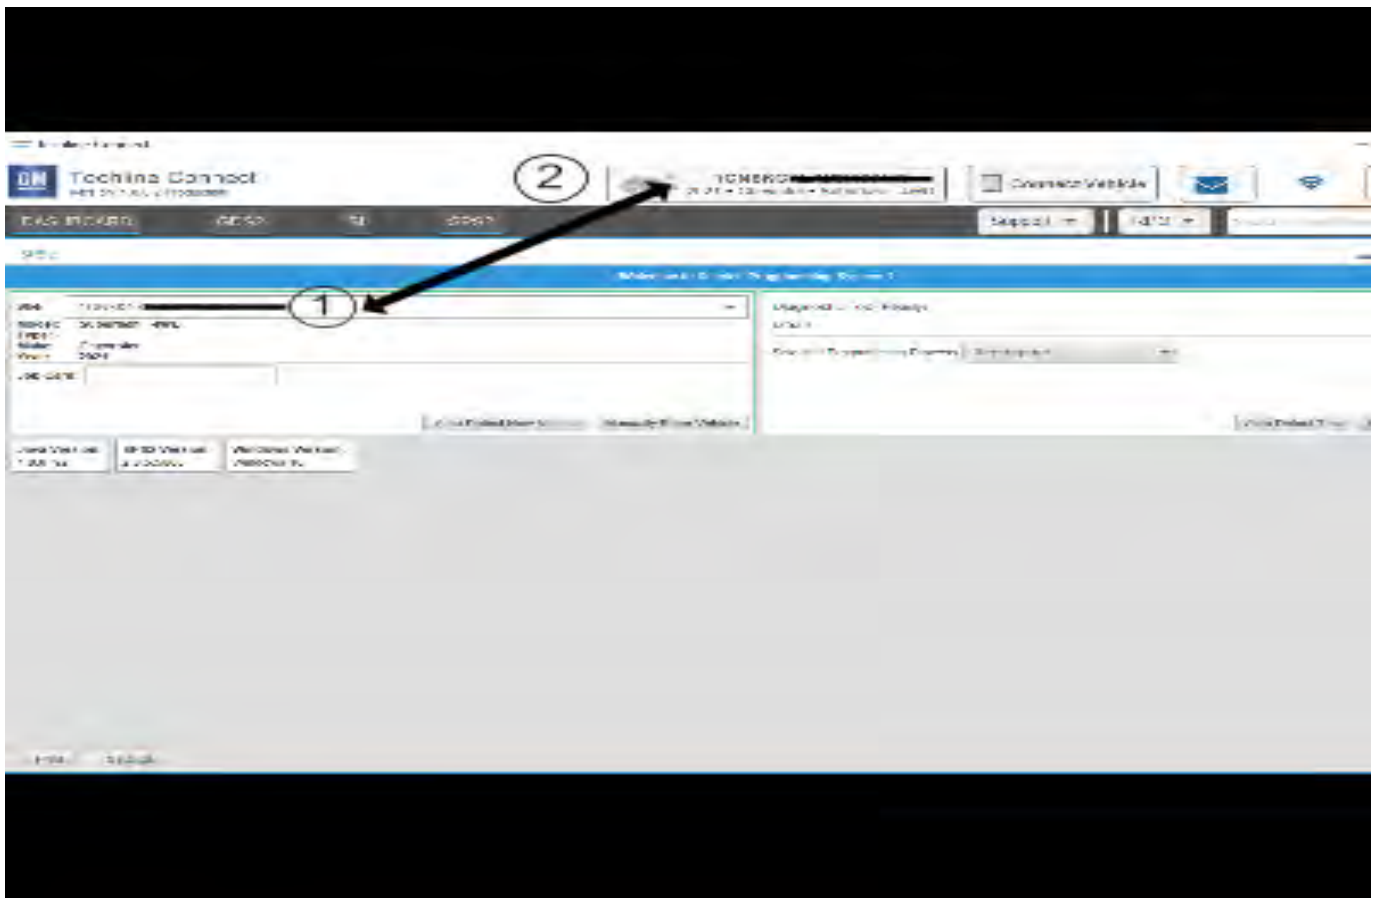
5743643

Caution: Be sure the VIN selected in the drop down menu (1) is the same as the vehicle connected (2) before beginning programming.
