SIB 51 10 21

SERVICE ACTION: CHECK BADGE ON TAILGATE, REPLACE IF NECESSARY

2021-05-24

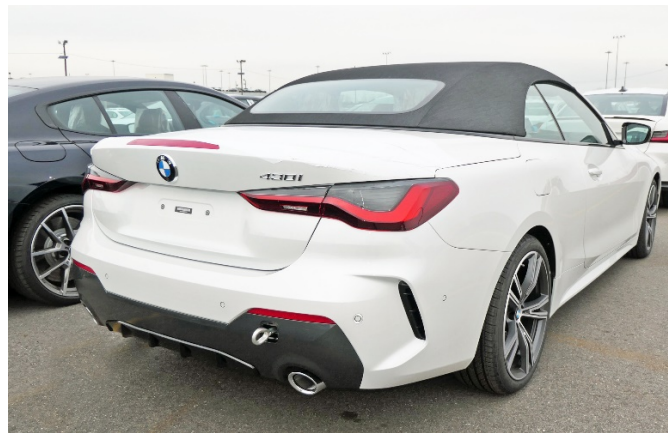
The "BMW" trunklid emblem (arrow) which contains the rear-view camera may not have been correctly fastened during vehicle production.

It is possible that the emblem & camera may become detached from the vehicle, such as when going through an automated car wash.

The badge may not have been properly installed.

Check the attachment of the emblem. Replace if needed.

- Apply a light force between the trunklid and the emblem.
- If the emblem cannot be moved by applying slight force, the emblem can remain on the vehicle.
- If the emblem lifts off the trunklid, the emblem must be removed, and a new emblem must be attached.
  - See repair instructions "Removing and installing/replacing rear BMW badge", REP 51 14 010.

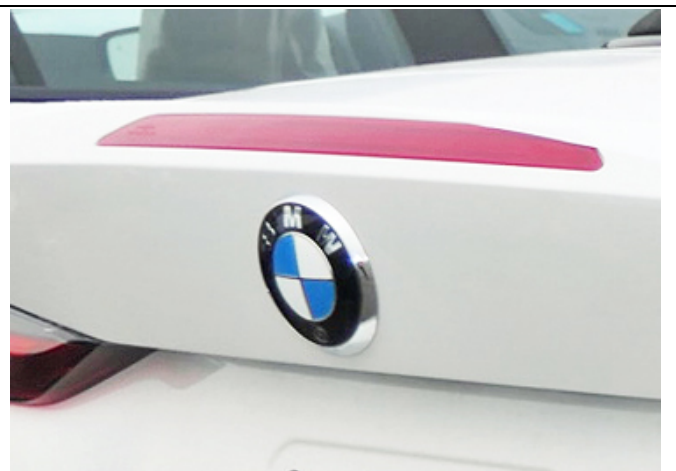
The rear-view camera is located at the "6:00" position (arrow).
