no.	Symptom	Subject	Photo	Notes and Indications - Corrective action
1	Issues during Top Case fixing to the plate	Top Case Kit Part no. 96781531AA

Tips & Tricks –Multistrada V4 Model Year 2021

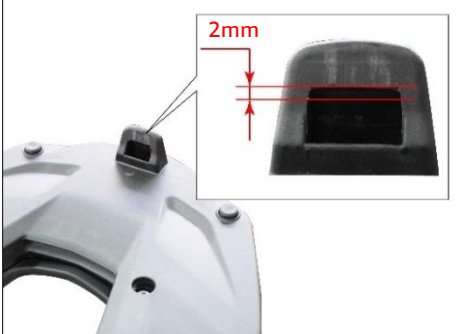
<p>We have received some reports concerning the difficulty in securing the Top Case (Kit Part no. 96781531AA) to the top plate Part no. 8291M033A due to a machining error of the supplier. In particular, the locking tooth on the upper plate Part no. 8291M033A shows a hole 2mm narrower than specified. To eliminate this defect, the locking tooth of the plate must be milled by <u>2mm in the upper area</u> using a flat file, as shown in the figure.</p>

<p>We inform you that the upper plates present inside the kits in stock have been restored.</p>
2	Anti-theft system kit Part no. 96681081AA malfunction	Anti-theft system kit Part no. 96681081AA

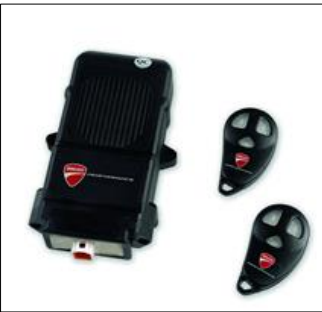
<p>After having installed the anti-theft system Kit Part no. 96681081AA and enabled it on the BBS control unit, some malfunctions may occur during activation due to a possible incorrect pin arrangement in the connector of the wiring branch supplied with the kit.</p>

<p>Follow the procedure described below:</p> <ol style="list-style-type: none"> 1) uncover connector (A) by moving sheath (B) backward; 2) uncover the wiring by removing a portion of insulating tape to make operations easier; 3) check the arrangement of Pins 5 and 6 and the relevant color on the 8-pin connector. If the pin arrangement is not correct, extract them working from the front side with a needle inside the groove so as to lift the retainer and invert them. 4) restore the cloth tape previously removed and the position of the protective sheath (B).

<p>The kits currently in stock have been restored.</p>

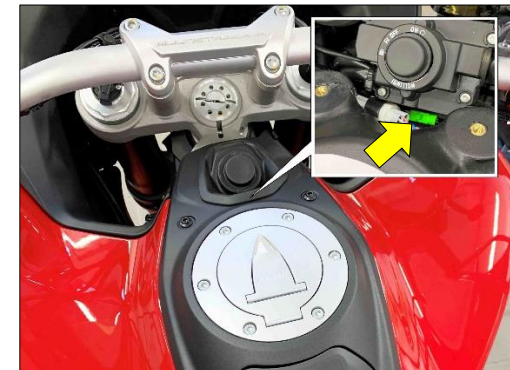
<p>We inform you that for the installation of the heated handgrip kit part no. 96680702A, the main wiring harness connectors where to connect the heated handgrips, are positioned below the ignition switch cover as shown in the figure.</p>

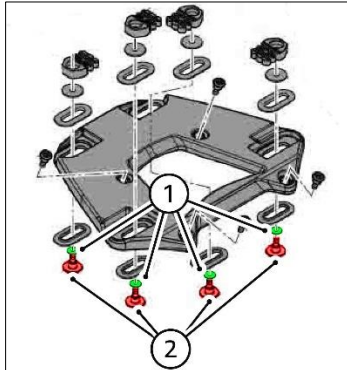
no.	Symptom	Subject	Photo	Notes and Indications - Corrective action
7	Possible incorrect operation of the swinging system - Top Case accessory kit part no. 96781531AA	Top Case Part no.96781531AA

<p>We inform you that the first Top Case accessory kits part no. 96781531AA delivered may not operate correctly with the swinging system, which may seem "too braked". To improve this condition, it is possible to insert 4 copper washers (1) part no. 85250231A on the 4 screws (2) retaining the bottom plate to the top one.</p> <p>For a better understanding of the assembly procedure of the Top Case accessory kit, a video has been made which can be viewed at the following link: https://youtu.be/DVEHKVvdKQI.</p> <p>All Top Case kits in stock will be restored by February.</p>

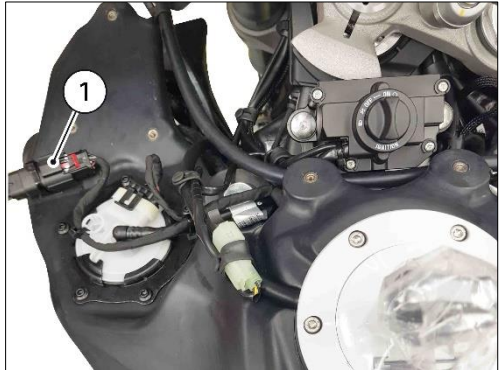
<p>We inform you that for the installation of the anti-theft system kit part no. 96681081AA, the main wiring connector (1) where to connect the anti-theft device, is positioned near the fuel pump flange, in the front left area of the fuel tank.</p>

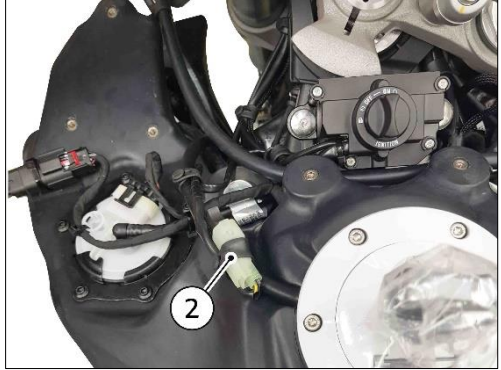
<p>We inform you that for the installation of the Hands Free fuel tank cap kit part no. 96681021AA, the main wiring connector (2) where to connect the Hand Free fuel tank cap, is positioned near the fuel pump flange, in the front left area of the fuel tank.</p>

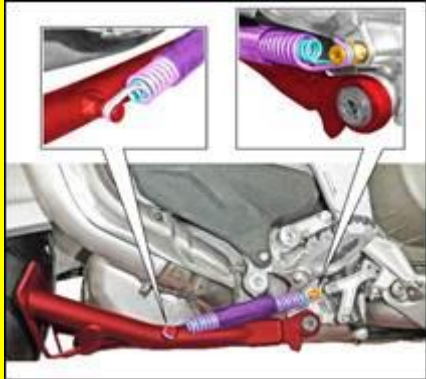
<p>We have received a few isolated reports of possible interference between the external central stand return spring and the footpeg holder plate when the central stand is closed.</p> <p>Check that the two side stand return springs are correctly installed and aimed as shown in the figure.</p>

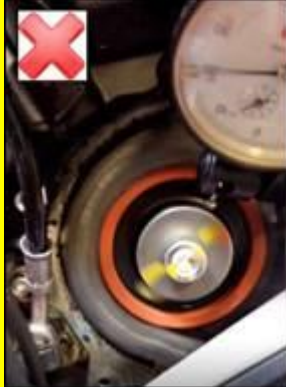
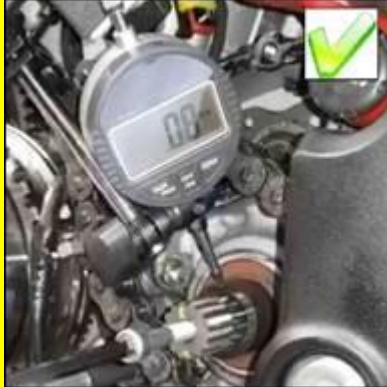
no.	Symptom	Subject	Photo	Notes and Indications - Corrective action
<div style="background-color: red; color: white; padding: 2px; transform: rotate(-45deg); display: inline-block;">NEW</div> 23	Possible oscillation of the final drive chain (non-uniform sliding)	Gearbox secondary shaft	-	<p>We have received some isolated reports about a possible oscillation of the final drive chain even if the chain is correctly tensioned. In these cases the customer may complain an uneven sliding of the chain at constant speed. In these cases, you are asked to check for a possible deformation of the gearbox secondary shaft by removing both the chain and the sprocket and taking the measurement with a dial gauge directly on spacer Part no.713P0011C, as shown in the figure (the measurement should NOT be taken on the sprocket since an uneven wear of the rubber material may occur during the first few kilometres): by slowly rotating the shaft, the value taken with the dial gauge must be at most 0.1 mm.</p> <div style="display: flex; justify-content: space-around; align-items: center;">

</div> <p>a) If the measurement shows values below 0.1 mm, replace the sprocket only. a) If the measurement shows a value greater than 0.1mm, fill out a YouTech service request.</p>
