HYUNDAI

Technical Service Bulletin

21-01-048H

WATER TEMPERATURE SENSOR LEAK INSPECTION AND REPAIR
(SERVICE CAMPAIGN T6Q)

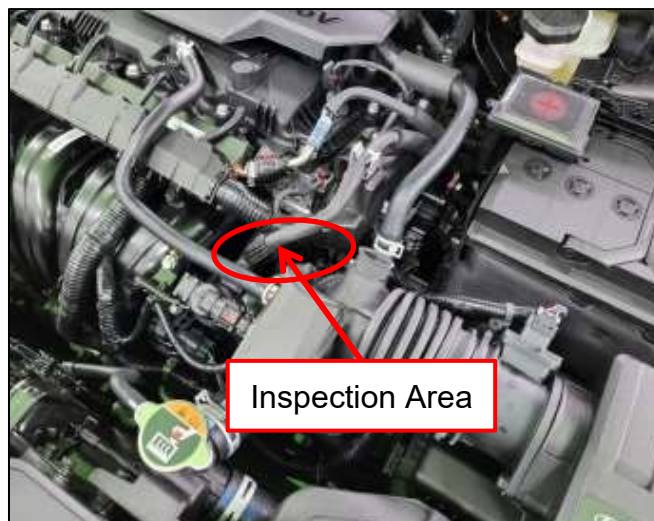
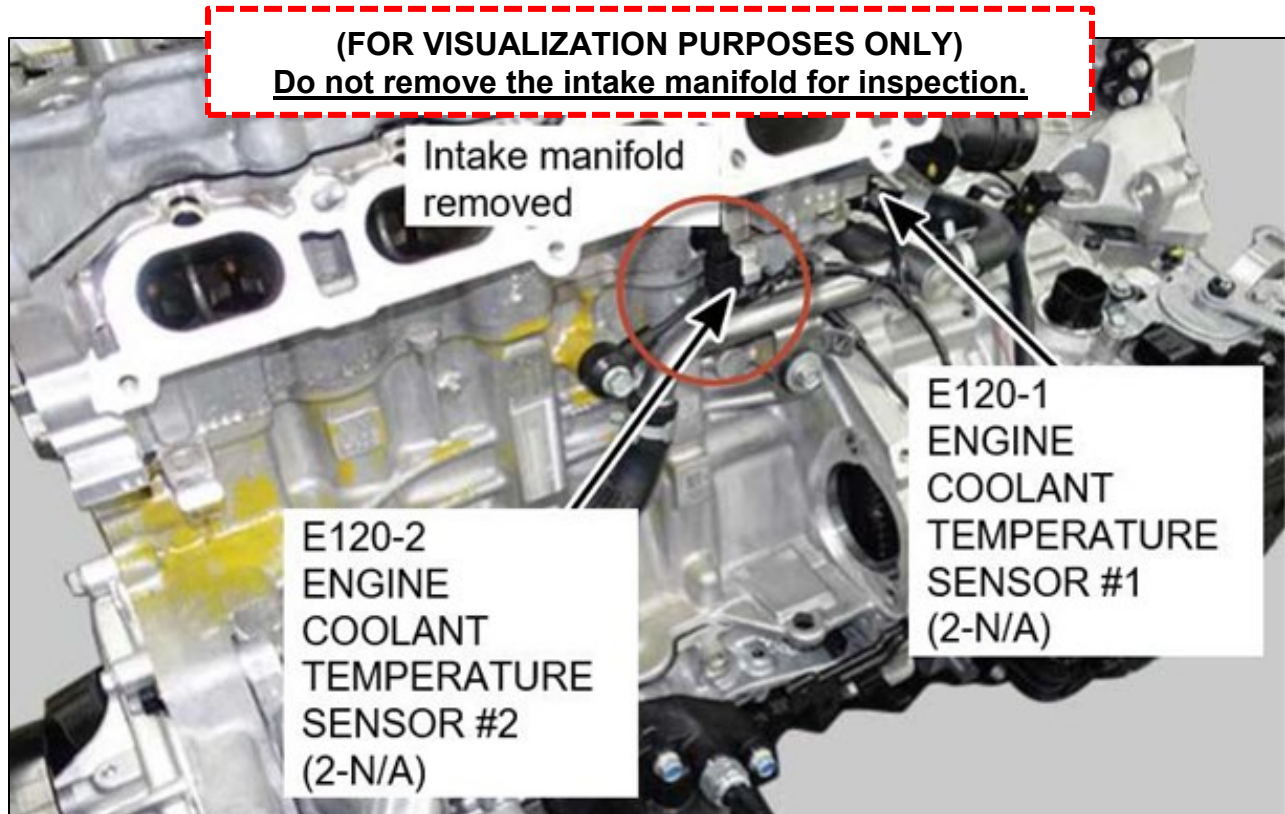
- The area to be inspected for coolant leak is the cylinder head and surrounding portions near the mid-point between the intake manifold and intake hose.

As shown above at areas surrounding sensor #2, visually check for signs of coolant leak.

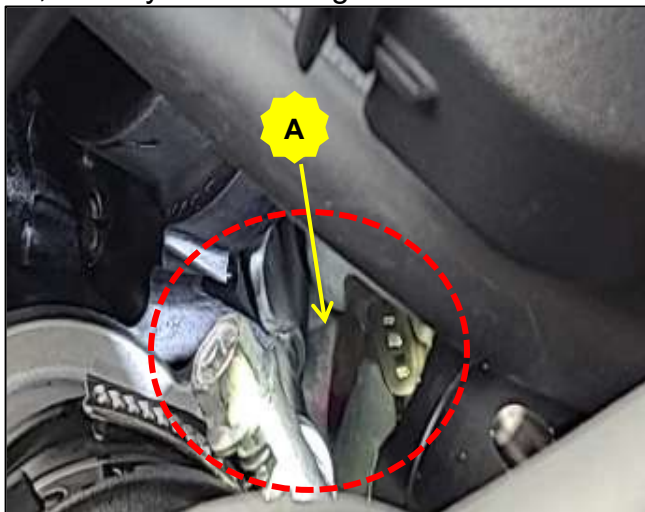
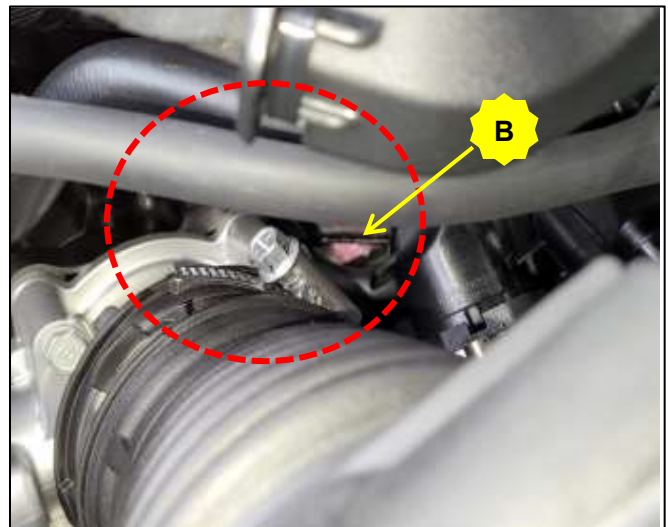
- Inspect for coolant leak residue near the cylinder head gasket (A), and areas near the lower end of the intake hose and the intake manifold (B).

- If no signs of coolant leaks are found, then the inspection procedure is complete.
- If coolant leaks are found, then perform the service procedure in the following pages.

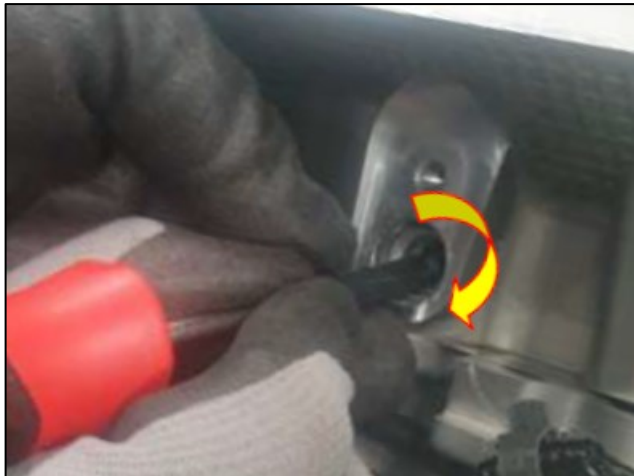
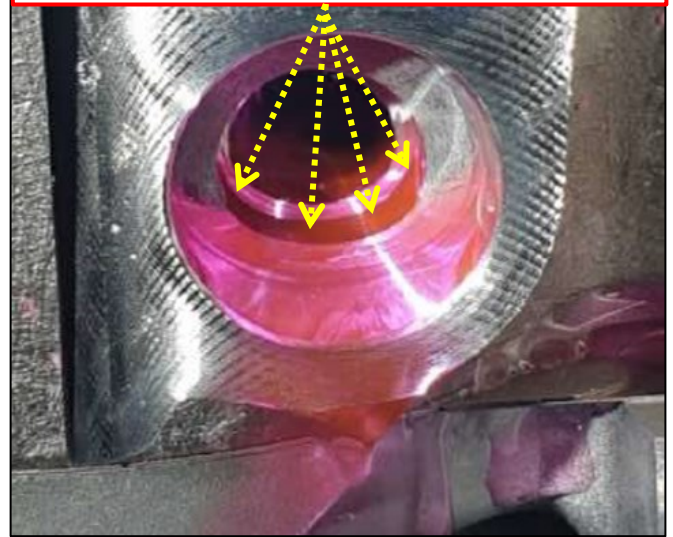
WTS O-ring sealing surface to be sanded

Description: On certain 2021-2022 Elantra vehicles, a coolant leak at the Water Temperature Sensor (WTS) may be observed due to machining burrs at the mounting port of the cylinder head, resulting in improper coolant sealing.

15. Remove the burr while rotating in the circular direction as shown by the arrow for about 8 ~ 9 times while maintaining a perpendicular angle to the WTS mounting hole.

After the burr of the WTS O-ring sealing surface has been sanded away, use shop air to blow away the removed burr chips and sanding debris from the WTS mounting hole and its surrounding areas.
