| HYUNDAI Technical Service Bulletin | GROUP AUTOMATIC TRANSMISSION | NUMBER 21-AT-007H |
| | DATE June, 2021 | MODEL PALISADE (LX2) SANTA FE (TMA) SANTA FE HYBRID (TM HEV) SONATA (DN8/DN8A) SONATA HYBRID (DN8 HEV) TUCSON (NX4/NX4A) TUCSON HYBRID (NX4 HEV) |
| SUBJECT: AUTOMATIC TRANSAXLE (8-SPEED FWD) POSITION SWITCH DTC P070500, P070512, P070514, P07051C, P070600, P070661 & P070696 DIAGNOSIS | | |

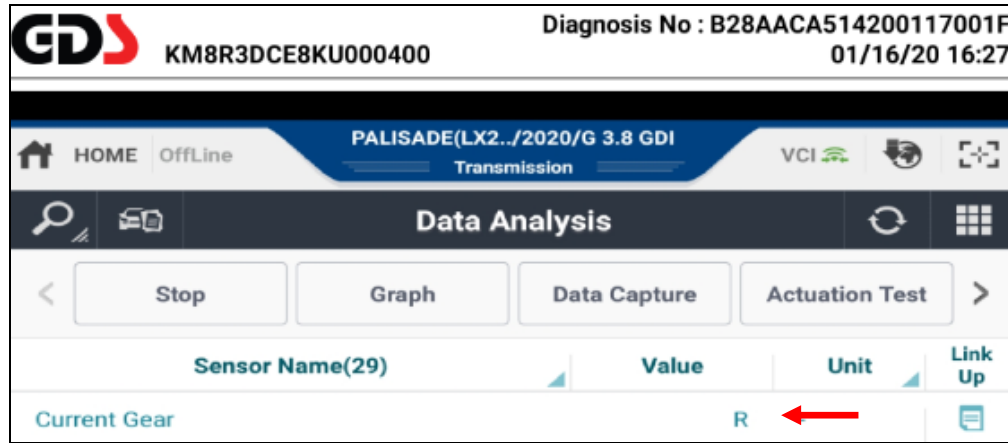
3. Select **Data Analysis**, **A/T** menu and **Current Gear**. Depress the brake pedal and move the shift lever through all gears (P, R, N and D) and monitor the **Current Gear**. Confirm the indicator on the cluster shows all gears. Turn the ignition **OFF**.

4. If the GDS shows:
 - The correct **Current Gear**, the wiring **currently** has no open/short circuits. Go to Step 6.
 - Does not show the correct **Current Gear**, go to Step 5.
5. Visually check the wiring harness between the ECU and position sensor (inhibit switch) for a damaged wire or open circuit/short circuit to ground. Check for a damaged pin or pin not fully inserted into the connector.
 - If damage is found, repair or replace the control wiring and drive the vehicle to confirm the repair.
 - If no damage or open/short circuit is found, go to Step 6.

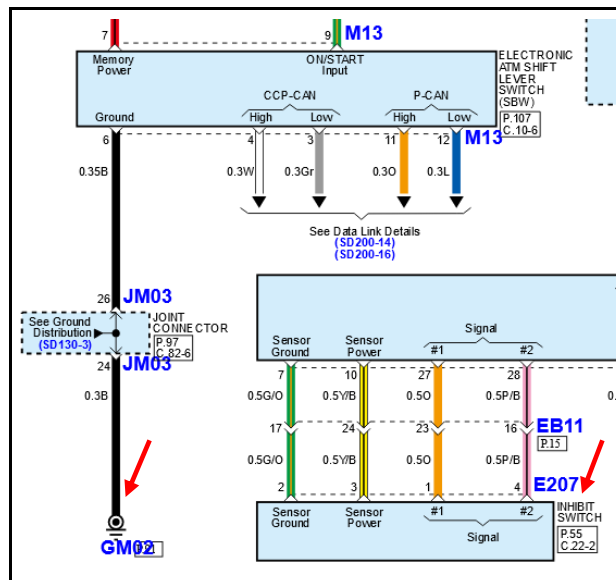
6. Check the grounds for the electronic shift lever. (Refer to ETM, SD450-1). Turn the ignition and headlights on. Use a DVOM to check the voltage drop between the wiring terminal and ground.

Specification: Less than 0.2 V.

- If more than 0.2V, clean the terminal and bolt threads and tighten the bolt.
- If less than 0.2V, go to Step 7.

Torque: 7~9 lb-ft, 1.0~1.2kgf.m, 10~12 N.m

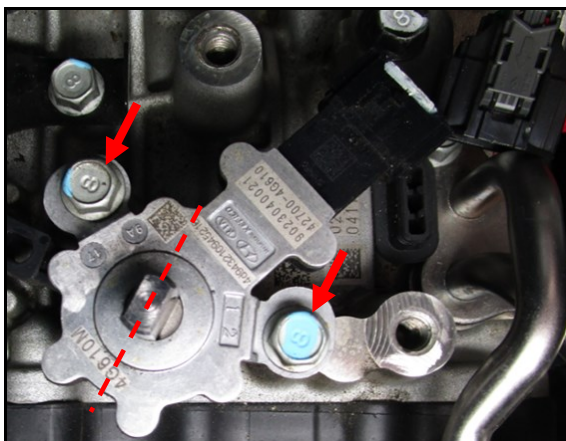
NOTE: The manual valve is shown in the Park position.

- 11. Remove 2 mounting bolts and remove the position sensor.

Install a new position sensor.

Install 2 bolts and loosely tighten the bolts.

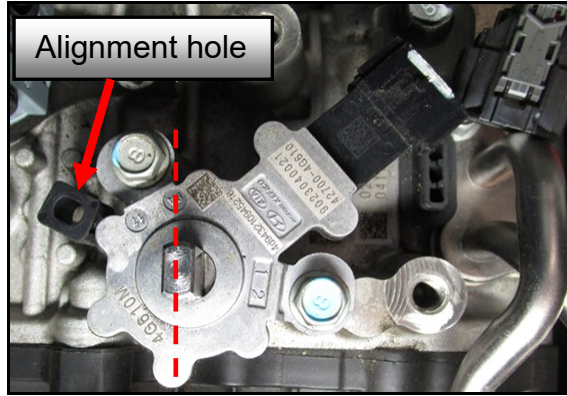
NOTE: The manual valve will be aligned 90° to the radiator.

12. Turn the manual valve 2 detents in the counter-clockwise direction to place the manual valve in the Neutral position.
