<b>HYUNDAI</b> <b>Technical Service Bulletin</b>	GROUP <b>Body</b>	NUMBER <b>21-BD-008H</b>
	DATE <b>June, 2021</b>	MODEL(S) <b>Santa Fe (TMa)</b>
<b>SUBJECT: FENDER NOISE REPAIR</b>

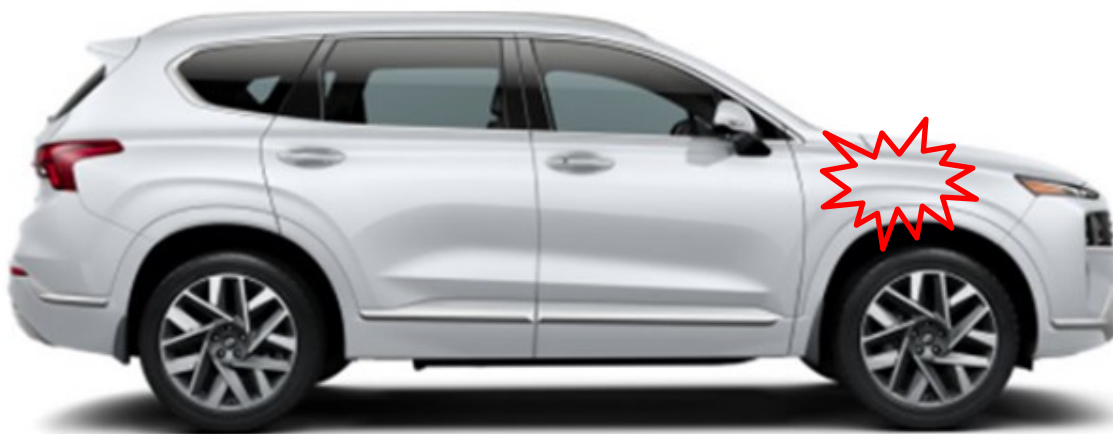
**Description:** This bulletin outlines the repair procedure for customers experiencing a popping or rattling noise from the front fender area of the vehicle while driving. The repair procedure outlined in this TSB only applies to vehicles manufactured within the production date range specified below and exhibit noise from the fender area.

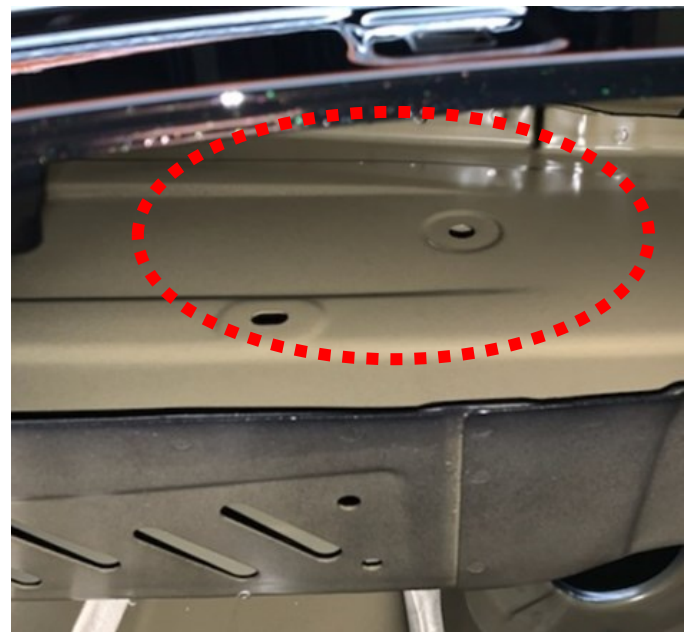
3. Inspect the panel by pressing on the sheet metal.

If the panel does not flex, this repair procedure does not apply.

If the panel does flex, proceed to the next step.
