# SERVICE BULLETIN

Classification: AN21-014	Reference: NTB21-053	Date: June 18, 2021
-----------------------------	-------------------------	------------------------

## 2021 SENTRA; NO START DUE TO BATTERY DISCHARGE THROUGH AUDIO UNIT

**APPLIED VEHICLES:** 2021 Sentra (B18)  
**APPLIED DATE:** Built between March 18, 2021 – June 2, 2021  
**APPLIED TRIM LEVEL:** SV and SR

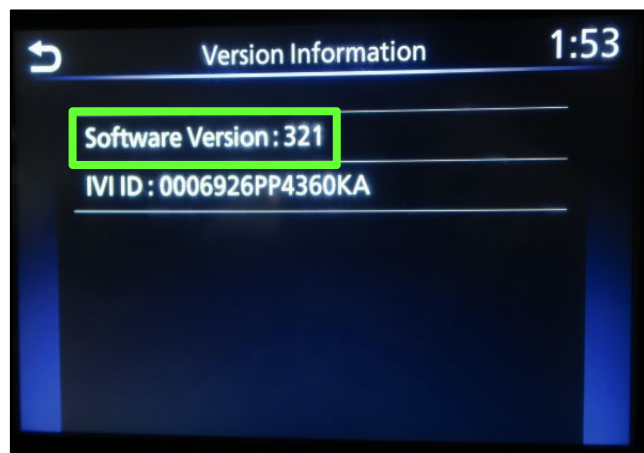
Figure 6

6. Verify the Software Version is **321**.
  - If the software version is 321, proceed to step 7.
  - If the software version is not 321, the service procedure is complete.

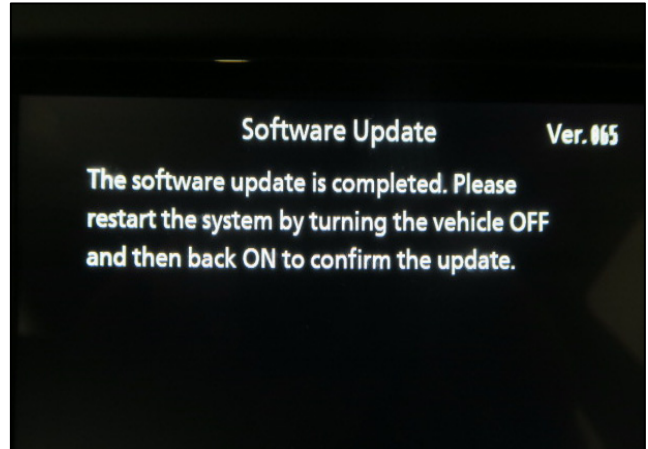
**NOTICE** Do not remove the USB drive until Figure 14 is displayed. If removed prior to this screen being displayed, the audio unit may be damaged.

21. When the message shown in Figure 14 is displayed, remove the USB drive from the USB port.
