Technical Service Bulletin

55 Power rear lid cannot be opened, DTC B113E07 and/or B113E29 are stored in the rear lid electronics module

55 21 58 2064020/1 July 16, 2021.

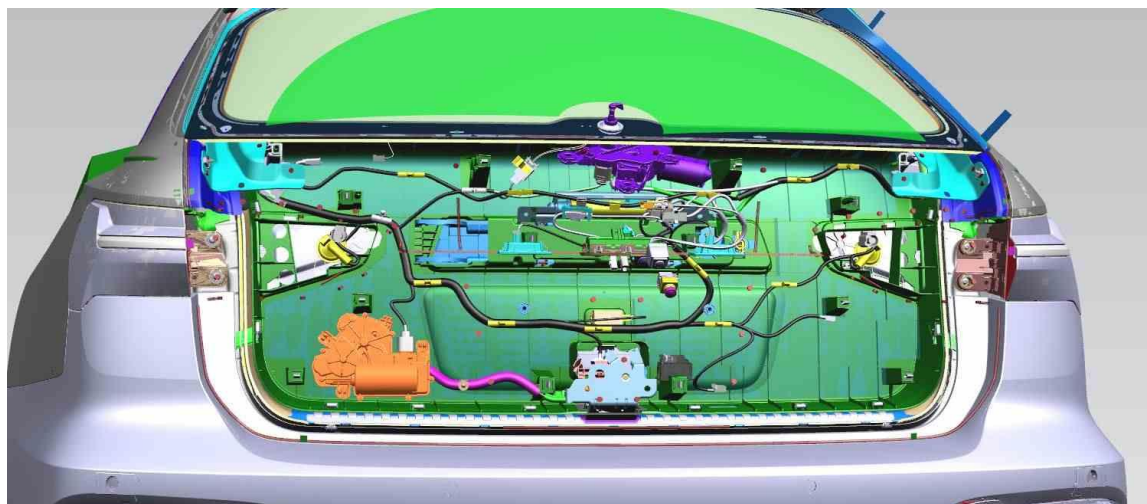
Figure 2. Carefully knock in the area of the closing assist motor. Its location varies and is model specific.

1. If it is not possible to open the power rear lid using the vehicle key, the interior/exterior buttons or the emergency release, carefully knock with your hand on the rear lid in the area of the closing assist motor (Figure 2). The resulting vibrations should release the blockage within the closing assist motor.

2. Open the rear lid and remove the rear lid lower trim panel according to the Elsa Repair Manual.
3. Replace the closing assist motor.
4. Check the operation of the closing assist motor and the power rear lid before reinstalling the rear lid lower trim panel.
5. Reinstall the rear lid lower trim panel and clear any relevant DTC(s).
