Technical Service Bulletin

96 "Audi Active Lane Assist/Traffic Jam Assist: malfunction!", DTC U112300 is stored in one of two control modules

96 21 72 2061932/3 July 26, 2021. Supersedes Technical Service Bulletin Group 96 number 21-65 dated March 19, 2021 for reasons listed below.

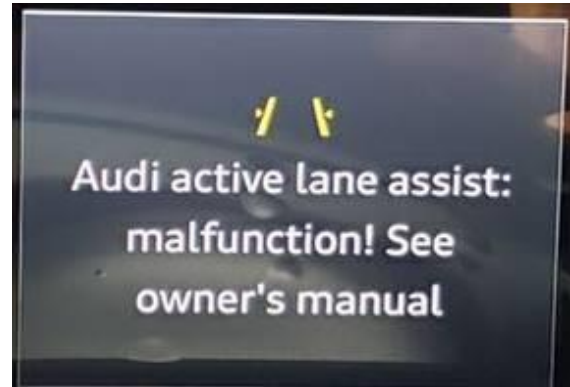
- “Audi Active Lane Assist: malfunction!” (Figure 1).

Figure 1. Example of a message.

The two DTCs U112300 mentioned in the condition point to a malfunction of the capacitive steering wheel.

1. Inspect the steering wheel for exterior or mechanical damage, for instance deep scratches.
2. If mechanical damage is found, this is due to external influence and may not be covered under warranty.
3. Remove the airbag from the steering wheel.

4. Make sure that all wiring visible on the steering wheel is in good condition and that all connectors are properly secured.
5. After completing steps 1 through 3 and not finding any obvious damage, then replace the steering wheel.
