Location: Chassis - Suspension

Topic: Damper Leak/Oil found around shock absorber during an inspection

Condition: Permanent and/or upon inspection

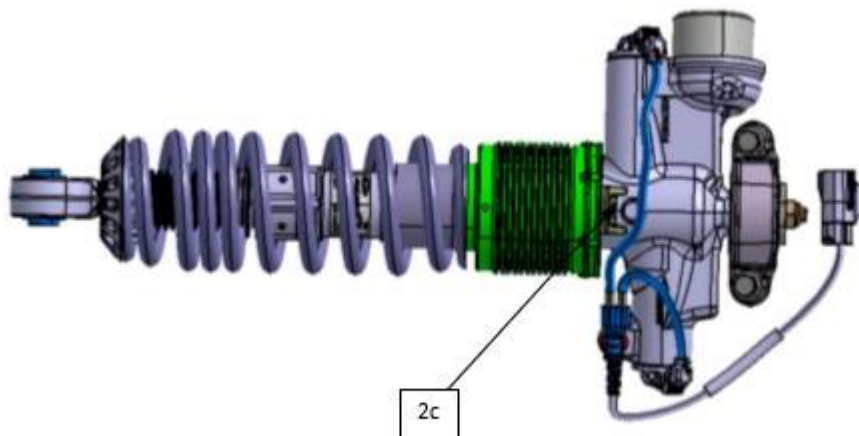
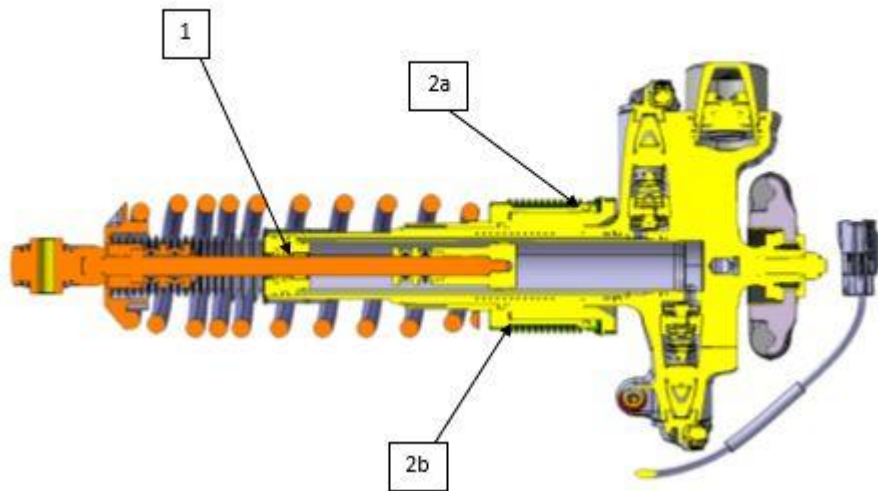
Known locations for component quality occurrences are identified below.

1. Rod Seal Leak

Leak propagates from the seal pack and runs down the rod before gathering at the lower spring coils. Usually identifiable by a spring that displays dirt contamination on its lower coils but is clean above this point.

2. Nose Lift Collar Leak

- a. Upper Seal - Leak propagates from the upper seal and runs down the outer lift gaiter. Usually identifiable by oil residue on the lift gaiter.
- b. Lower Seal - Leak propagates from the seal pack and runs down the damper body. Usually identifiable by oil residue on the damper gaiter.

If a leak is found, please proceed as follows:

- Take clear, well-lit and in-focus images as they will be required for any warranty claim.
- Clean any oil from affected area using suitable cleaning agents.
- Take vehicle on an assessment test drive.
- Re inspect area; If the leak has not returned, no further action is required.
- If the fluid leak is still present, the damper(s) needs to be replaced. Ensure the following information is available in the WP for warranty purposes. Failing to include this information may result in claim rejection.
 - a. Clear, well-lit and in-focus images of the before and after condition.
 - b. Direction on the assumed failure, based on the failure modes identified above.
 - c. Clear, well-lit and in-focus images of the label showing the part no. of the faulty damper.

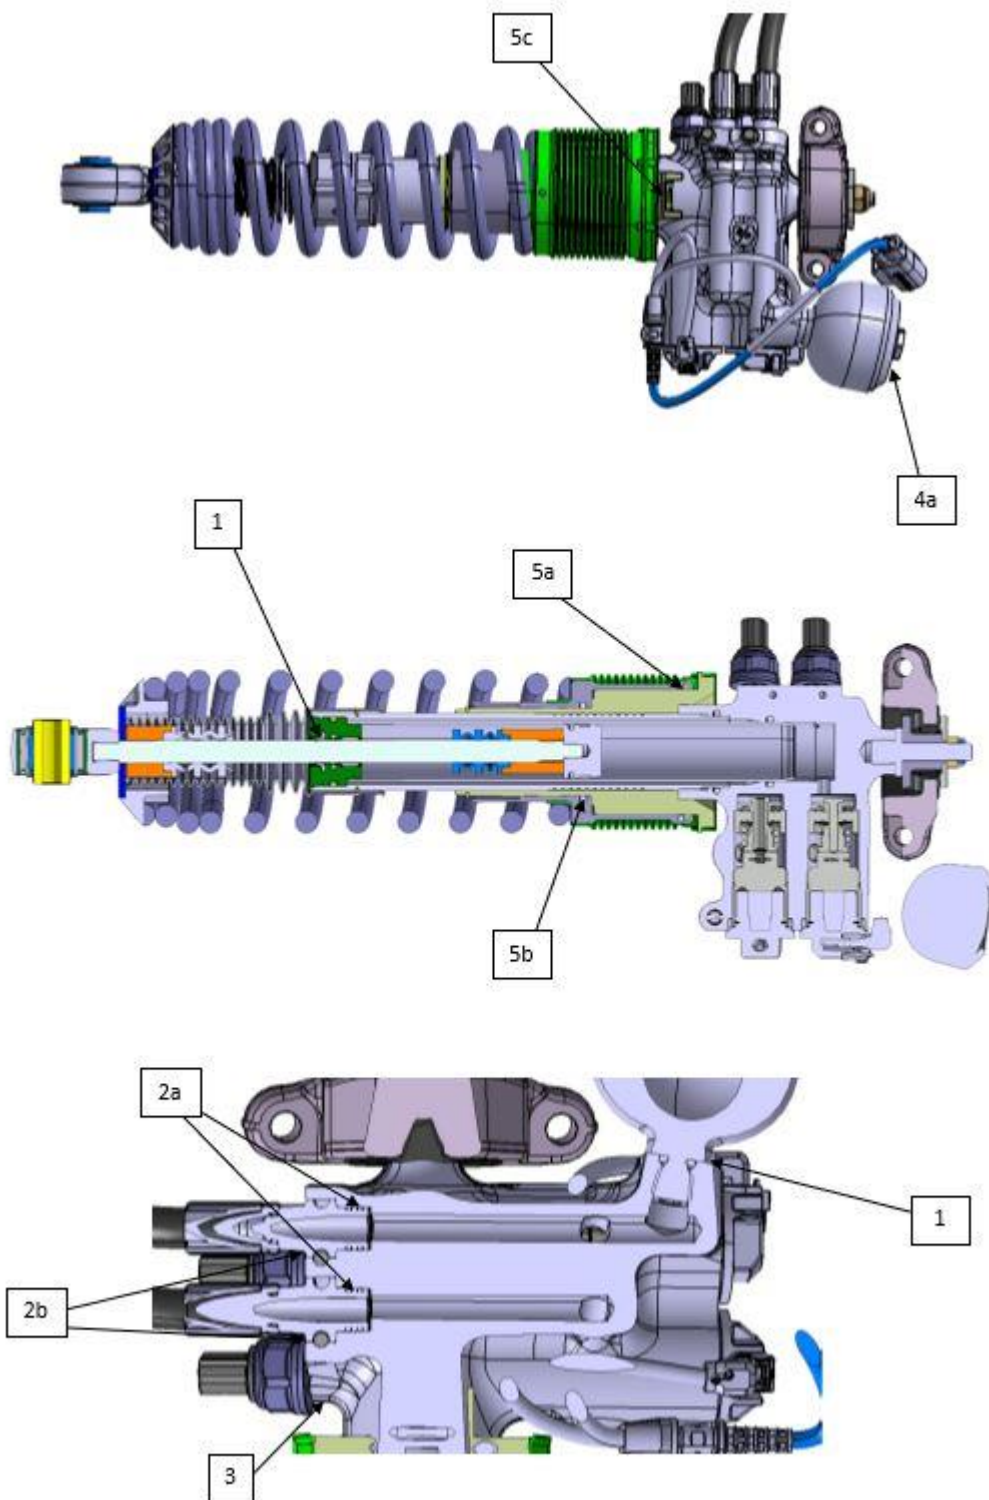
Known locations for component quality occurrences are identified below.

1. Rod Seal Leak

Leak propagates from the seal pack and runs down the rod before gathering at the lower spring coils. Usually identifiable by a spring that displays dirt contamination on its lower coils but is clean above this point.

2. Kinetic Line Leak

Residue between the O-Rings (2a) and Backing Plate (2b) can run down the machined surface on the damper forging. This can be wiped clean and will not return.

3. Pressure Sensor Leak

If pressure sensor is only hand tight a leak can be present. If pressure sensor torque is to target, oil residue is usually a result of a weep from the Kinetic Lines (see point 2).

4. Accumulator Leak

Oil present around either the top surface of the accumulator (4a) or around the interface with the Valve Housing forging (4b).

5. Nose Lift Collar Leak

- a. Upper Seal - Leak propagates from the upper seal and runs down the outer lift gaiter. Usually identifiable by oil residue on the lift gaiter.
- b. Lower Seal - Leak propagates from the seal pack and runs down the damper body. Usually identifiable by oil residue on the damper gaiter.
- c. Banjo Fitting - Leak propagates from the banjo/lift block interface. Usually identifiable by oil residue running down the front of the lift gaiter from the banjo fitting.

If a leak is found, please proceed as follows:

- Take clear, well-lit and in-focus images as they will be required for any warranty claim.

- Clean any oil from affected area using suitable cleaning agents.
- Take vehicle on an assessment test drive.
- Re inspect area; If the leak has not returned, no further action is required.
- If the fluid leak is still present, the damper(s) needs to be replaced. Ensure the following information is available in the WP for warranty purposes. Failing to include this information may result in claim rejection.
 - a. Clear, well-lit and in-focus images of the before and after condition.
 - b. Direction on the assumed failure, based on the failure modes identified above.
 - c. Clear, well-lit and in-focus images of the label showing the part no. of the faulty damper.

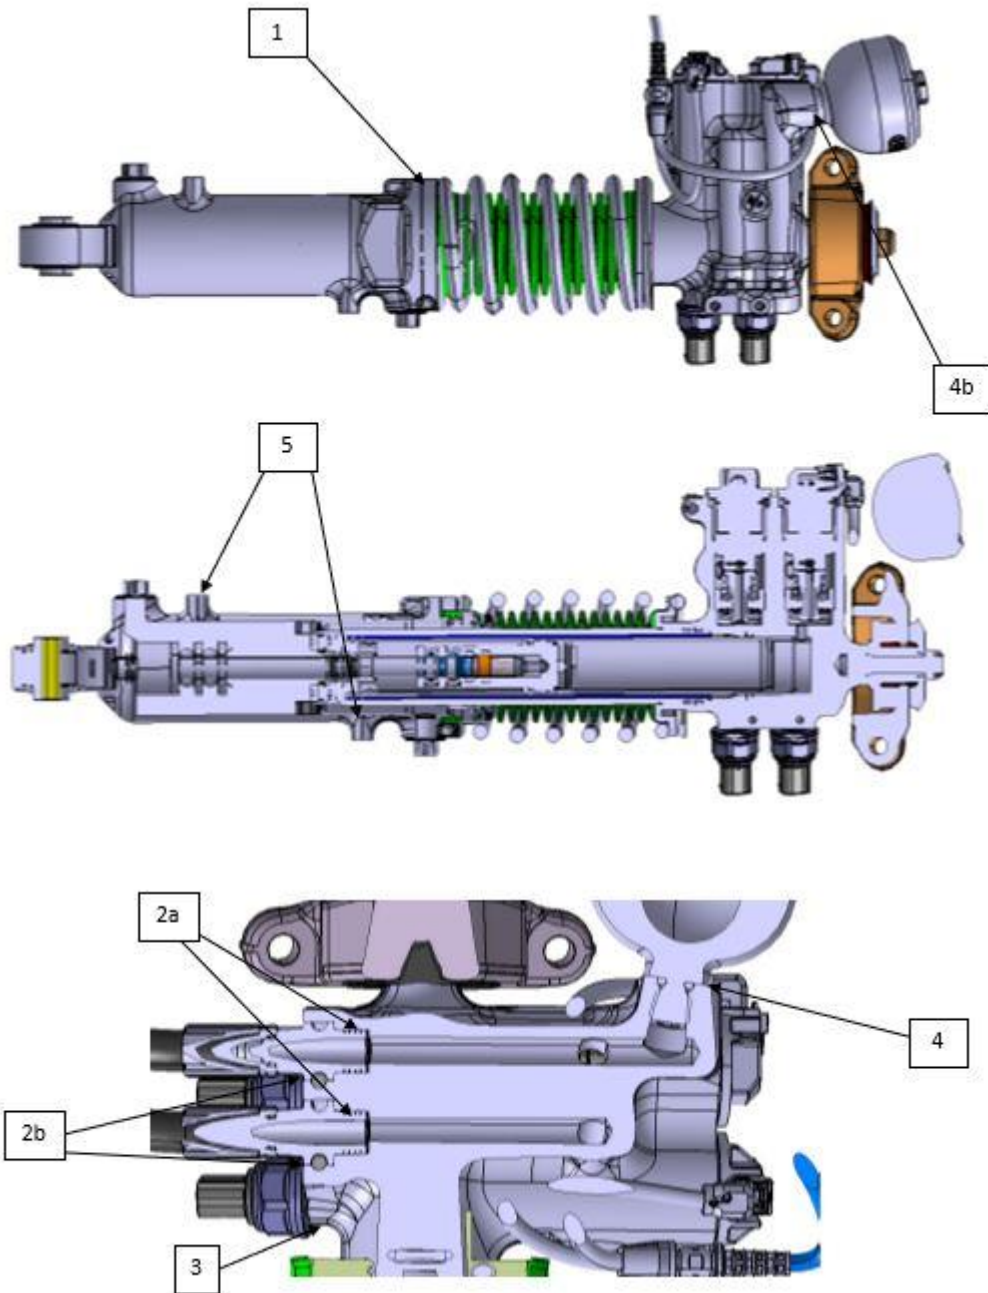
Known locations for component quality occurrences are identified below.

1. Rod Seal Leak

Leak propagates from the seal pack and runs down the heave body. Usually identifiable by a discolouration of the heave body.

2. Kinetic Line Leak

Residue between the O-Rings (2a) and Backing Plate (2b) can run down the machined surface on the damper forging. This can be wiped clean and will not return.

3. Pressure Sensor Leak

If pressure sensor is only hand tight a leak can be present. If pressure sensor torque is to target, oil residue is usually a result of a weep from the Kinetic Lines (see point 2).

4. Accumulator Leak

Oil present around either the top surface of the accumulator (4a) or around the interface with the Valve Housing forging (4b).

5. Heave Circuit Banjo Fitting.

6. Oil leak from the banjo connections, usually a function of an incorrectly torque fastener.

If a leak is found, please proceed as follows:

- Take clear, well-lit and in-focus images as they will be required for any warranty claim.
- Clean any oil from affected area using suitable cleaning agents.
- Take vehicle on an assessment test drive.
- Re inspect area; If the leak has not returned, no further action is required.

- If the fluid leak is still present, the damper(s) needs to be replaced. Ensure the following information is available in the WP for warranty purposes. Failing to include this information may result in claim rejection.
 - a. Clear, well-lit and in-focus images of the before and after condition.
 - b. Direction on the assumed failure, based on the failure modes identified above.
 - c. Clear, well-lit and in-focus images of the label showing the part no. of the faulty damper.
