Technical Service Bulletin

57 Exterior door handles do not return to the zero position

57 21 80 2060196/3 July 26, 2021. Supersedes Technical Service Bulletin Group 57 number 20-71 dated July 24, 2020 for reasons listed below.

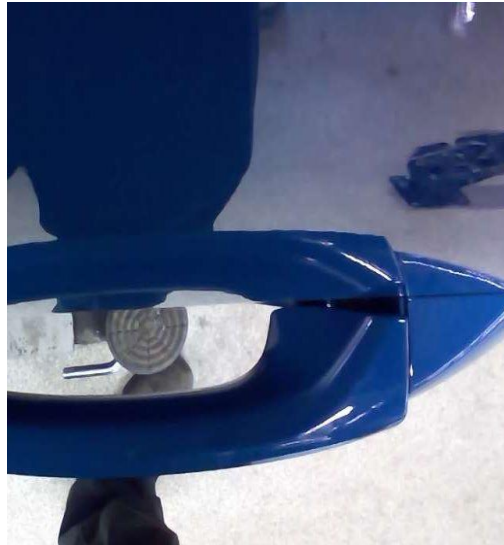
- Exterior door handles are binding and are not returning to the zero position.

Due to material tolerances, the door handle guide is binding within the door handle mounting bracket.

Figure 1. Door handle binding and not returning to zero position.

1. Check the function of all door handles. Door handles should return to the zero position without binding and/or jamming (Figure 1).

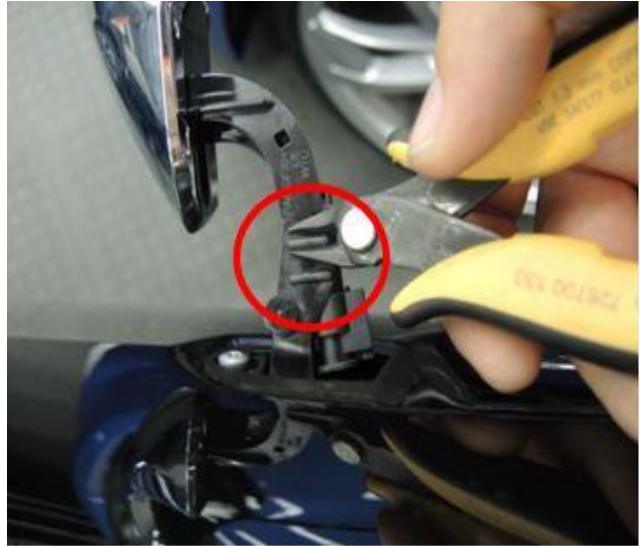
Figure 2. #1 and #2 door handle ribs prior to removal.

- Using precision diagonal cutting pliers, remove door handle rib #1 and #2 on the pivot side of the mounting bracket, toward the front of the vehicle (Figure 2).

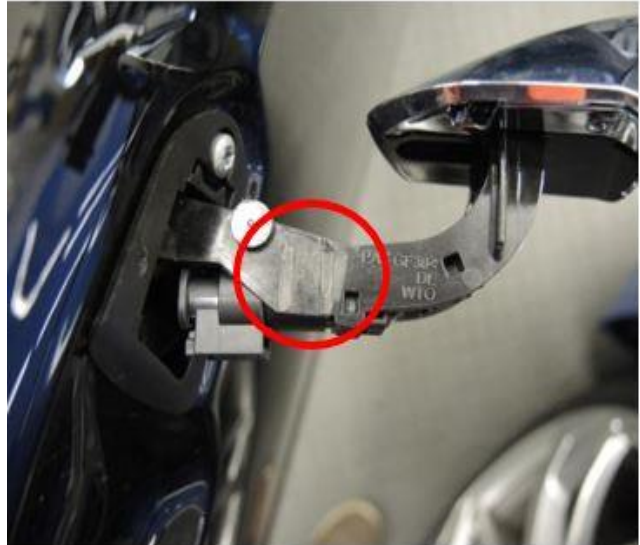
Figure 3. The door handle is shown with #1 and #2 ribs removed, leaving an even surface.

- After removing both ribs, ensure that the resulting surface is smooth and without any protrusions (Figure 3).

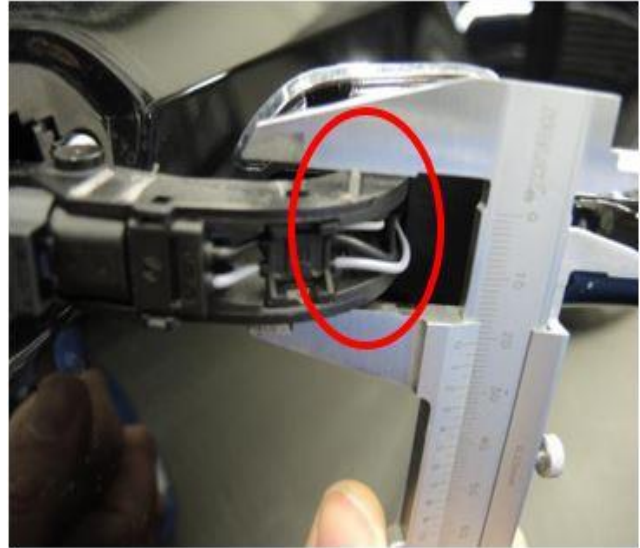
Figure 4. Measuring dimension of a door handle at rib #3.

- Using a vernier caliper, measure the dimension from the bottom edge of the door handle to the top of rib #3 (Figure 4).

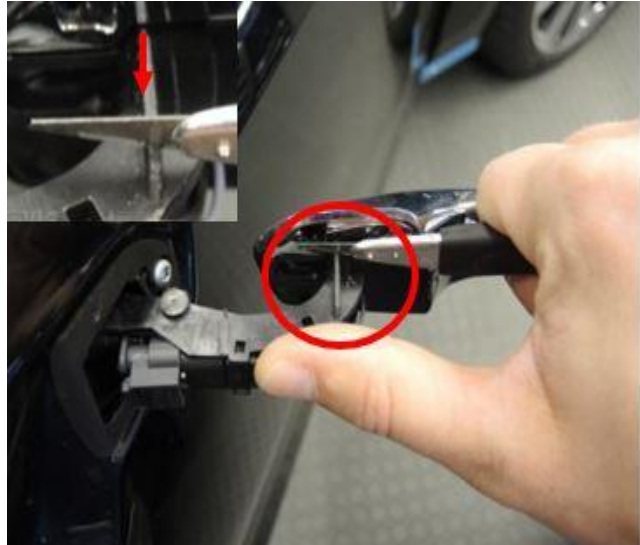
Figure 5. Rib #3 shown with the direction of scraping motion.

- Scrape the top of rib #3 with a precision/utility knife in direction of the arrow until the dimension is 20.9 mm (~ 0.82 inches) (Figure 5).

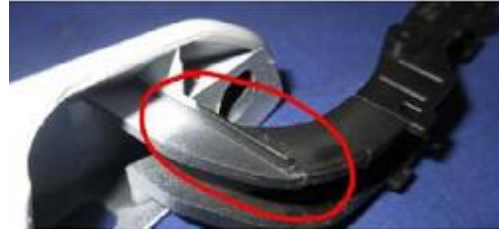
Figure 6. Top of rib #3 to be sanded down.

- Sand down the top surface of rib #3 with sanding paper until the door handle at rib #3 measures approximately 20.6 mm (~ 0.81 inches) (Figures 4 and 6).

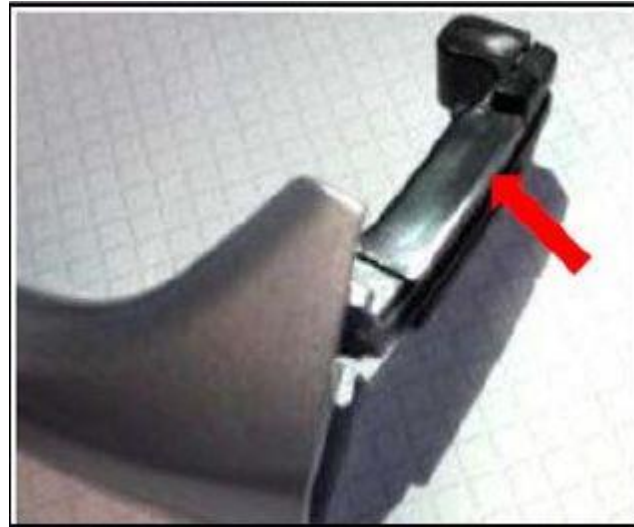
Figure 7. The door handle guide piece to be replaced.

8. Replace the door handle guide piece on the lock cylinder side, towards the back of the vehicle (Figure 7) with a new guide piece (check parts table for part number).
