# Technical Service Bulletin

## 90 Instrument cluster driver information system display is blank

90 21 11 2063913/2 July 26, 2021. Supersedes Technical Service Bulletin Group 90 number 21-09 dated June 30, 2021 for reasons listed below.

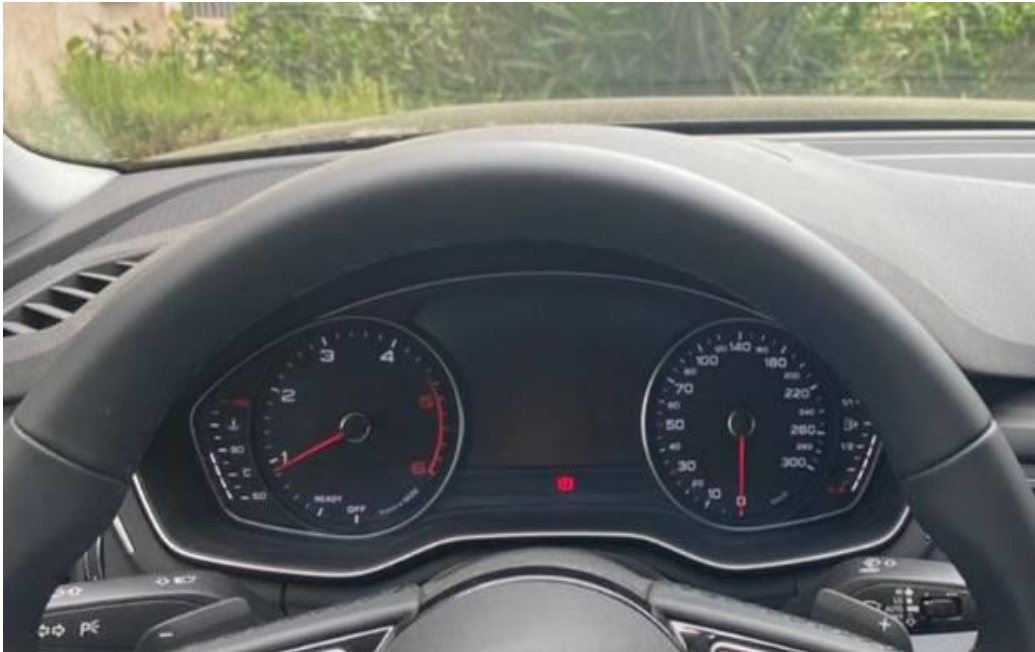
- The driver information system in the instrument cluster (PR Code 9S7) is blank.
- The speedometer, tachometer and bar graphs showing the fuel level and coolant temperature work normally (Figure 1).

**Figure 1.** Instrument cluster display is blank.

There is a hardware defect in the instrument cluster.

1. Follow all instructions in TSB 2011732: *00 Software Version Management (SVM), operating instructions*.
2. Update the instrument cluster, J285 (address word 0017) using the SVM action code as listed in the table below, if necessary:
