39-20-01 - Bevel Box Case Half Leak

Release date: 7/29/2021

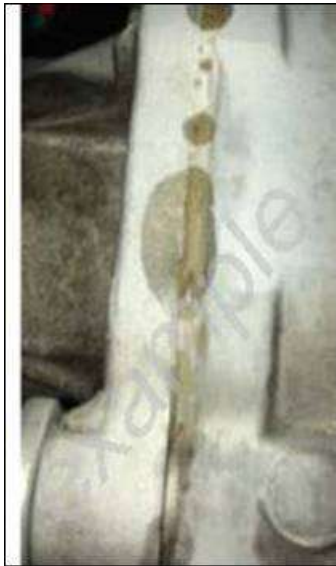
Figure 1.

Gear oil leak from the case halves of the bevel box due to currently used sealant type (Figure 1).

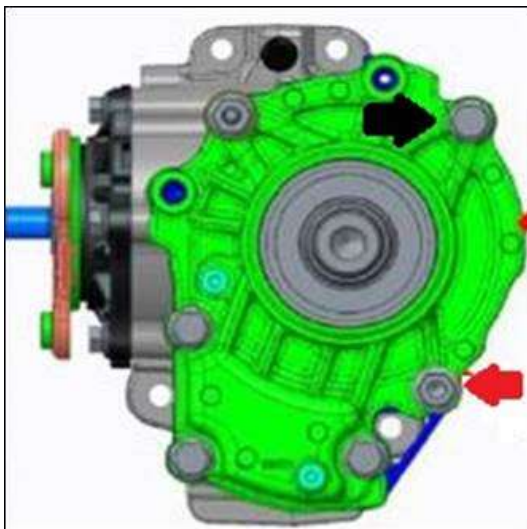
Figure 2.

Source of leak is between the case halves at the right side of the bevel box between the two bolts seen in Figure 2 (red and black arrows).
