**Symptom on Chassis – Cannot Adjust Electric Steering Column Upwards or Downwards:
Observe Specified Procedure (SY 02/21)**

Model Line: **911 (992)**

Model Year: **As of 2019**

Concerns: **Servo motor for electric steering column and front-end electronics control unit (BCM)**

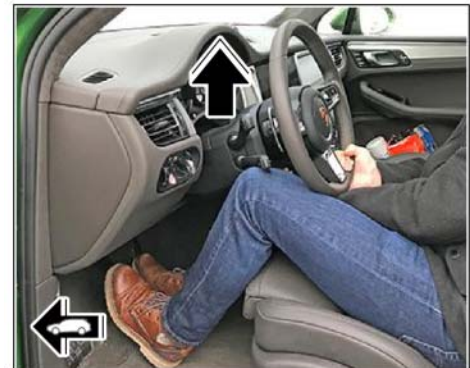
Electric steering column (shown on Macan)

Cause: This may be due to particle deposits in the servo motor for the electric steering column. This produces increased resistance by forming a non-conductive oxidation layer.
This oxidation is due to the diagnostic current, low processing current and the oiled carbon brushes.

- 1.1 Sit in the vehicle and position the knees under the steering wheel. ⇒ *Electric steering column (shown on Macan)*

- 1.2 Press the steering wheel in ⇒ *Electric steering column (shown on Macan)*

-direction of arrow- using a lot of force and at the same time actuate the switch for steering column height adjustment in the corresponding direction of adjustment.
