## Alignment of Fuel Tank - Fill Cap Cover and Mobile Phone Compartment Cover

Multistrada V4 Model Year 2021 (all model versions)

Service Repair Bulletin SRV-SRB-21-050

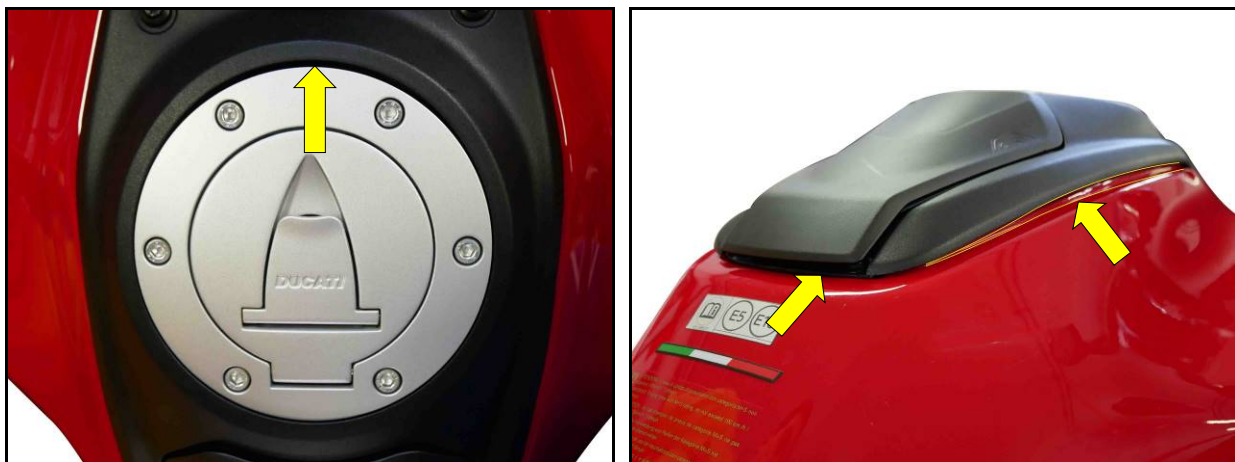
In the event of a possible misalignment of the Fuel Tank's Fill Cap Cover (with respect to the Fill Cap itself) and/or incorrect closure of the Mobile Phone Compartment Lid, please follow these suggestions to help resolve concerns on this matter.

It is possible to realign the Fuel Tank's Fill Cap Cover and the Mobile Phone Compartment Cover by acting on the fuel tank cover fixing screws. In cases where, after following the operations described below, it is not possible to restore the alignment to an acceptable value (for example due to the deformed cover), fill out a **YouTech** service request. Be sure to include notes describing your actions and the issue, as well as clear photos of the alignment problem.
