**Complaint – Porsche Communication Management (PCM) does not Work: Reset Central Computer (93/21)**

Model Line: **Macan (95B)**

Model Year: **As of 2019 up to 2021**

Concerns: **Central computer (PCM 5.0)**

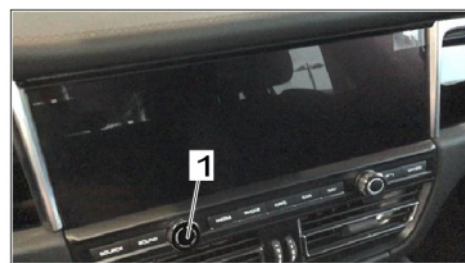
*Volume control PCM*

Information: Porsche Communication Management (PCM) cannot be switched on and the central computer cannot be controlled using the PIWIS Tester.

This fault type can occur after an undervoltage in the on-board electrical system. The central computer goes into an undervoltage protection mode when doing this.

Action required: Reset the central computer. To do this, hold down the volume control ⇒ *Volume control PCM-1* - for ten seconds when the ignition is switched on.

If this procedure is not successful, contact your Technical Support.
