Service Bulletin

Bulletin No.: 21-NA-131

Subject: Memory Seat Module Does Not Adjust

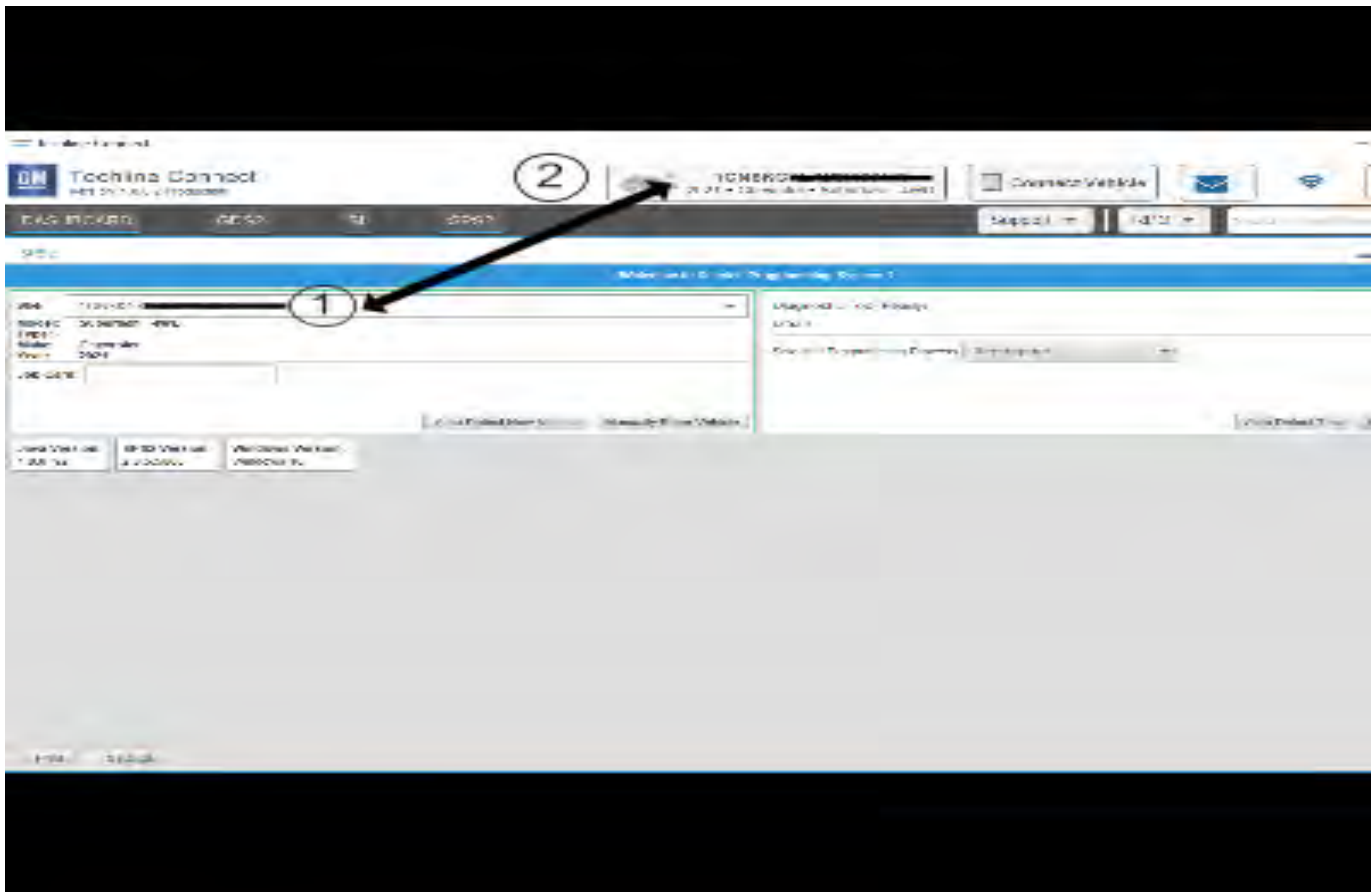
5644477

Caution: Be sure the VIN selected in the drop down menu (1) is the same as the vehicle connected (2) before beginning programming.

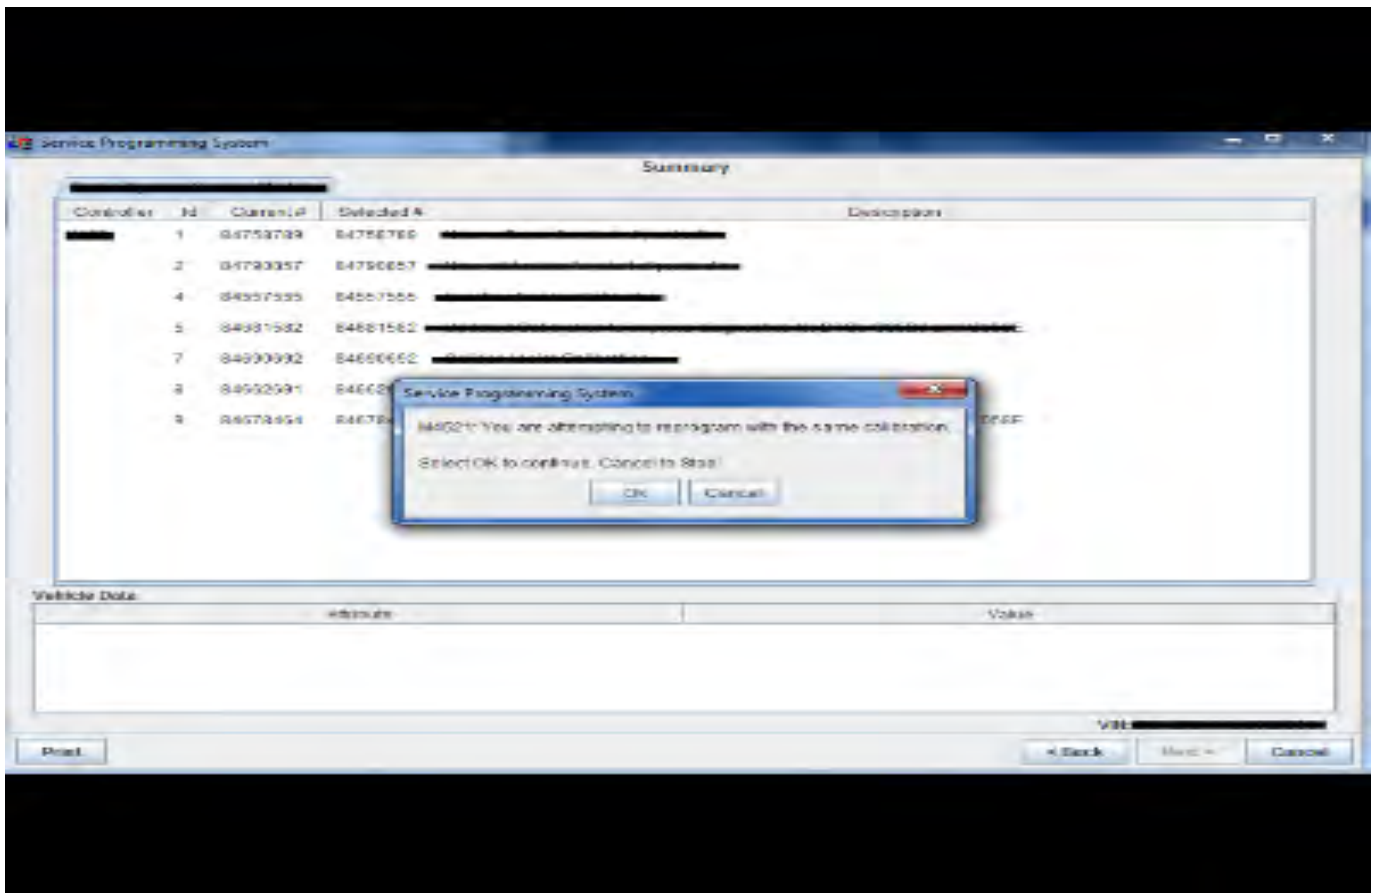
5431207

Important: Techline Connect and TIS2WEB screens shown above.

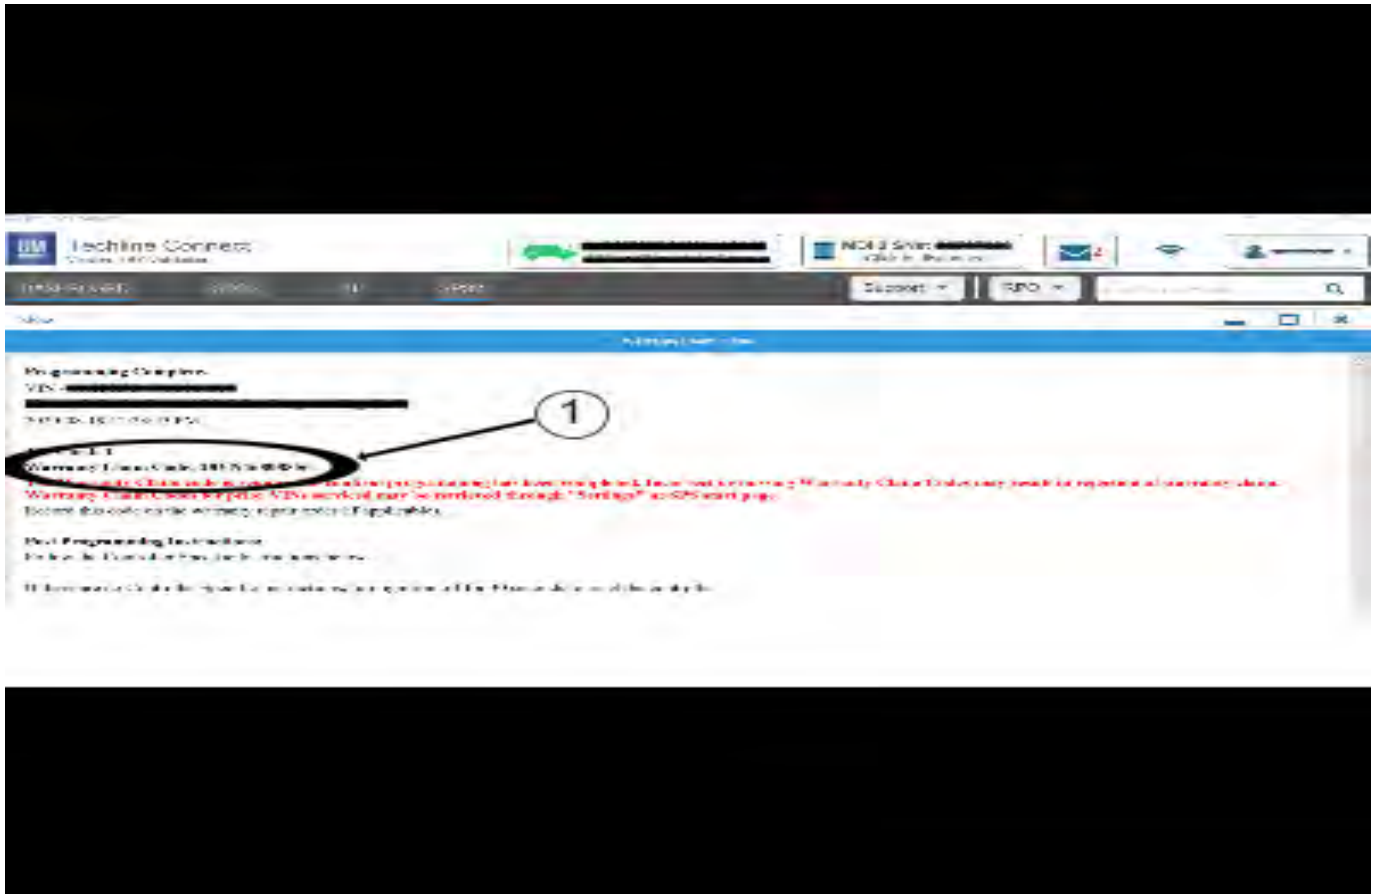
5431209

Note: The screenshots above are an example of module programming and may not be indicative of the specific module that is being programmed. Module selection and VIN information have been blacked out.

Important: To avoid warranty transaction rejections, you **MUST** record the warranty claim code provided on the SPS Warranty Claim Code (WCC) screen shown above on the job card. Refer to callout 1 above for the location of the WCC on the SPS screen.

- Record the SPS Warranty Claim Code on the job card for warranty transaction submission.
