GLOBAL SAFETY FIELD INVESTIGATIONS  
DCS5809  
URGENT - DISTRIBUTE IMMEDIATELY

Subject: N212336570 - Service Update  
Vehicle May Falsely Set Fuel Injector Diagnostic Trouble Codes  
P026C and/or P20EE (Unsold Only)

Models: 2021 Chevrolet Silverado HD  
2021 GMC Sierra HD  
Equipped with Duramax 6.6L Turbo-Diesel (RPO L5P)

## N212336570 Vehicle May Falsely Set Fuel Injector Diagnostic Trouble Codes P026C and/or P20EE (Unsold Only)

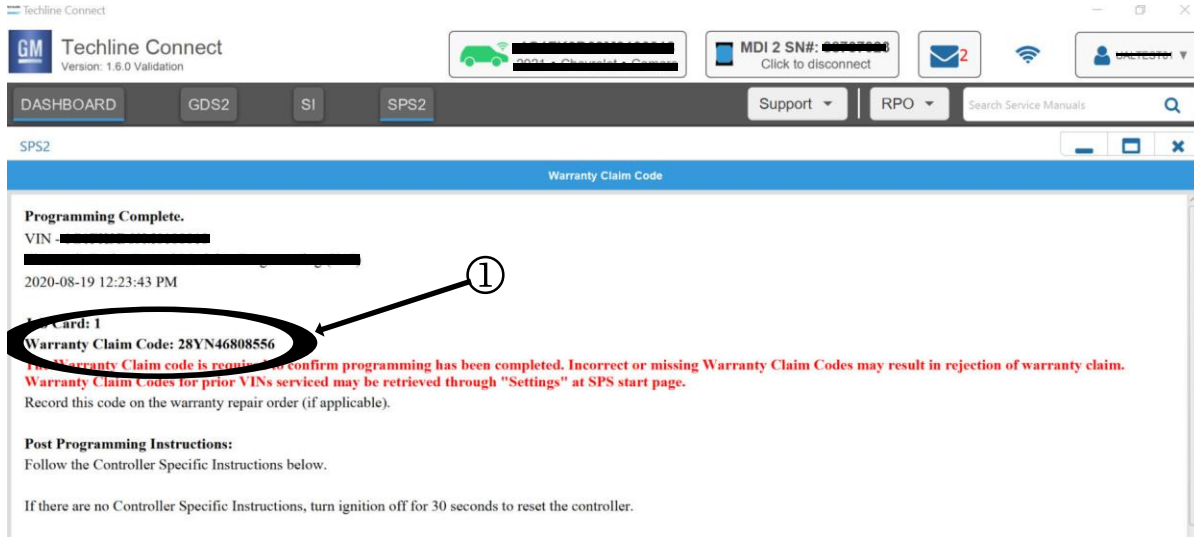
5644478

**Note:** The screenshots above are an example of module programming and may not be indicative of the specific module that is being programmed. Module selection and VIN information have been blacked out.

**Important:** To avoid warranty transaction rejections, you MUST record the warranty claim code provided on the Warranty Claim Code (WCC) screen shown above on the job card. Refer to callout 1 above for the location of the WCC on the screen.

- Record SPS Warranty Claim Code on job card for warranty transaction submission.
