SIB 61 02 08 Wiring Harness Chafing

Service Information Bulletin

Subject: F 650 GS (R13) Wiring Harness Repair

Model: F 650 GS and F 650 GS Dakar (R13)

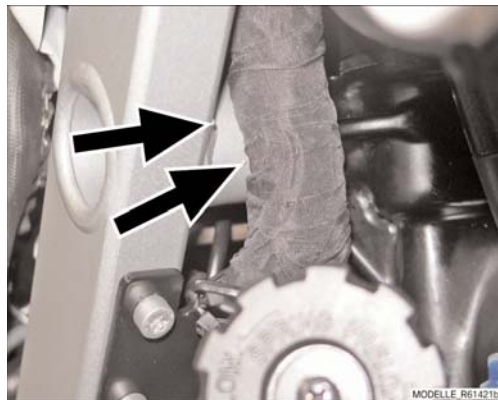
Details: The wiring harness of the F 650 GS and F 650 GS Dakar (R13) models is routed along the right-hand top rail of the frame. Weld spatter on the frame and/or adverse routing in the vicinity of the banjo bolt of the hydraulic spring base adjuster can result in chafing of the wiring harness. If this goes unnoticed, in extreme cases it can result in a broken wire or shorting and lead to malfunctions. See figures 1-3.

Figure 1: weld spatter

- 3) Examine the frame for weld spatter. Weld spatter on the welded-in round tube is critical, and the same applies to weld spatter on the inboard side of the rectangular section frame tube (see Figure 1). Remove weld spatter, if present, with a scraper or chisel. Usually only a small amount of force is necessary to chip off weld spatter. Touch up damage to the paintwork with a touch-up pencil, for example BMW part number 51 91 0 302 241 (concealed areas).

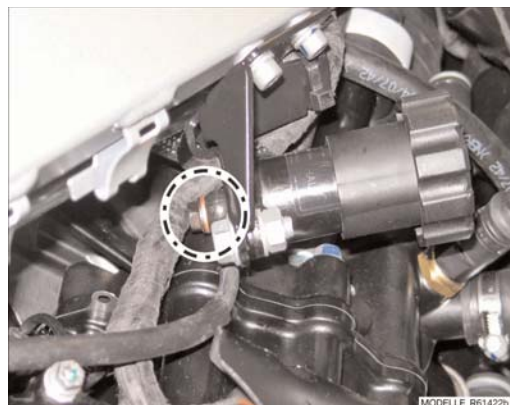
Figure 2: tight spot at banjo bolt

- 4) Use two cable ties (as shown in Figures 4 & 5) to secure the wiring harness to the bracket of the adjuster knob, making sure that the wiring harness is routed clear of the banjo bolt by a sufficient margin.

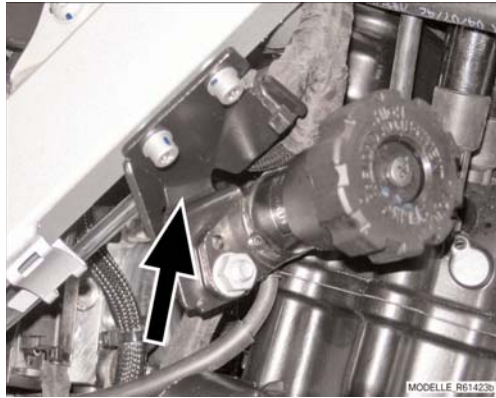
Figure 3: cable tie missing

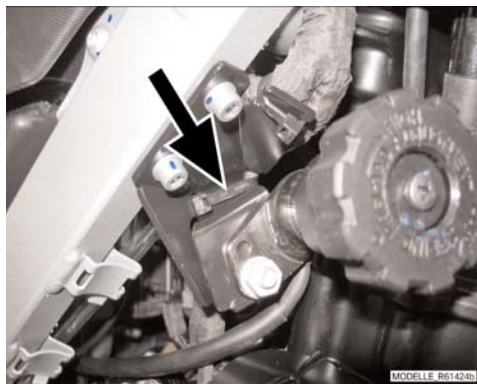
Figure 4: second cable tie

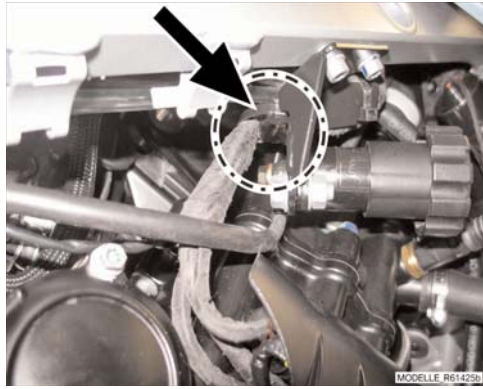
Figure 5: second cable tie, rear view
