# TECHNICAL SERVICE BULLETIN

Technical Service Bulletin: 502-1397

# TECHNICAL SERVICE BULLETIN 502-1397 REMEDY INSTRUCTIONS

Make(s): TANDARA  
 Model(s): MANY, SEE BELOW  
 Model Year(s): 2021

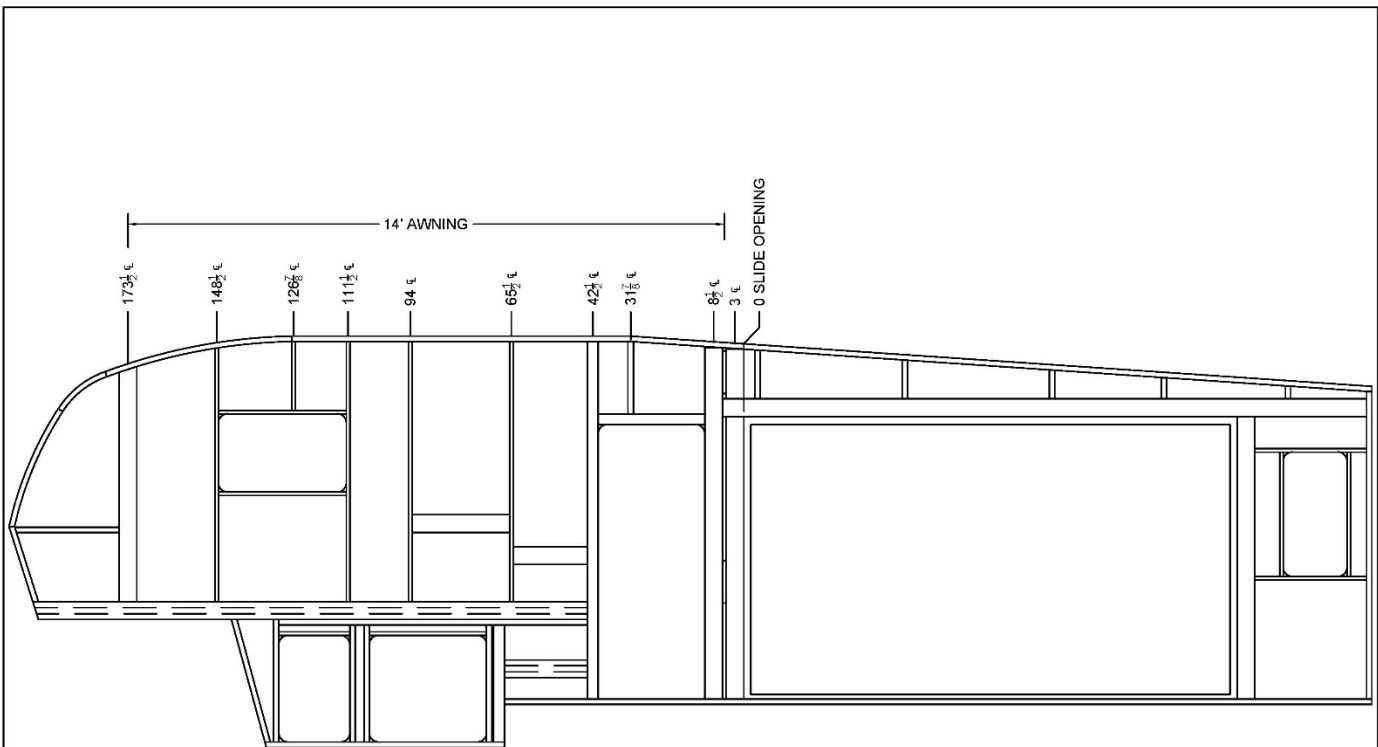
Concern:  
 The awning rail is not secured properly to a backer in the sidewall.

STEP 1: USING THE INCLUDED DRAWINGS FOR REFERENCE, LOCATE AND INSTALL ADDITIONAL 1" WOOD SCREWS (MAX. LENGTH, NON-SELF TAPPING) IN THE AWNING RAIL. ENSURE EACH FASTENER HITS THE ALUMINUM TUBES IN THE WALL AS DEPICTED;

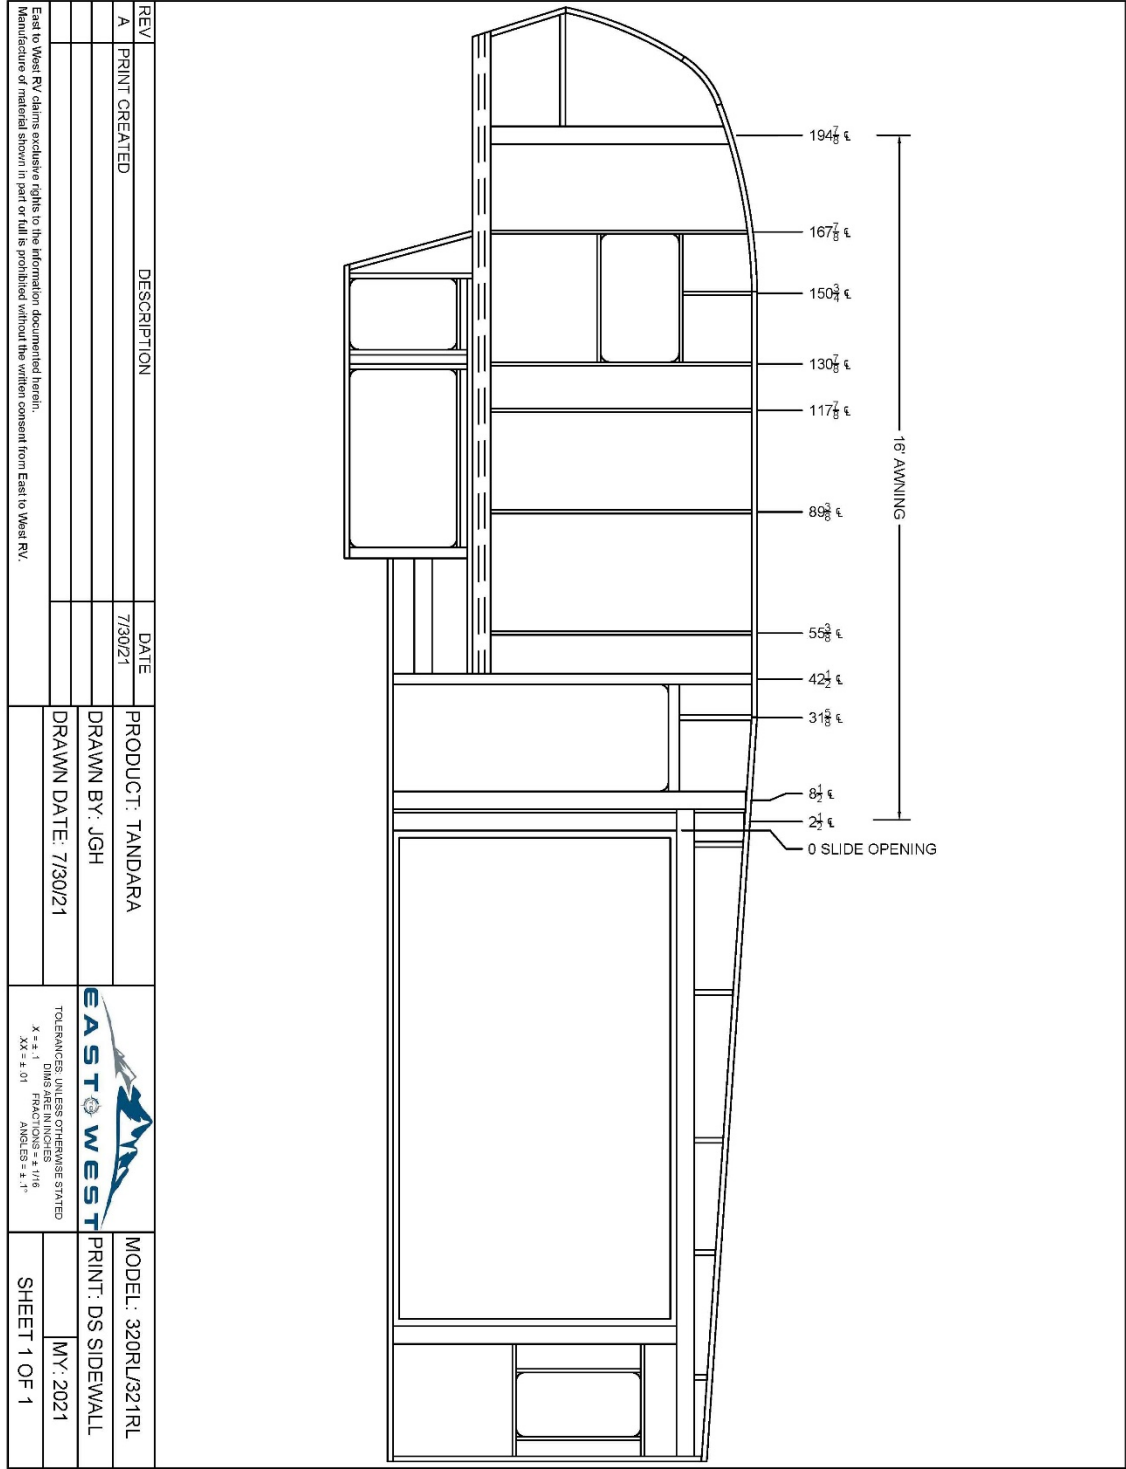
Concern:  
 The awning rail is not secured properly to a backer in the sidewall.

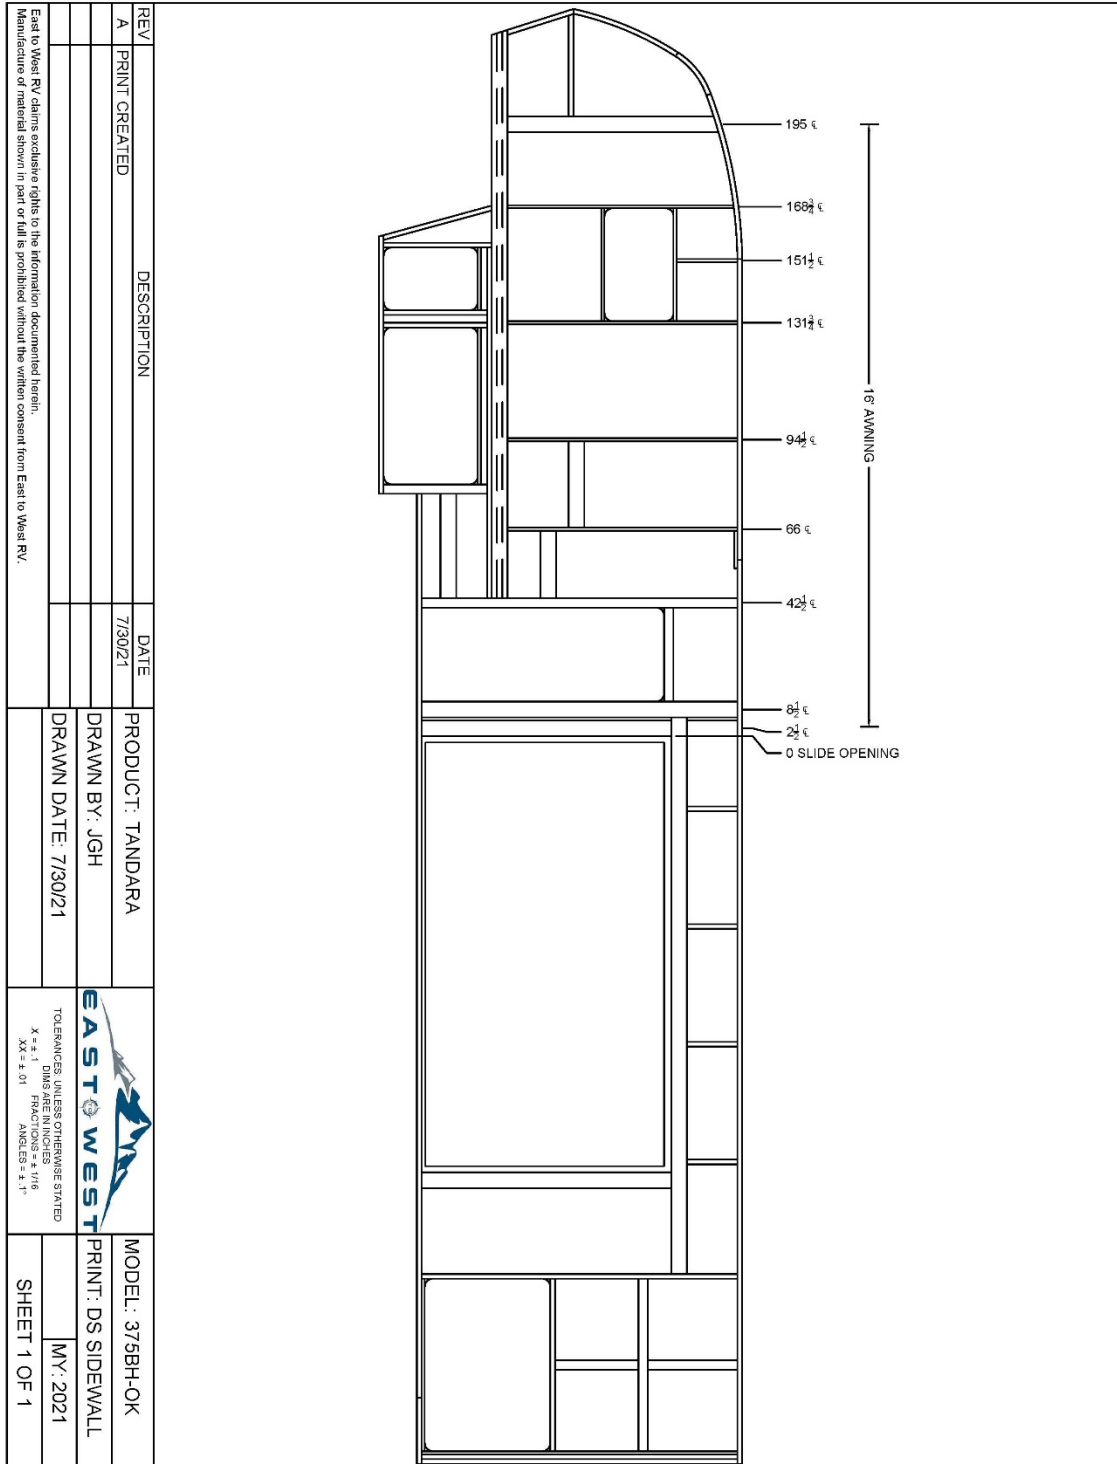
Concern:  
 The awning rail is not secured properly to a backer in the sidewall.

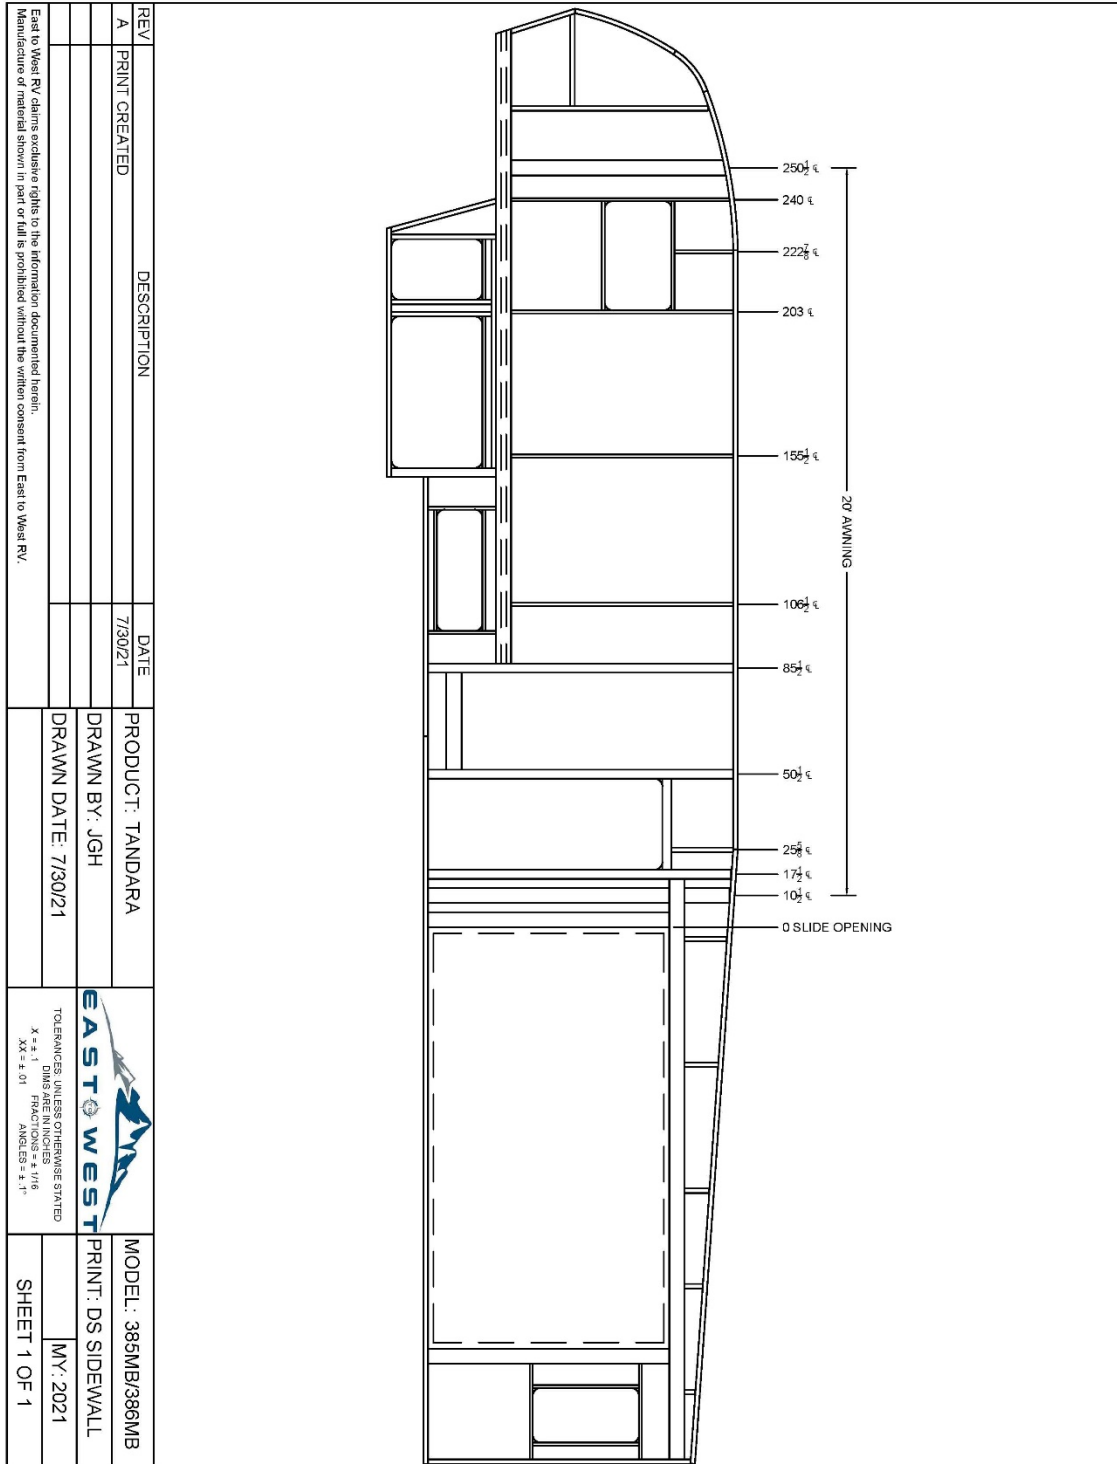
Concern:  
 The awning rail is not secured properly to a backer in the sidewall.
