Technical Service Bulletin

SUBJECT:		No: TSB-21-42A-001REV2	
HOOD LATCH & BUMPER HEIGHT ADJUSTMENT - REVISION		DATE: March 2021	
		MODEL: See Below	
CIRCULATE TO:	<input type="checkbox"/> GENERAL MANAGER	<input checked="" type="checkbox"/> PARTS MANAGER	<input checked="" type="checkbox"/> TECHNICIAN
<input checked="" type="checkbox"/> SERVICE ADVISOR	<input checked="" type="checkbox"/> SERVICE MANAGER	<input type="checkbox"/> WARRANTY PROCESSOR	<input checked="" type="checkbox"/> SALES MANAGER

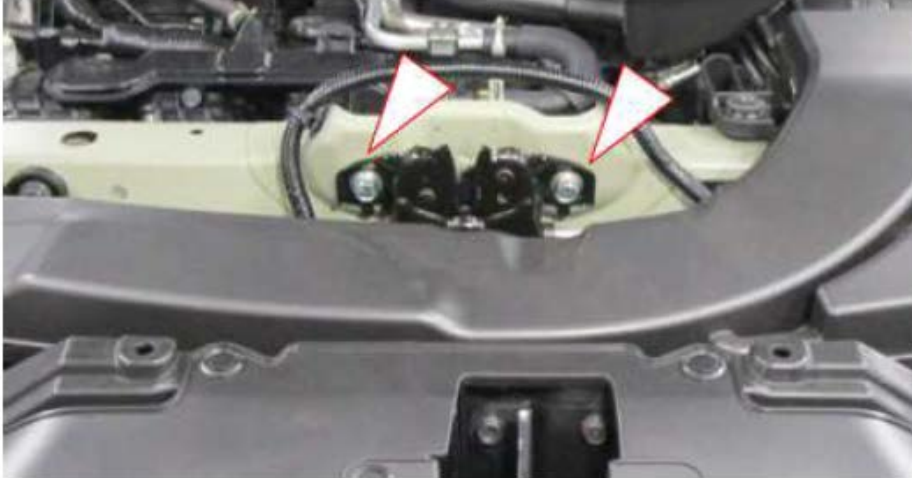
A hood flutter may occur on *certain* 2022 Outlanders. This is caused by improper Hood Latch and Bumper Height Alignment. ◀

3. Loosen 2 bolts which secure the Latch to the Body and move Latch down to its lowest position.

4. Fasten 2 bolts with fixing torque 22Nm and loosen by 1 revolution.
 - a. Drop the Hood from the height of 100mm for the for centering of the Latch.
 - b. Open the Hood and fasten 2 bolts with fixing torque 19 -22Nm to secure the Latch.
 - c. Install the Latch Cover with 2 bolts, fixing torque 4 -6Nm.
 - d. Install the Upper Bar Cover with 10 clips.
