**August 11, 2021**

Version 3

**Product Update: 2016–20 HR-V Software Update and CVT Inspection**Supersedes 21-046, Dated June 1, 2021, to revise the information highlighted in **yellow**.**AFFECTED VEHICLES**

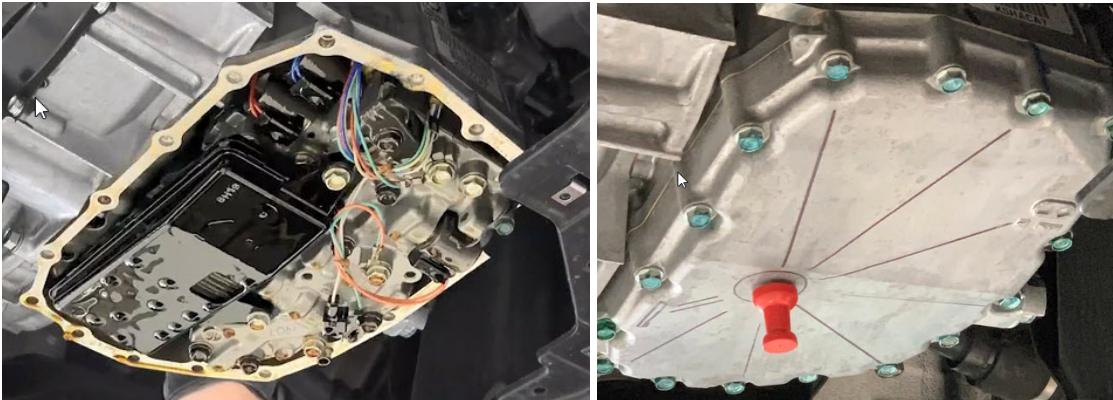
NOTE: While sliding the magnet on the oil pan, you may feel the magnet sticking in some areas shown on illustration below. This is normal as there are some bolts under the oil pan that attach the valve body to the transmission.

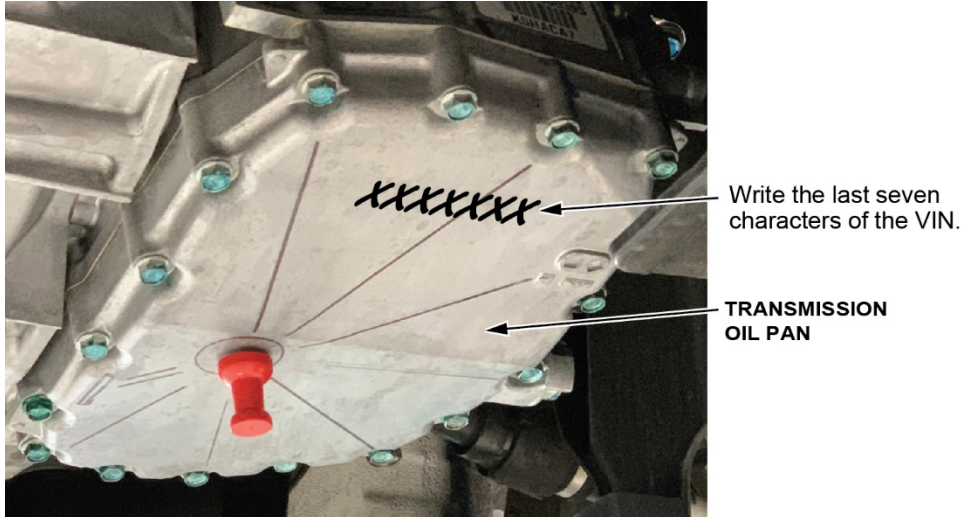
10. After tracing all 7 lines from the outside to the inspection area, let go of the magnet to see if it sticks in place. If the magnet sticks to the oil pan in the inspection area there is a problem with the transmission. Write the last 7 characters or digits of the VIN on the bottom of the oil pan. Take a clear picture of the magnet sticking to the oil pan in the inspection area, make sure the VIN characters are clearly seen in the picture, then go to service bulletin 21-047, *Warranty Extension 2016 - 20 HR-V CVT Premature Belt Deterioration*. If the magnet does not stick to the oil pan, go to the next step.
