91-21-02 MIB3 Composition & Discover Media Infotainment System Malfunctions

Release date: 8/16/2021

Transaction No: 2064286/2

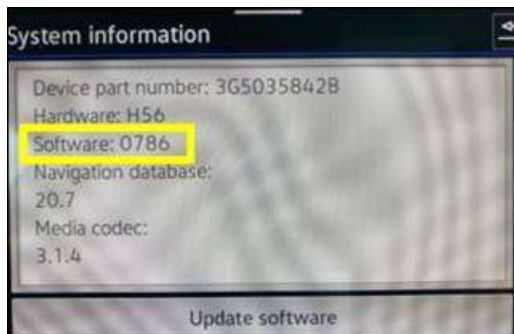
Figure 1.

If the current software level is lower than **0805**, proceed with this Technical Bulletin.

If the current software level is greater than or equal to **0805**, this work procedure does not apply.

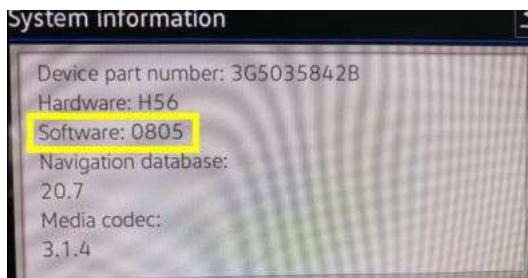
Figure 2.

Confirm that the software is updated to version **0805**. (Menu > Settings > System Information) (Figure 2).
