## Technical Service Bulletin

Transaction No: 2061309/3

48-20-01 - Electromechanical Power Steering - Creaking Noise when Turning

Release date: 8/30/2021

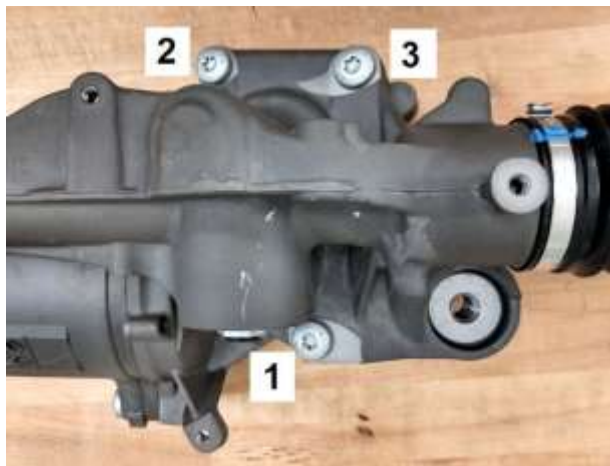
Figure 2

Noise resulting from tension between the servo motor unit and the steering gear housing.

- Remove the T30 Torx screws holding the heat shield in place and remove it from the steering gear.
- Note the position of the servo motor unit within the steering gear housing.
- Following the sequence 1, 2, and 3 shown (Figure 2) loosen the three T40 Torx screws about half a turn to relieve tension in the servo motor unit.

- Tighten the three T40 Torx screws in sequence 1, 2 and 3 (Figures 2, 4, 5 and 6) with a torque of **10 Nm**.
- Retighten the three T40 Torx screws in sequence 1, 2 and 3 (Figures 2, 4, 5 and 6) with a turning angle of **65°**.
- Verify the final torque of the three T40 Torx screws in sequence 1, 2, and 3 (Figures 2, 4, 5 and 6) using a torque value of **25 Nm** while checking that no more than **10°** of additional turn is applied.

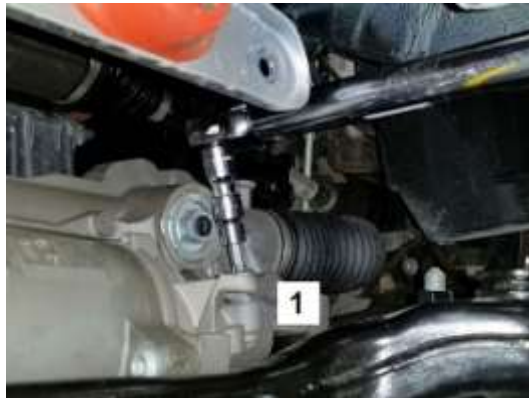
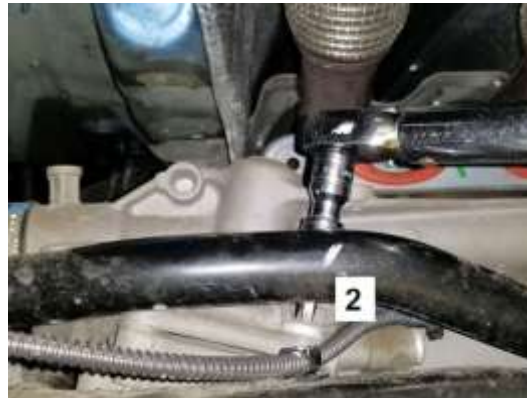
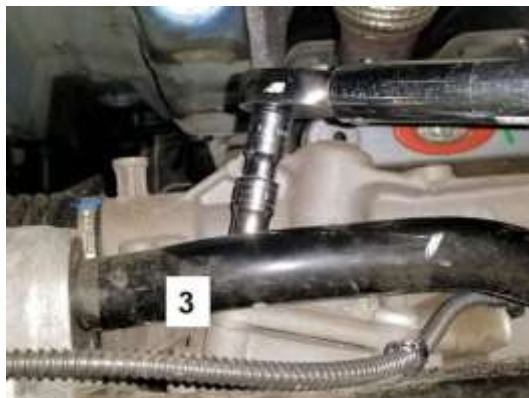
If a torque of **25 Nm** is not reached with no more than **10°** of additional turn (max. total turn **75°**), then the steering gear must be replaced! Worn or damaged threads are non-repairable.
