TECHNICAL SERVICE BULLETIN

8F35 - Illuminated MIL, DTC P0766, Intermittent No Reverse Engagement

21-226811 August
2021

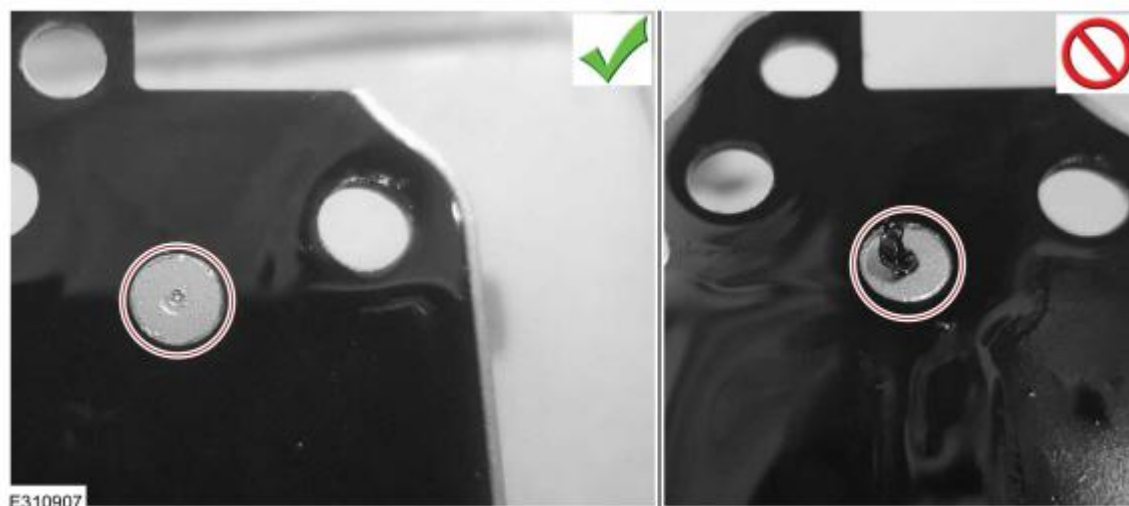
Figure 1

Issue: Some 2019-2021 Edge/Nautilus/Transit Connect, 2020-2021 Escape/Corsair and 2021 Bronco Sport vehicles equipped with a 8F35 transmission may exhibit an illuminated malfunction indicator lamp (MIL) with diagnostic trouble code (DTC) P0766 stored in the powertrain control module (PCM) and/or intermittent no reverse engagement concerns. This may be due to contamination in the main control valve body separator plate orifice. To correct the condition, follow the Service Procedure steps to clean the contamination from the main control plate.

1. Remove the main control valve body. Refer to Workshop Manual (WSM), Section 307-01.
2. Remove the main control separator plate. Refer to WSM, Section 307-01.
3. Clean and remove any debris from the separator plate orifice. (Figure 1)
