**992-Upper Oil Pan Seal Housing Leak**

Models	Model Year	Model Type	VIN Range	Vehicle-Specific Equipment
911	Up to 2021	992	N/A	N/A

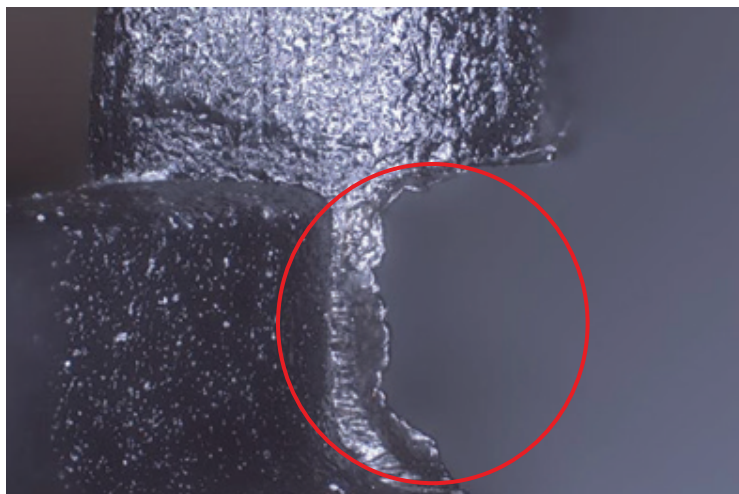
The aforementioned condition may be caused by an injection molding defect known as **flashing** which may be responsible for sharp edges in the upper oil pan housing as seen in **Figure 1**.

Figure 1 - Sharp Edges on Upper Oil Pan

Please replace the affected seal (**Part # OPB 115 111 B**) in case any oil leak coming from the rear (engine area) of the vehicle. Before replacing, please remove the plastic body of the new seal and check for the conditions described above. If flashing can be seen on the plastic body, remove it with an appropriate tool and check the seal for damage. If the seal is undamaged, reassemble the plastic body and seal correctly.

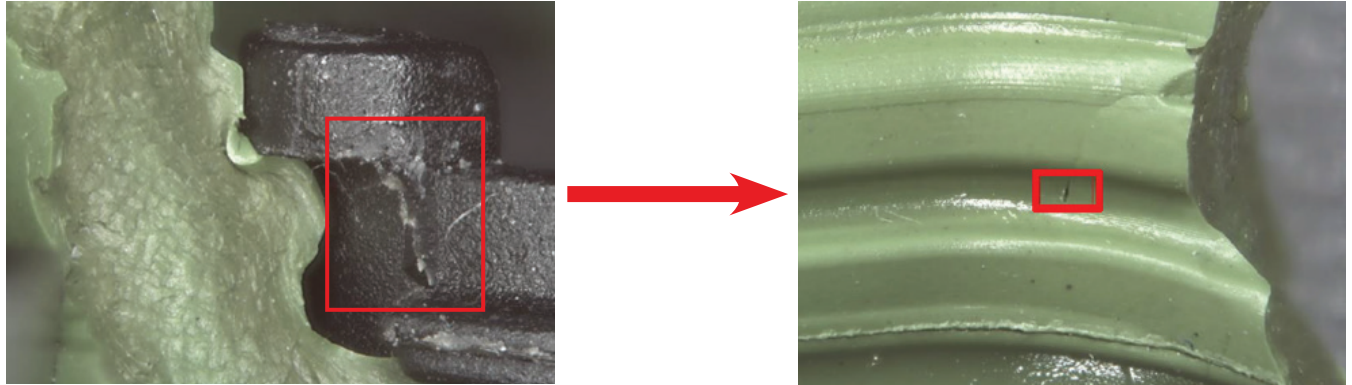
These sharp edges can potentially cause cuts to seals within the oil pan, and cause improper sealing of oil passages. Oil leaks can result from this in the above mentioned conditions. **Figure 2** below shows the damage on the seals caused by the sharp edges pictured in **Figure 1**.

**Figure 2 - Effect of Injection Molding Defect Causing Damage in Seal**
