SERVICE BULLETIN

APPLICABILITY: 2020-22MY Legacy / Outback, Forester, & Ascent

NUMBER: 12-323-21

SUBJECT: Water Intrusion / Door(s) Area

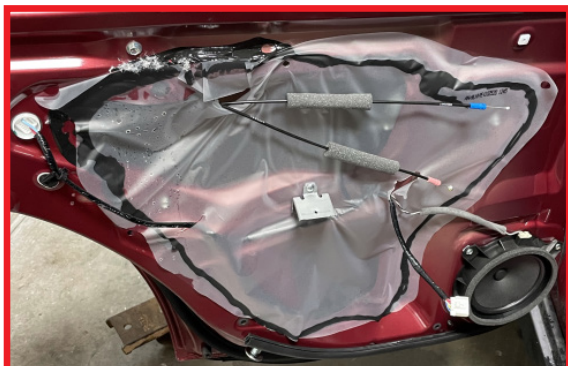
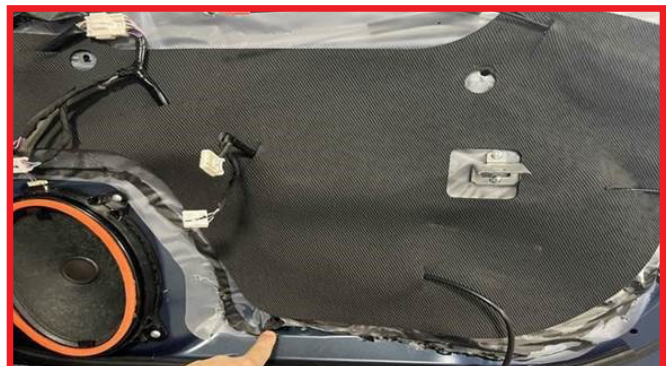
Scenario #1 – Vapor barrier not sealing properly, allowing water into the cabin area.

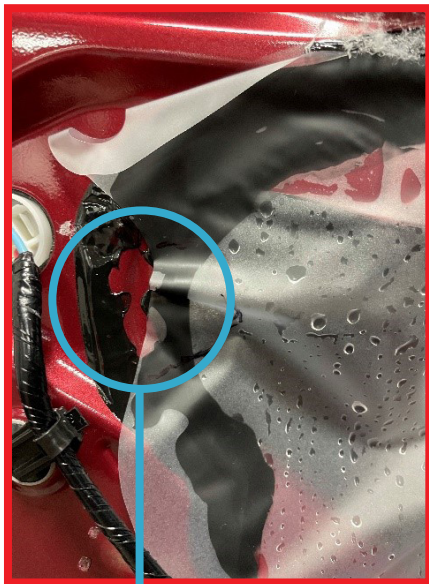
- STEP 5)** **CAREFULLY** separate the affected section vapor barrier sealing cover. Inspect the butyl tape-to-cover areas for any voids or poor contact areas.

Butyl Tape Void

STEP 9) When voids in butyl tape coverage are found, clean affected areas of the body with Subaru Brake Cleaner (SOA868V9117 or equivalent) on a dampened paper towel. **DO NOT** use any cloth containing fibers as it will contaminate the butyl tape. Allow the area to thoroughly dry. Apply the butyl tape to the affected areas. Press firmly on the ribbon backing when applying. Peel away the ribbon backing and reinstall the vapor barrier section.

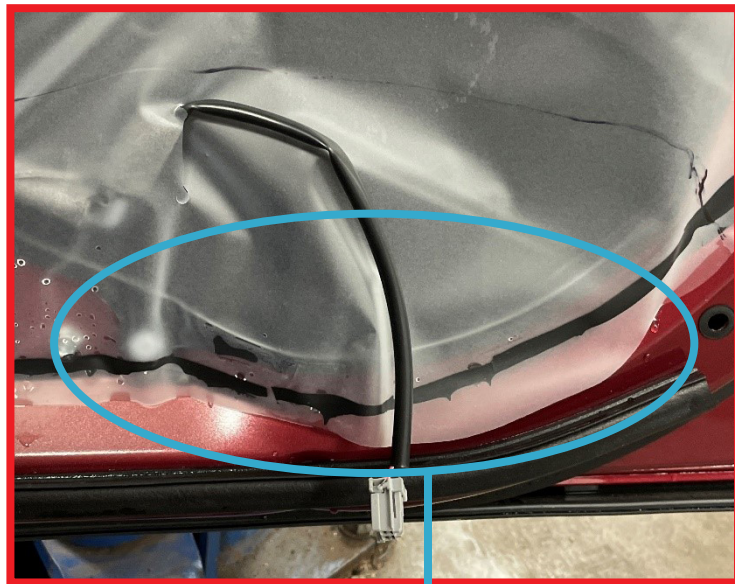
Butyl Tape Poor Contact / Separation

STEP 10) Firmly press the outside of the vapor barrier against the new and existing butyl tape ensuring there is good contact. Be sure there is sufficient contact in **ALL** areas.

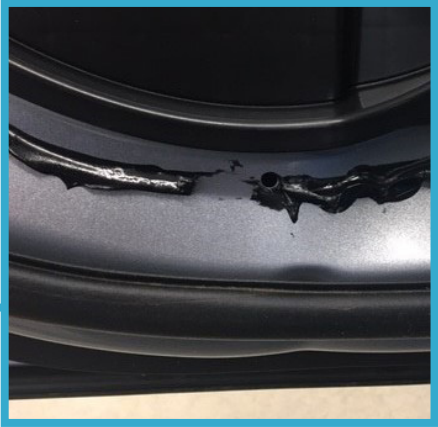
Example of Butyl Tape Void

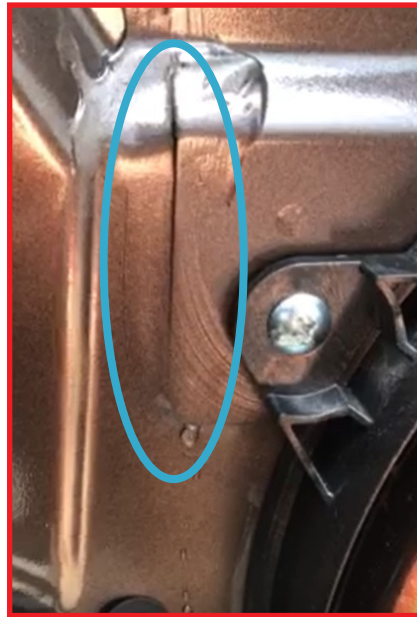
Scenario #2 – Seam sealer void identified near the front door speaker area as shown below.

- STEP 5)** Remove all moisture, clean affected area with Subaru Brake Cleaner (SOA868V9117 or equivalent) applied to a clean shop cloth and allow to thoroughly dry.

- STEP 6)** Following the manufacturer's instructions, **CAREFULLY** apply the recommended seam sealer to affected area and allow to dry.
- STEP 7)** **CAREFULLY** reinstall all components in reverse order of removal.
