43-069 - DPF Regeneration Two-Position Switch Parameter Update

43-069

Inlet/Exhaust/Aftertreatment - 43

DPF Regeneration Two-Position Switch Parameter Update

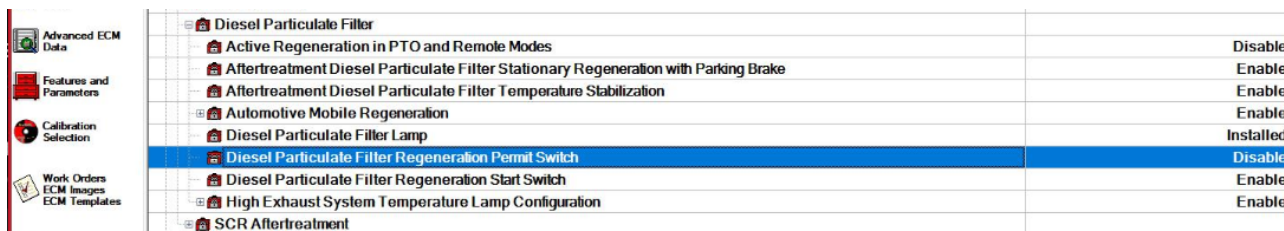
A DPF regeneration two-position switch parameter is causing inhibited DPF regeneration. A parameter update, via Cummins Insite, restores proper DPF regeneration function.

1. Connect to the truck with Cummins Insite.
2. Select **Features and Parameters** and locate the parameter named *Diesel Particulate Filter Regeneration Permit Switch*.

3. Set the status to **Disable**.
