MOST Bus Network: Overview, Troubleshooting, and Repairs

Year	Model	Trim Level
2018 and later	Odyssey	ALL
2019 and later	Passport	ALL
2019 and later	Pilot	ALL

This job aid contains information on the MOST Bus Network and troubleshooting information for common problems.

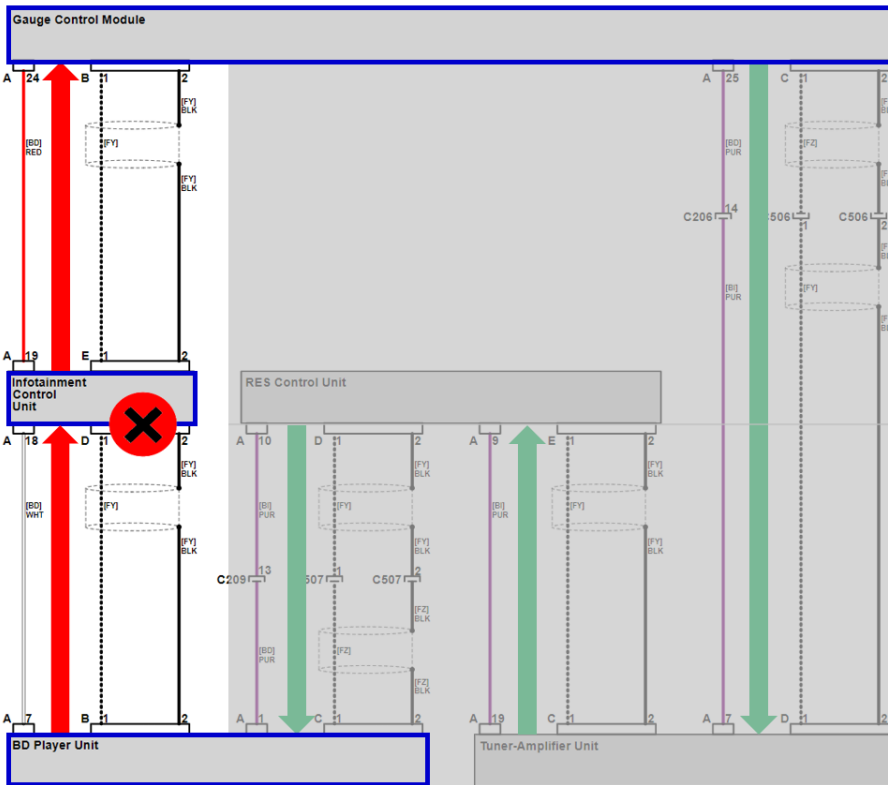
Troubleshooting this circuit revealed a bad connection at the MOST connector in the infotainment control unit.

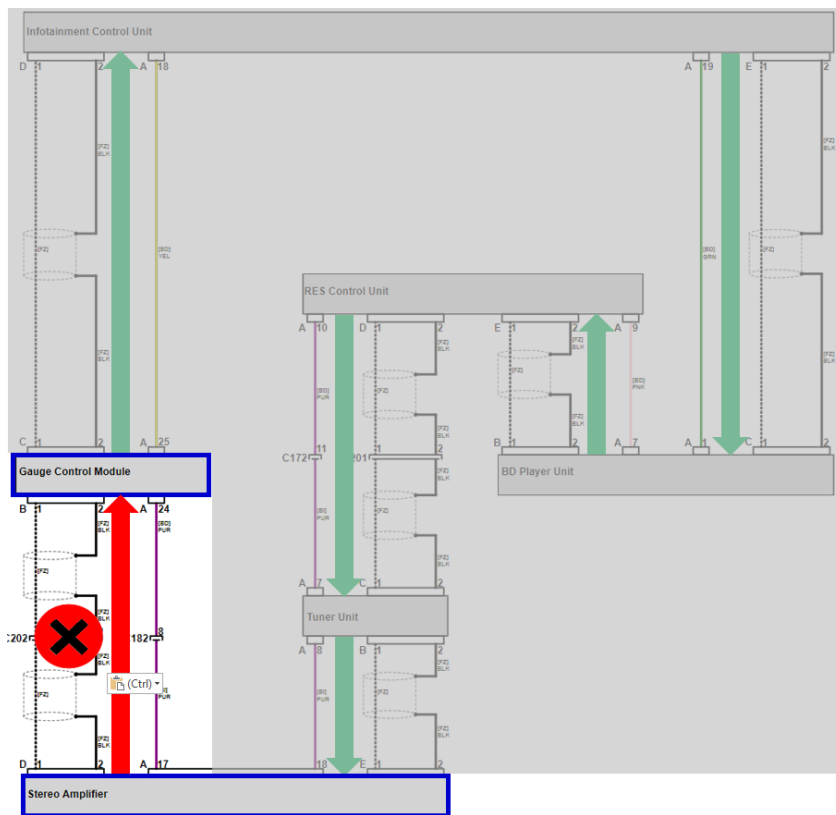
Troubleshooting this circuit revealed a bad connection at inline connector C202.

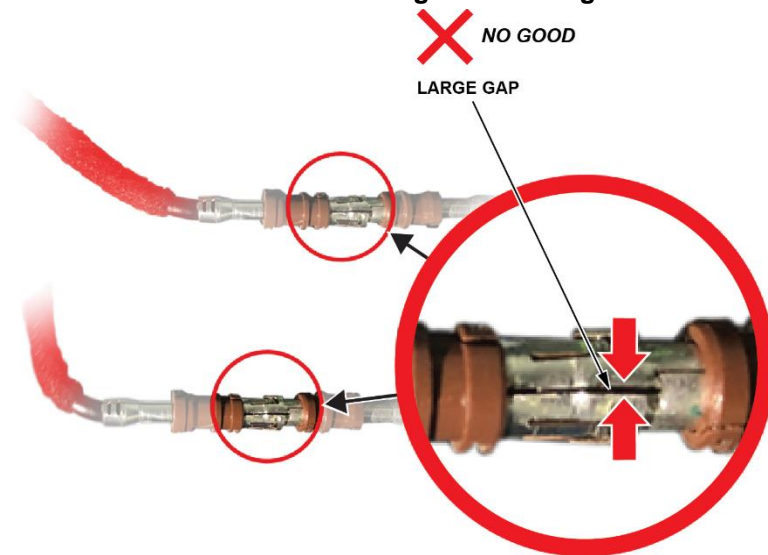
Harness tension at 45 and 90 degrees creating side load. The terminal will spread at the gap.

NOTE: The various service bulletin repair procedures available on SIS related to repair MOST-related problems will have you install a new terminal to help avoid terminal spreading. However, it is important to still make sure that the harness wire and connectors are installed back to their original condition.

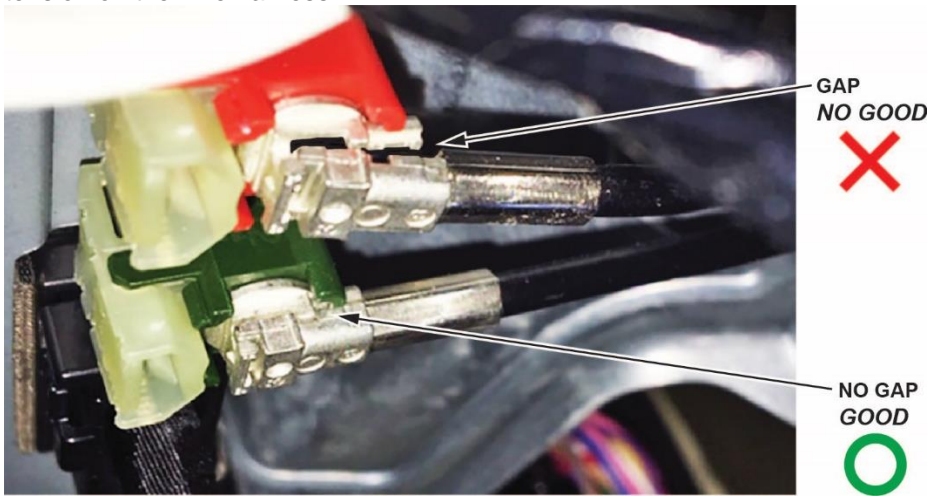
Example 1

The green connector sits correctly, perpendicular to the control unit, while the red connector sits at an angle caused by tension on the wire harness.

In both examples, the connector is considered damaged, and the wire harness must be replaced. These connectors **are not** repairable.

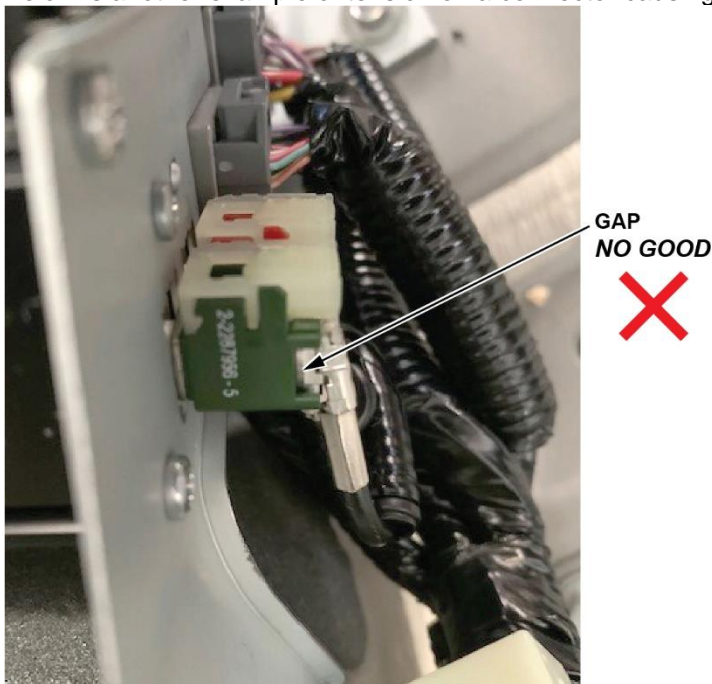
Below is another example of tension on a connector causing the green connector to sit an angle.

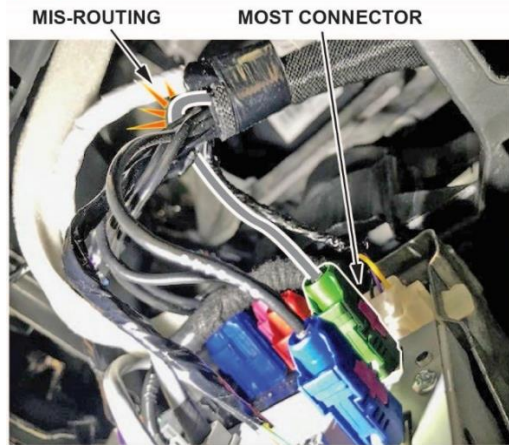
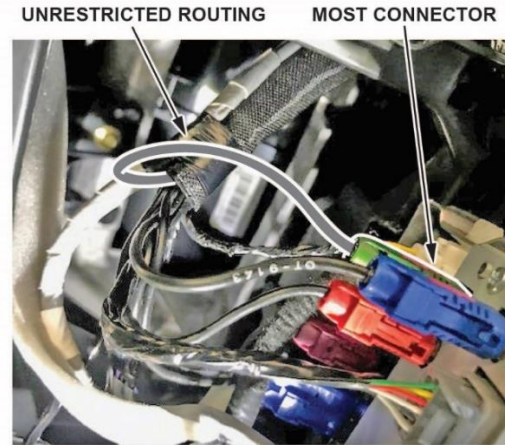
Example 2

One wire is mis-routed causing tension to the green connector. To repair this, disconnect the MOST connector and reroute the harness wire to remove the tension.

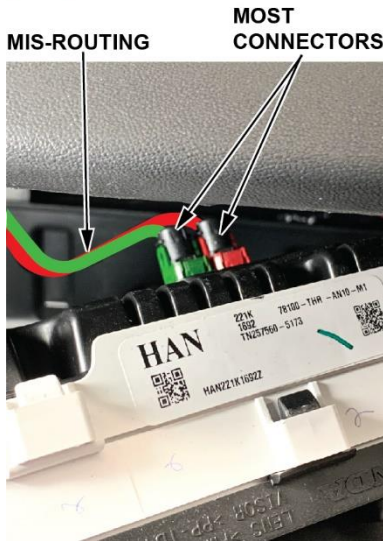
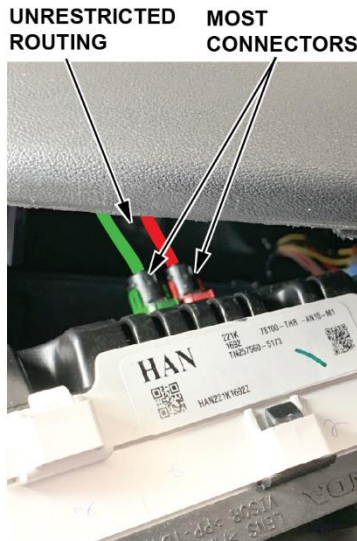
Below are more examples of incorrect harness mis-routing.

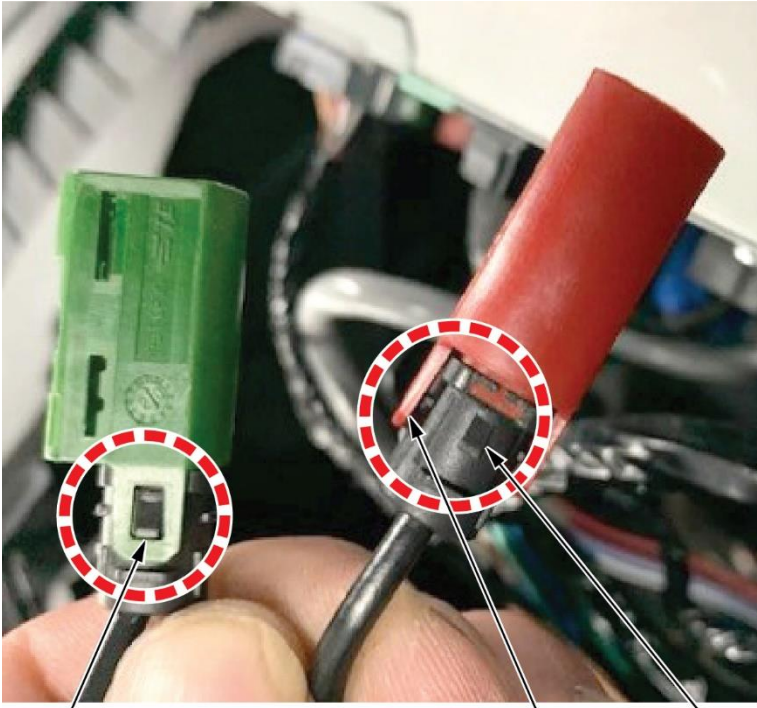
Example 4

The updated terminal is correctly installed onto the green FAKRA housing but not on the red one. The connector was installed 90 degrees off and was not engaged to the locking tabs.

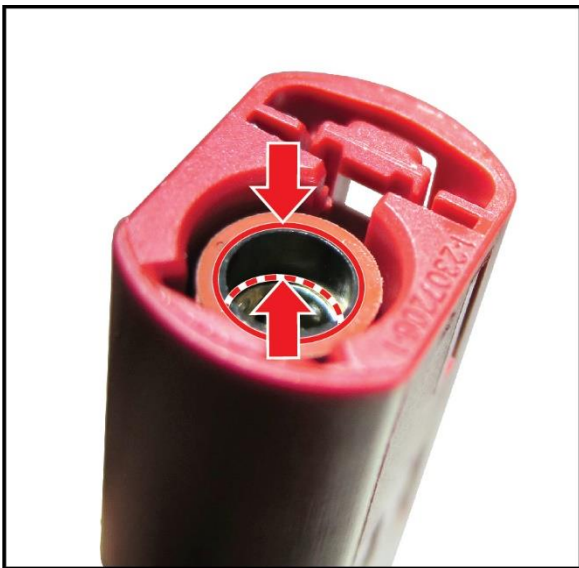
Example 5

The wire is not fully seated into the new terminal. The edge of the wire must sit with the edge of the updated terminal.

When inserting the wire into the new terminal, make sure you hear a click to ensure it is fully seated.
